NEW MOUNT STREET
ELEVATION MARKUPS TO ACCOMPANY
SCHEDULE OF REPAIR WORKS TO EXTERIOR
AXIS ARCHITECTURE
22-06-18

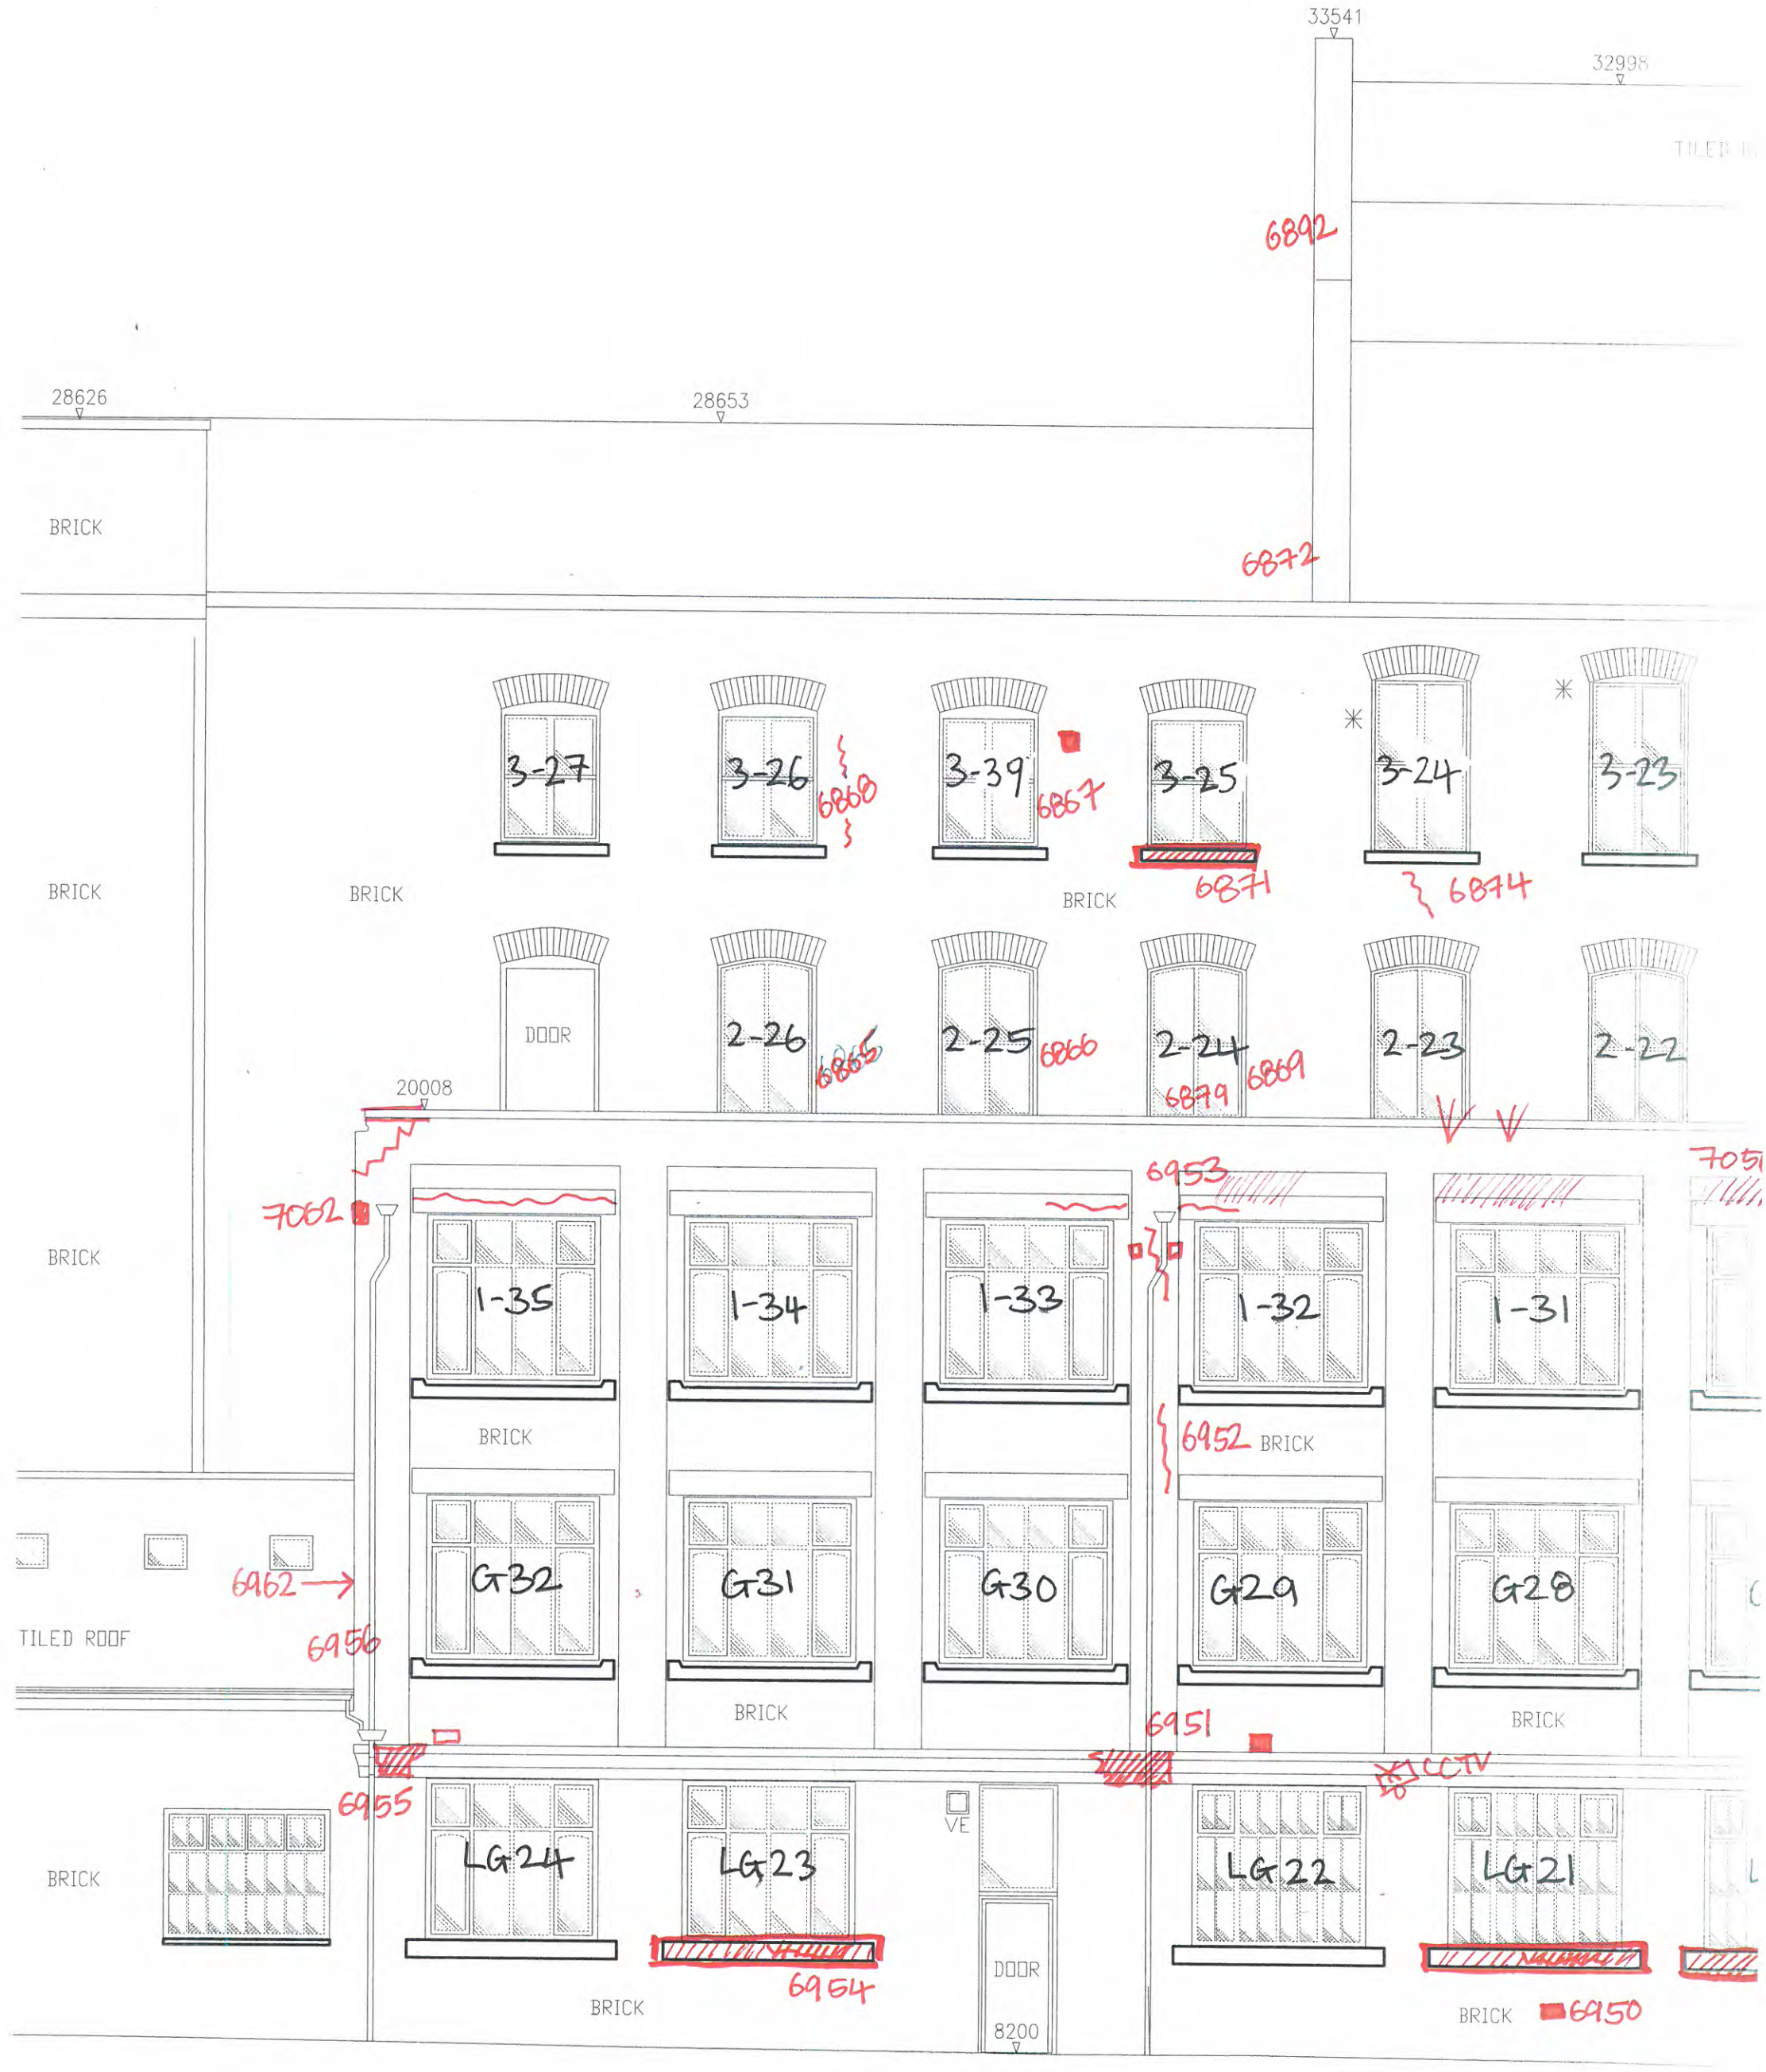
NAPLES STREET 1/2

WINDOW CORRECTION TO 5 UPPER WINDOWS
ORIGINAL WINDOWS WERE PATTERNED IN FROM
ADJACENT WINDOWS AS THEY ARE NOT VISIBLE
FROM THE GROUND SURVEY POSITIONS

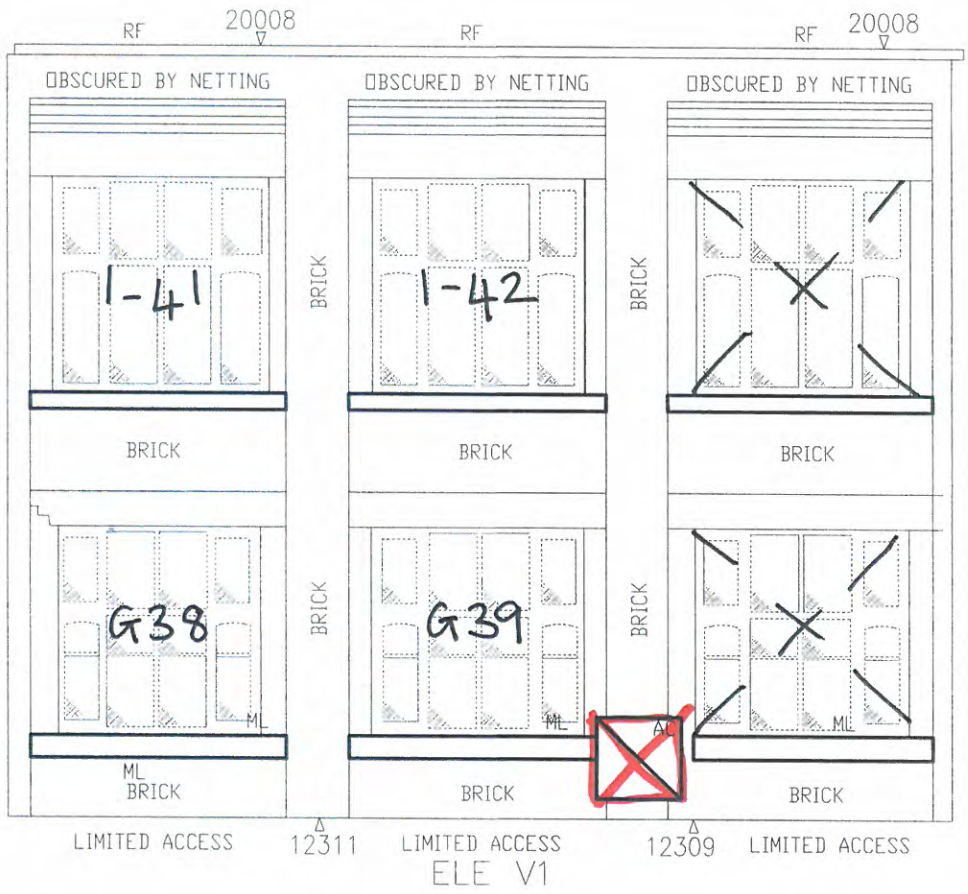
ATRIUM - BUILDING 2

NO COVERAGE ON PHOTOGRAPHIC SURVEY

ALL A/C UNITS, CABLING + PIPEWORK TO BE REMOVED AND BRICKWORK MADE GOOD.

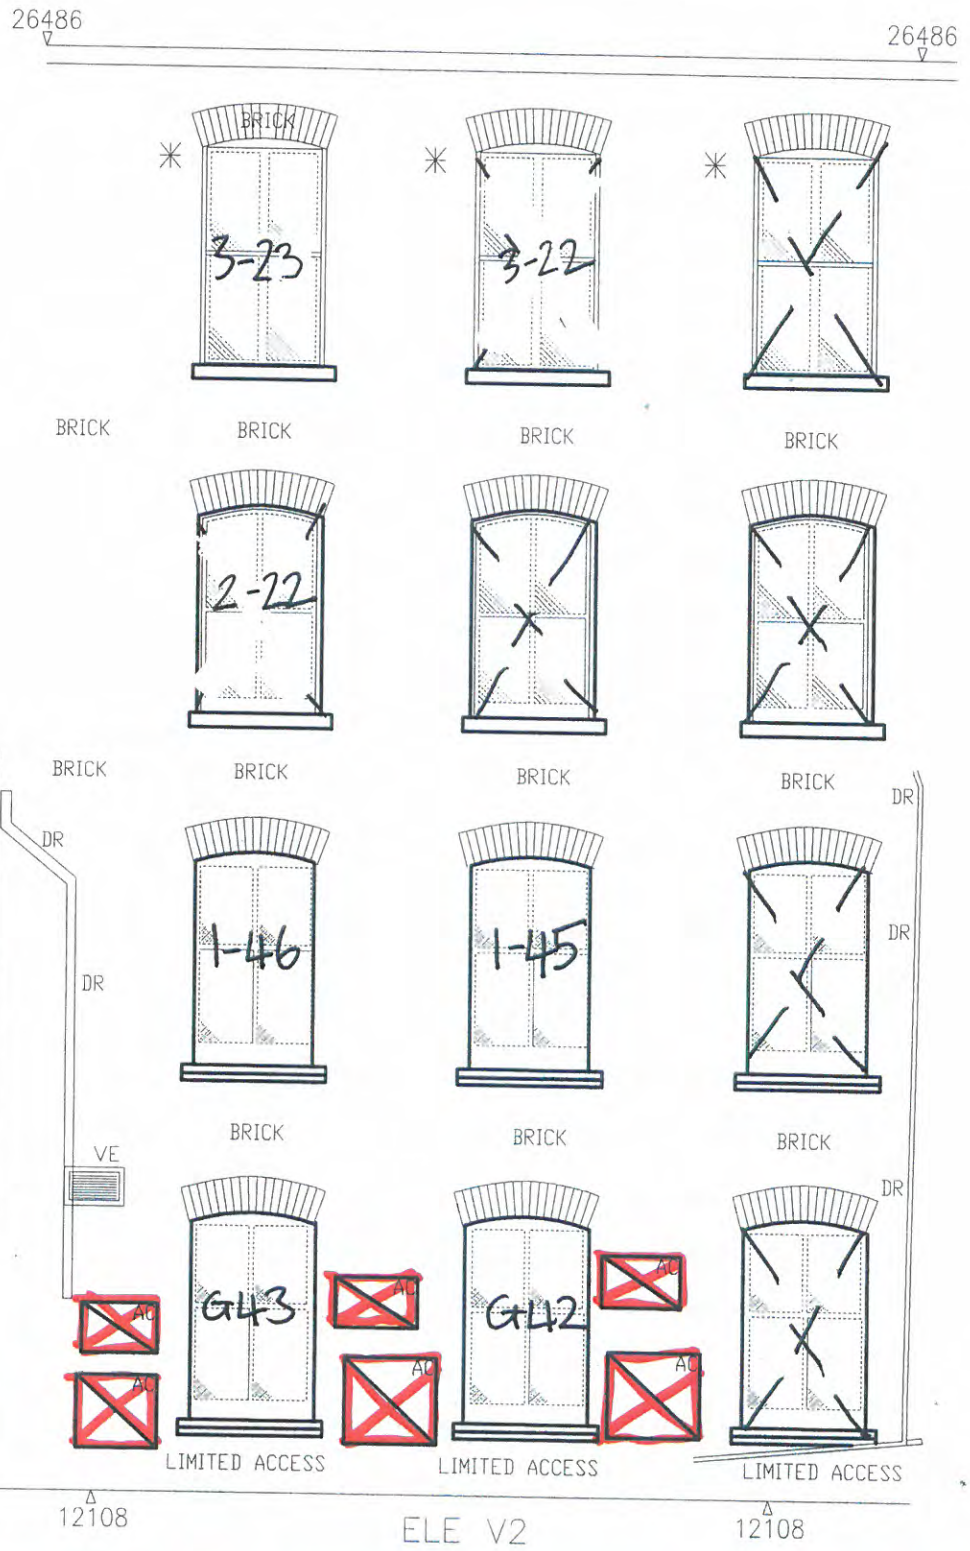
ATRIUM - BUILDING 1

NO COVERAGE ON PHOTO SURVEY.

ALL A/C UNITS, CABLING + PIPEWORK TO BE REMOVED AND BRICKWORK MADE GOOD.
