Newall Green Primary School
Photograph Report of existing roof materials

JOB TITLE
Newall Green Primary School

DRAWING TITLE
Photograph Locations

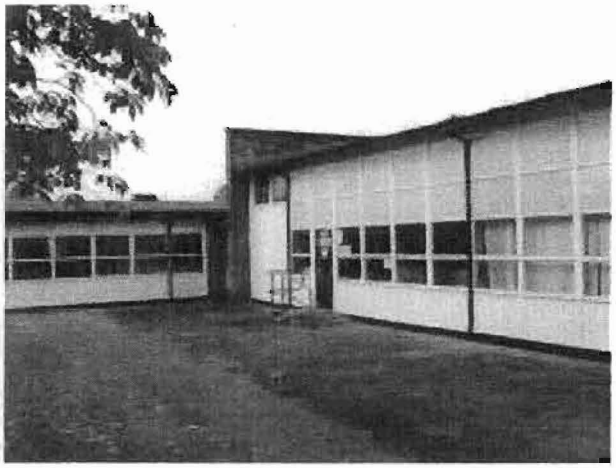
Photograph Number 6
This photograph shows the details as the pitched felt roof over classrooms meets a lower felt roof covering the corridor.
The higher roof is constructed from lattice girders covered with timber decking and finished with felt waterproofing.
The lower felt roof is constructed of board deck finished with felt waterproofing.
There is no insulation to either roof.

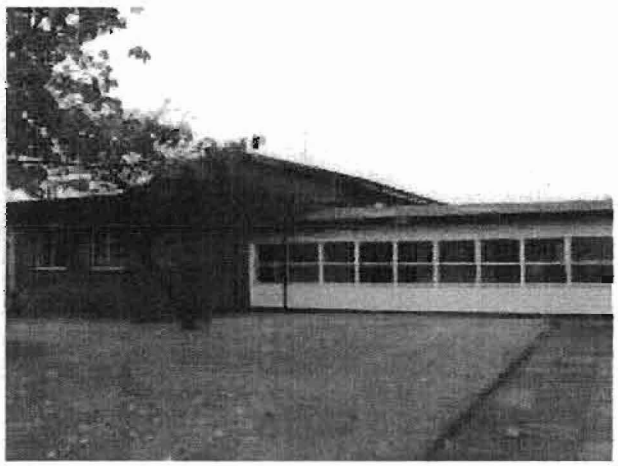
Photograph Number 7
This photograph shows the details of the the pitched roofs between corridor and classrooms.
The low shallow pitched roof is constructed from timber decking and finished with felt waterproofing.
There is no insulation in this roof.
