client
FIRST BUS PLC

project
Queens Road Depot, Manchester
Window Replacment Works

drawing
Proposed Typical Window Elevation and Detail

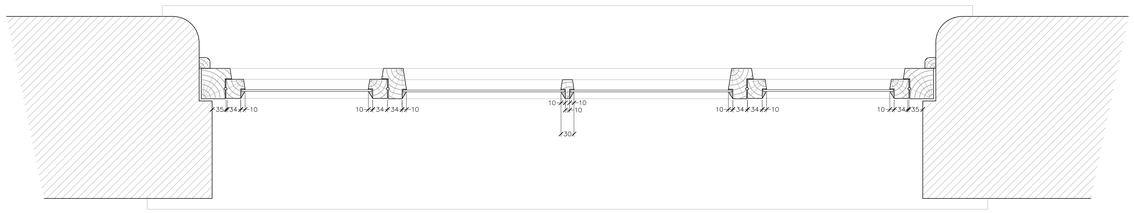
EXISTING TYPICAL SECTION
1 : 5

The existing windows are extremely poor condition with large sections of missing putty pointing. The existing windows are fitted with wire mesh to reduce the risk presented by glass falling from the frames
