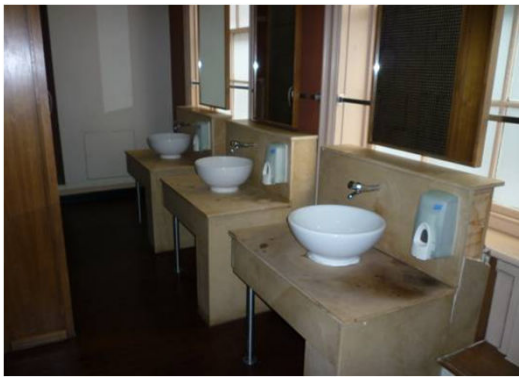
Damaged floor tiles and staining to mosaic tiling within female wc vanity area

Service voids and altro flooring to be installed in female wc, full redecoration to A-spec
