St James Basement

Ceiling plan detail
Panel 6

scheme 1552
no. **P(116)**
rev -

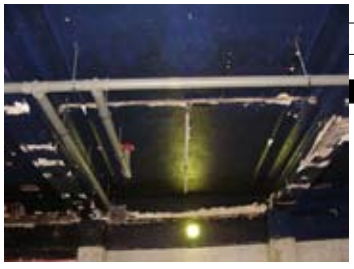
PANEL 6

Structure currently exposed to be made good but moulding not recreated

Area missing. Lime-based plaster moulding to be repaired.

Area missing. Lime-based plaster ceiling to be repaired.

Structure currently exposed. Plaster moulding to be repaired.

ALL SMALL MISSING AREAS TO BE REPAIRED
