CONDITION 7(c) DRAINAGE VERIFICATION REPORT

Victoria Riverside, Dantzic Street

Far East Consortium

12/09/2024

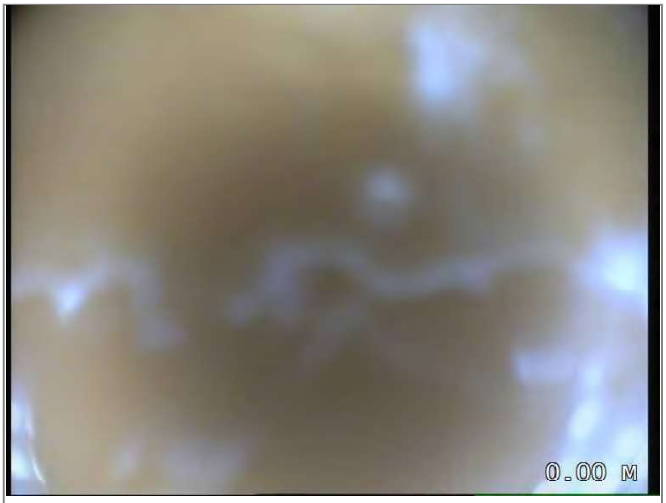
Start node type: Source

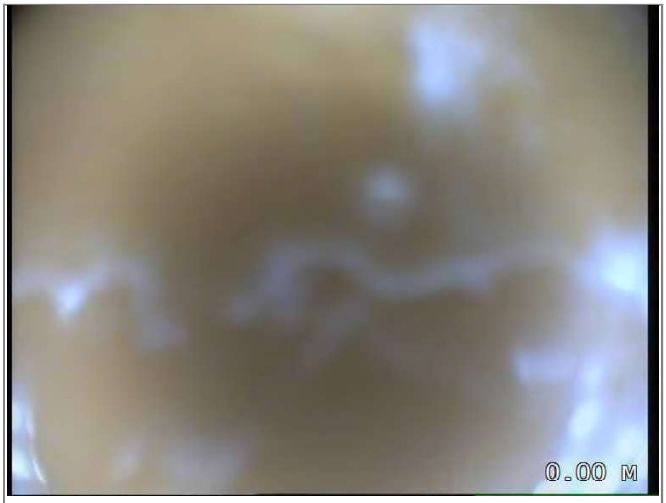
Water level 05% height/diameter

Line of drain/sewer deviates left - Remark: JOINS CARRIER

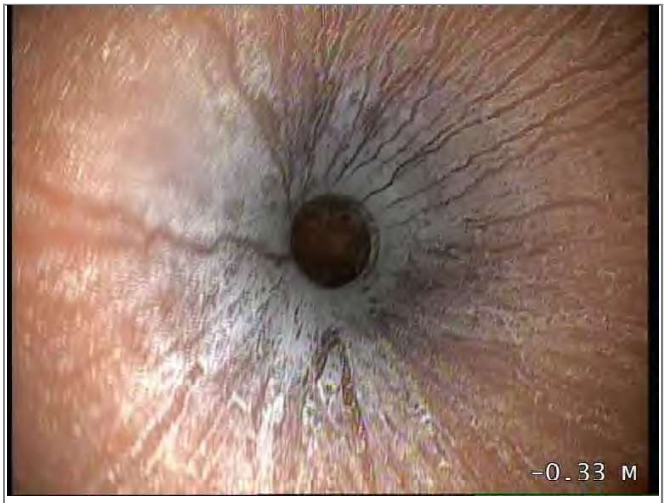
Start node type: Source

Water level 05% height/diameter

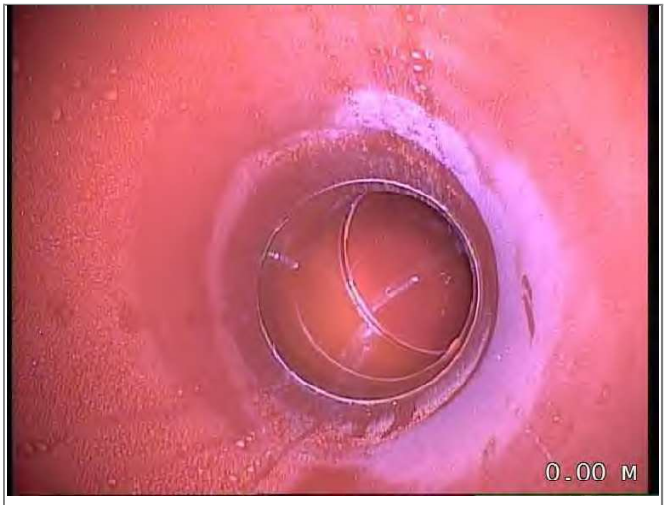
Water level 05% height/diameter

Line of drain/sewer deviates right - Remark: S1.11-S1.12 CARRIER

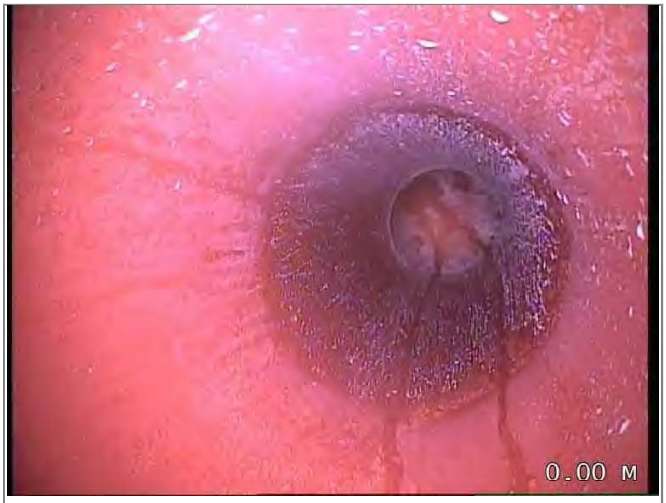
Water level 05% height/diameter

Line of drain/sewer deviates right - Remark: S1.11-S1.12 CARRIER

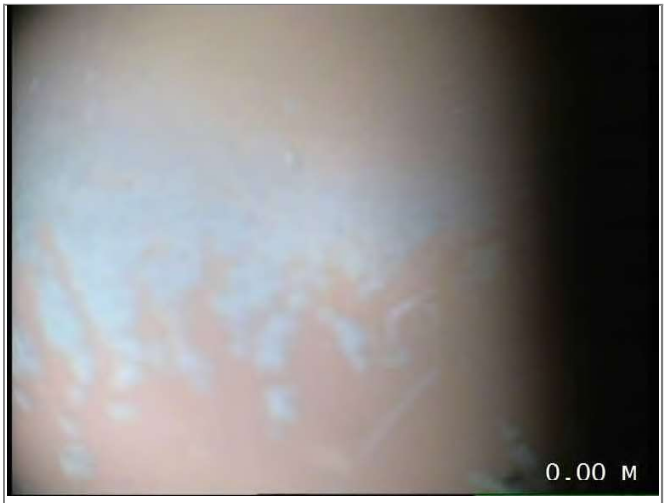
Start node type, manhole, reference F2.2 LEG1

Water level 05% height/diameter

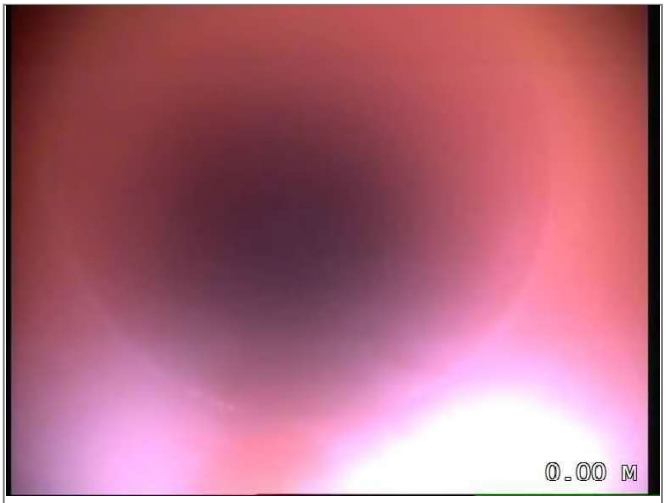
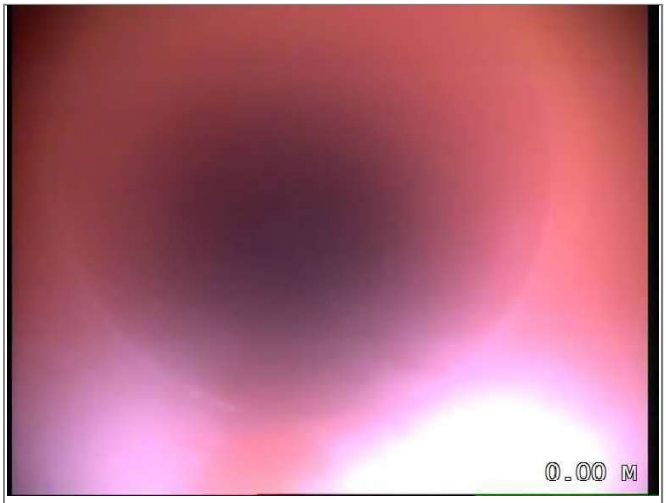
Start node type, manhole, reference F2.4

Water level 05% height/diameter

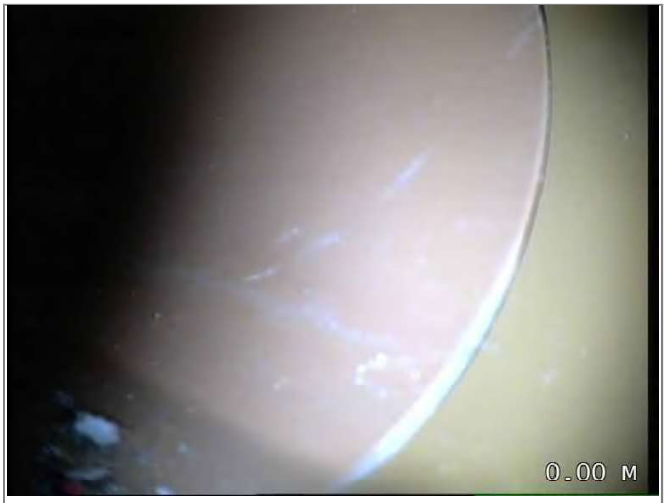
Start node type, manhole, reference F2.6 LEG2

Water level 05% height/diameter

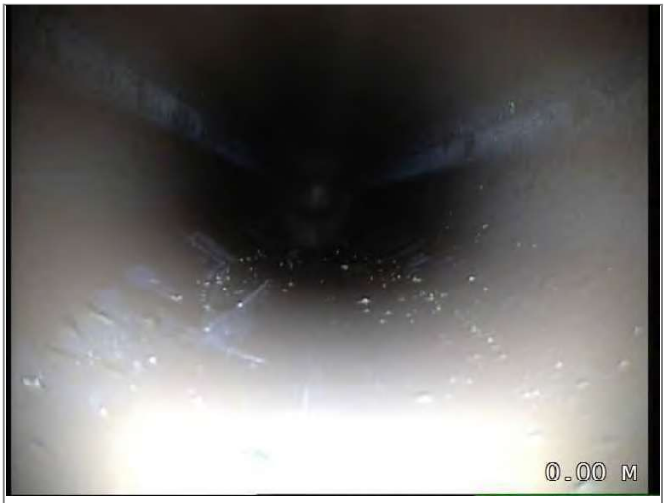
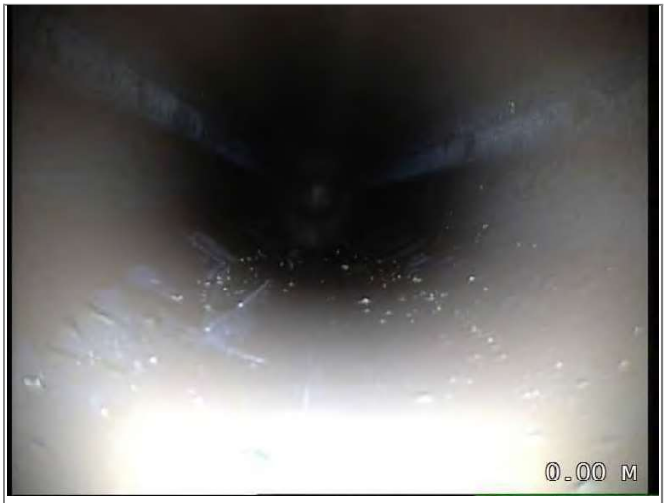
Start node type, manhole, reference F2.6

Water level 05% height/diameter

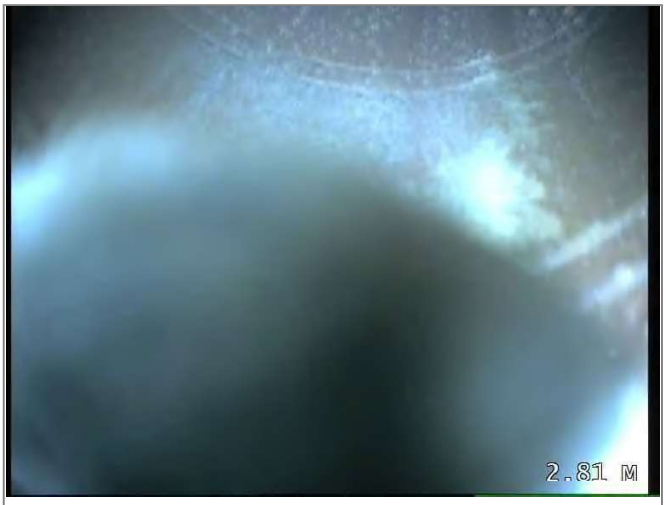
Start node type, manhole, reference F2.11 LEG3

Water level 05% height/diameter

Finish node type, outfall, reference RESTBEND

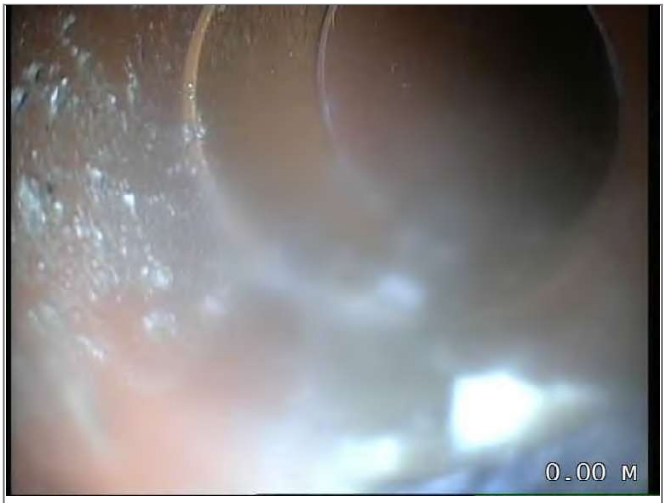
Start node type, manhole, reference F2.10A LEG1

Water level 05% height/diameter

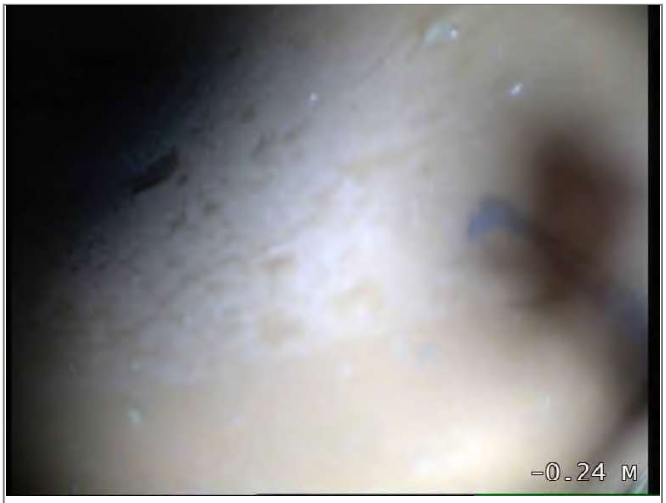
Start node type, manhole, reference F2.10 LEG3

Water level 05% height/diameter

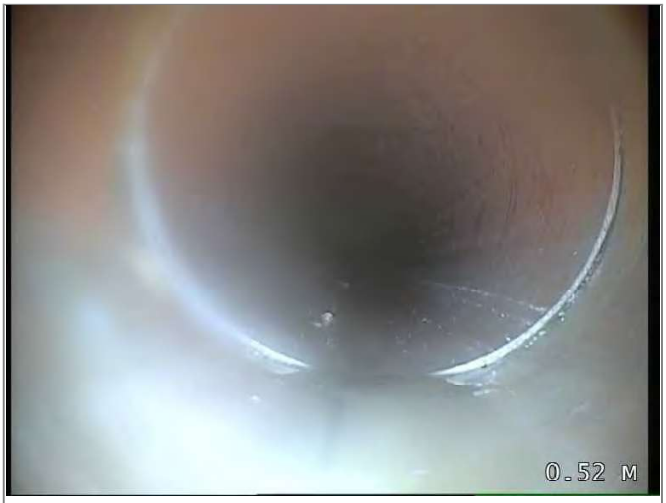
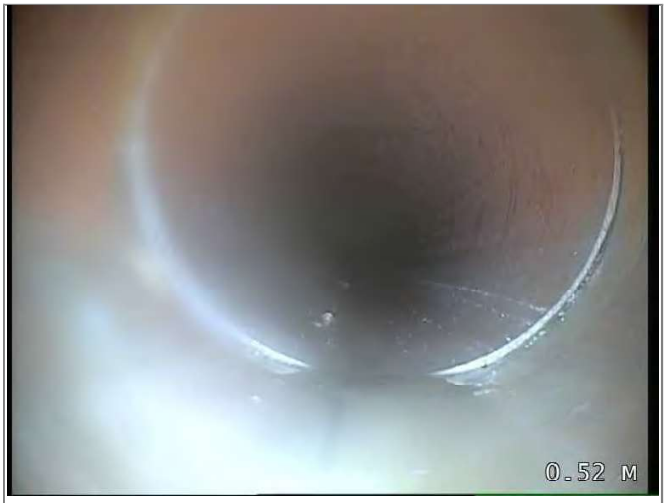
Start node type, manhole, reference F2.13

Water level 05% height/diameter

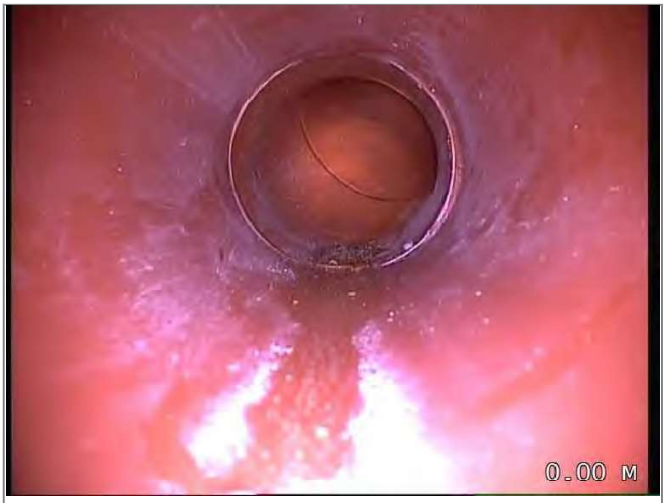
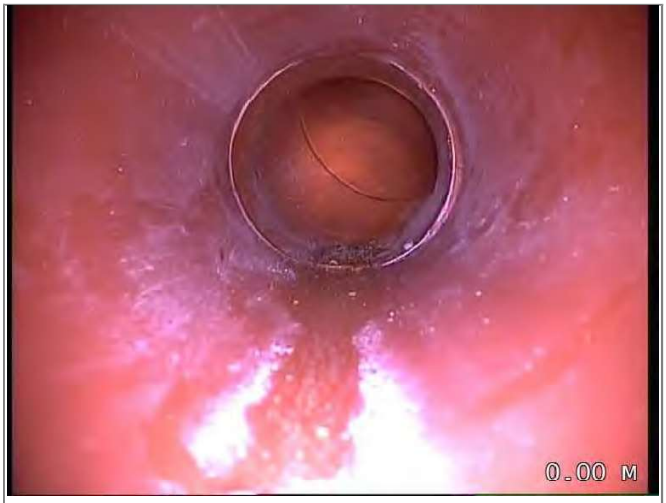
Start node type, manhole, reference F1.17 LEG2

Water level 05% height/diameter

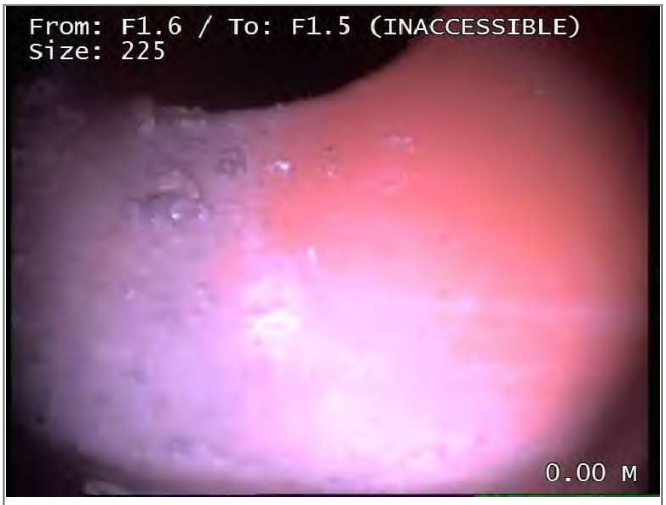
Start node type, manhole, reference F1.6

Water level 05% height/diameter

Dimensions of drain/sewer changes to 150mm

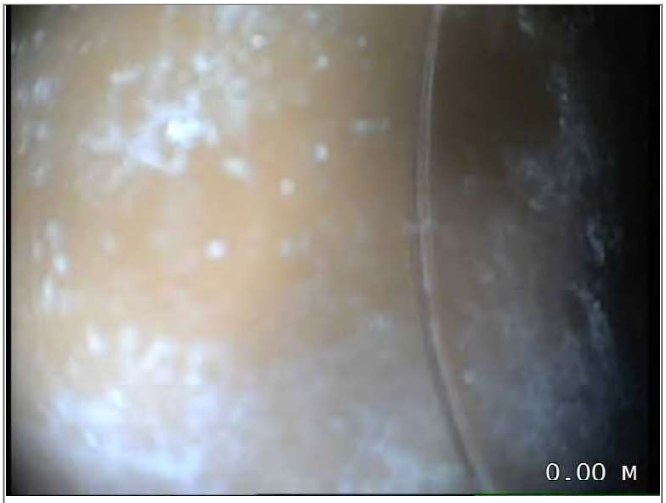
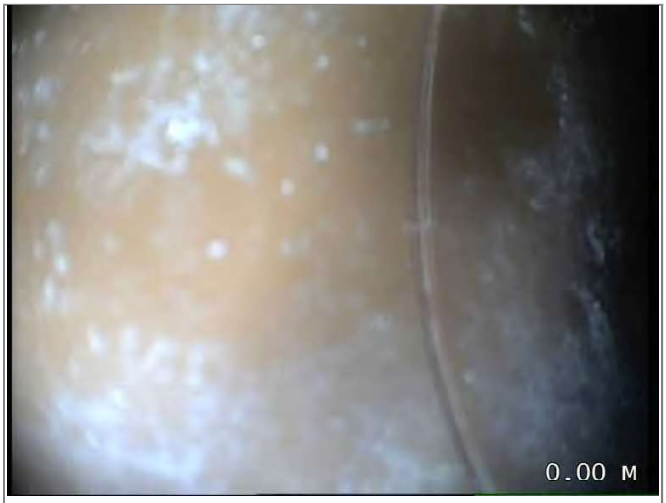
Start node type, manhole, reference F1.26 LEG2

Water level 05% height/diameter

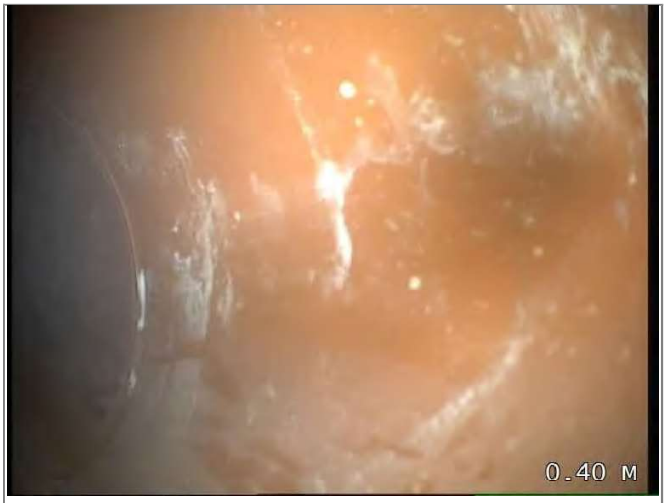
Start node type, manhole, reference F1.1 LEG1

Water level 05% height/diameter

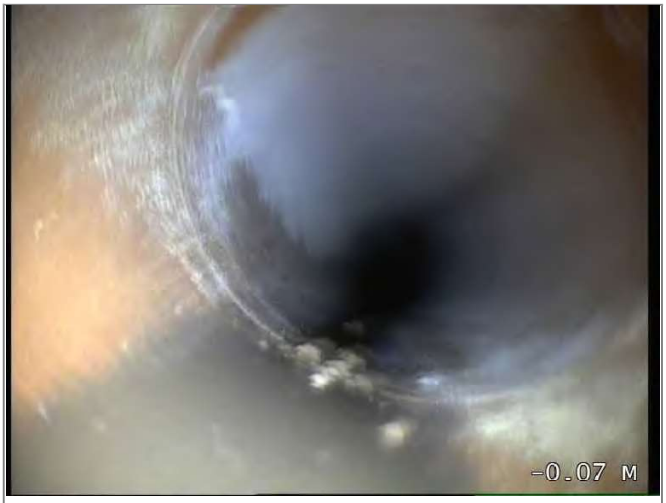
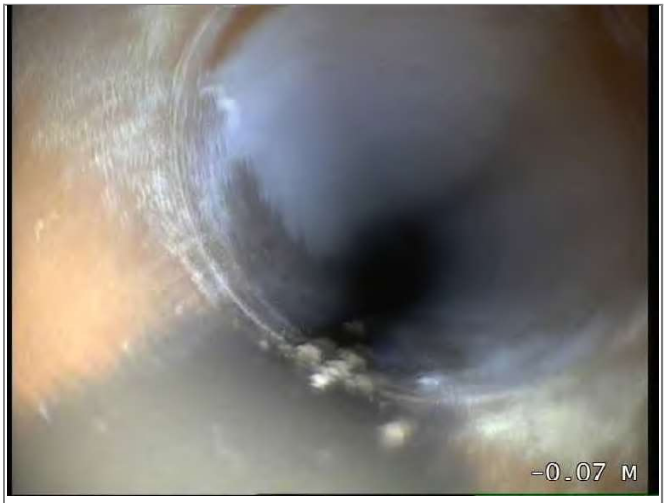
Start node type, manhole, reference S1.21B

Water level 05% height/diameter

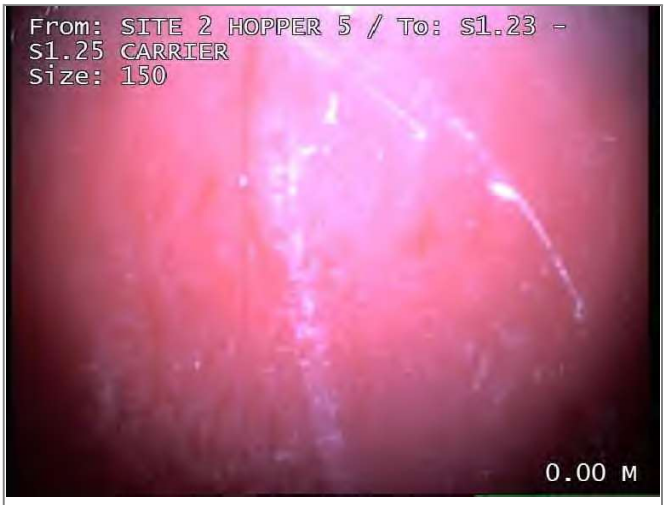
Water level 05% height/diameter

Line of drain/sewer deviates down

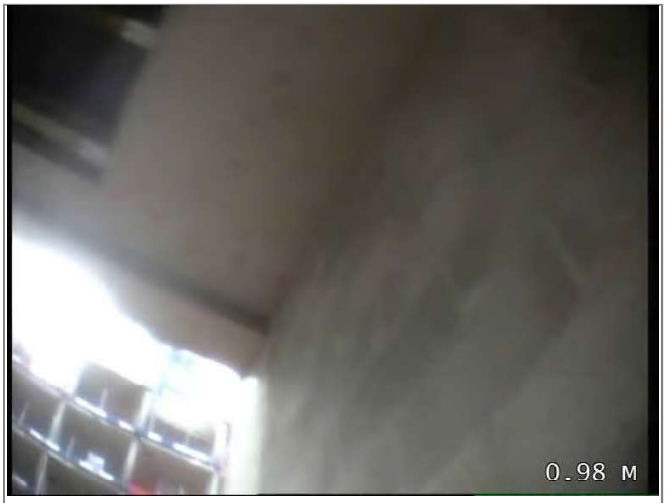
Water level 05% height/diameter

Line of drain/sewer deviates left - Remark: RESTBEND

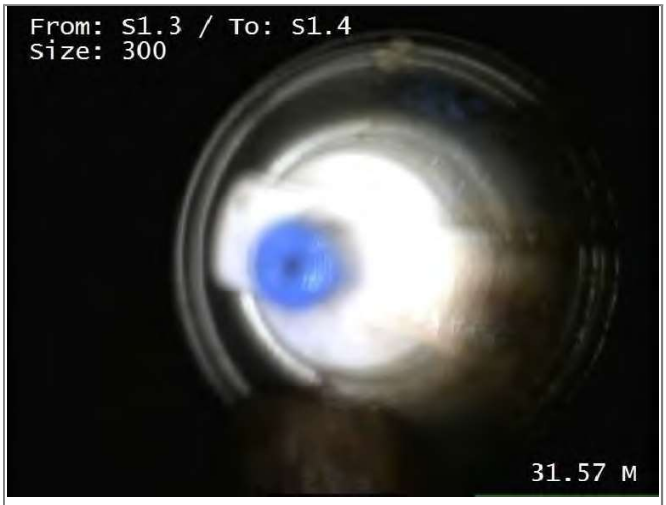
General photograph taken at this point - Remark: LINE PAINT CAN IN DRAIN

UNABLE TO PUSH FURTHER

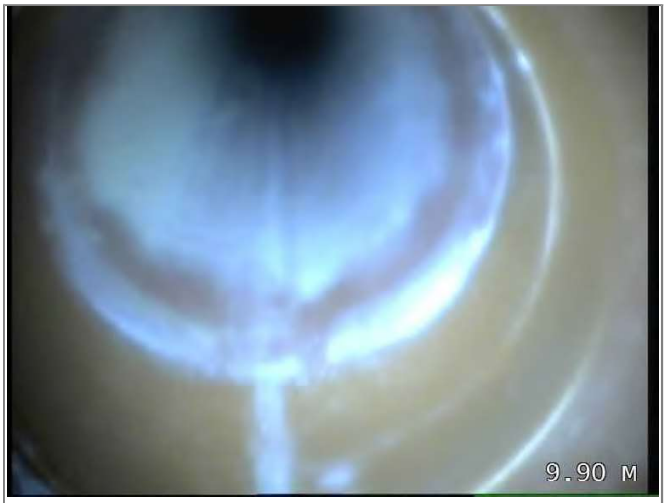
Start node type, manhole, reference F1.15 LEG 1

Connection other than junction at 9 o'clock, diameter 100mm

Line of drain/sewer deviates up

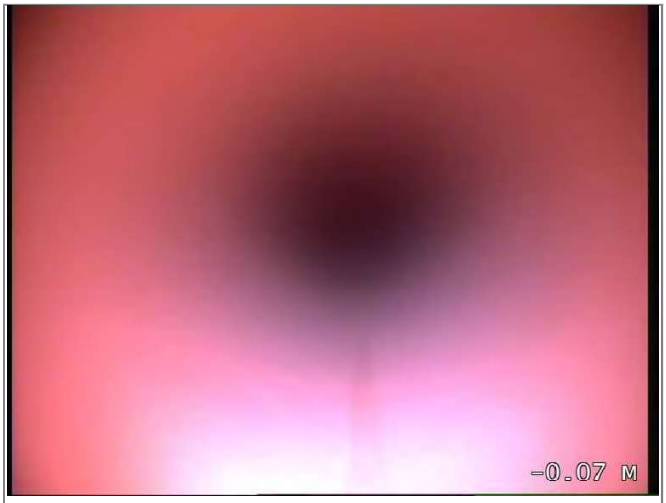
Start node type, manhole, reference S1.7A LEG 1

Water level 05% height/diameter
