Zone 16

Defect Survey

Defect Survey Sheet

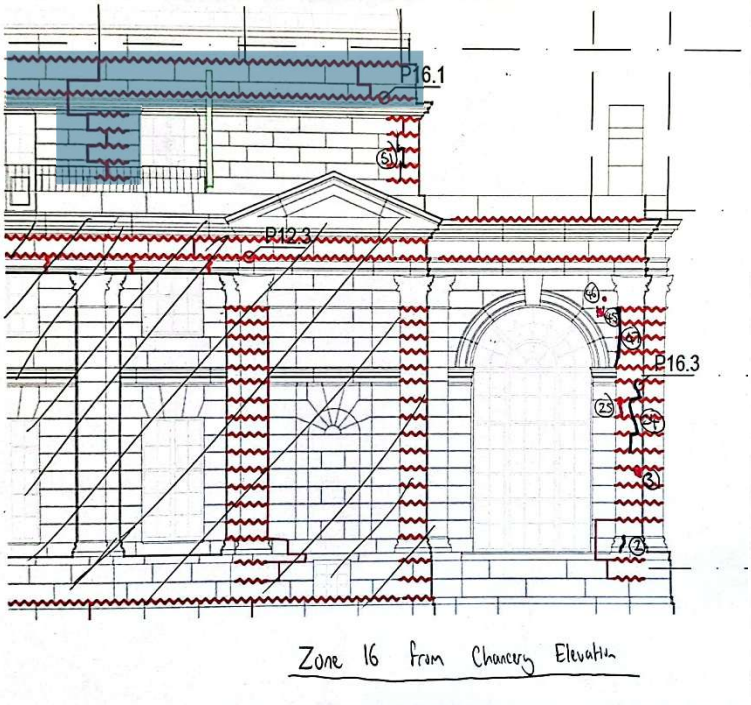
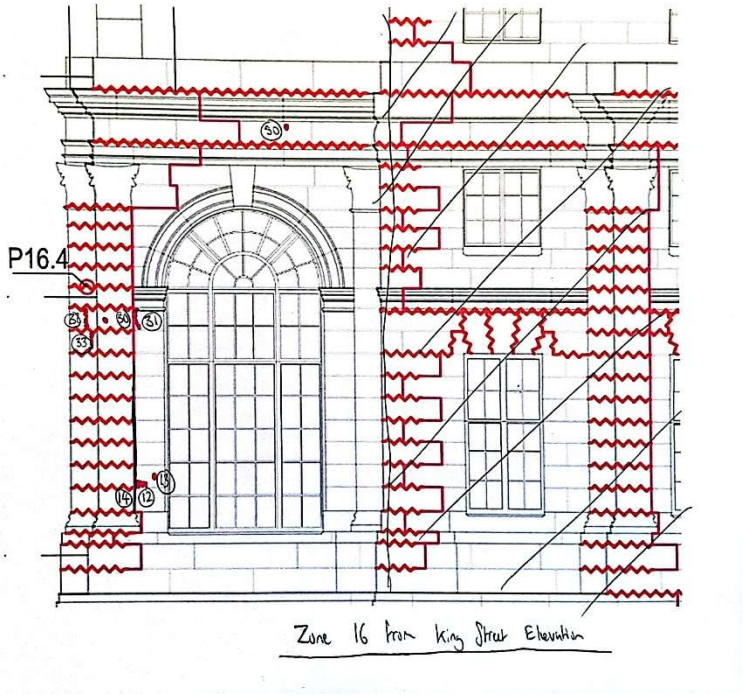
The parts of the drawings which are shaded in have not been surveyed as they are not yet accessible and will have to be surveyed separately.

Throughout the zone there are a few cracks which run up the corners of the columns in the mortar joints, these are numbers 5, 10, 14, 15, 24, 40, 47.

There are also two large cracks which are repairs number 17 and 24.
