Date: 22nd October 2024
Reference: 15-974 V16

GAS MEMBRANE VALIDATION – BENNETT STREET

Project Name:	Bennett Street
Project Number:	15-974
Client:	Kellen Homes
Date:	02-10-2024
Project Manager:	M. Dee
Engineer:	J. James
Ground Gas Risk Assessment:	Vapor Membranes Required
Gas Membrane Installers Name & Qualifications:	JCW Gas Membranes Ltd, NVQ Level 2 – Installation of Gas Membranes in Construction
Plot:	91-94, 97, 98

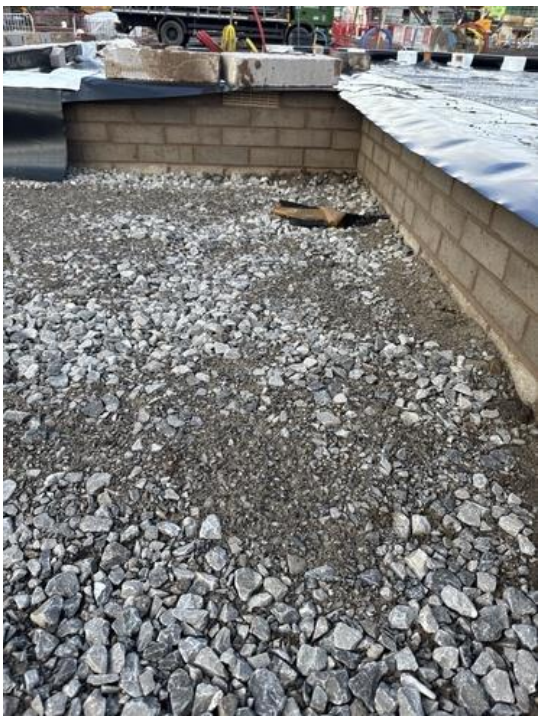
Photo 12

Condition of sub-grade and underside of gas membrane: Check that the subgrade does not contain rough/uneven surfaces, is appropriately clean and that there are no hard/sharp objects. That protective sand blinding or geotextile (if specified) is present and meets the design criteria. (Lift back the membrane and photo the subfloor)	Pass
Slab / membrane condition (is membrane clear of snow, standing water, debris or insulation): Can membrane be fully seen and photographed – ask contractor to remove an debris so membrane can be fully seen an inspected – this is a requirement of NHBC and local authorities.	Pass
External Wall Air bricks: Numbers, size. positions as design drawing? (Minimum of 3 walls)	Pass

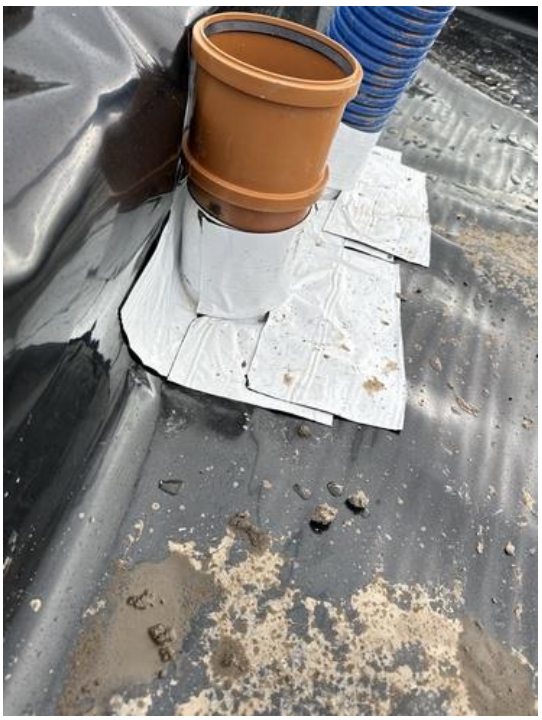
Photo 72

Plot Inspection 5	12 / 12 (100%)
Plot Number	98
Type of Development: if other add Note	House
Floor Slab Type	Block and beam suspended
Are telescopic vents present?	Yes
Gas Membrane Type: Manufacturer, gauge, and colour. (Take photos were possible showing Label)	GP TITANFLEX
Installer's name, company and qualification	PRS
Gas Membrane Condition: Open punctures, tears, rips, stretching, Presence of debris, Repairs, Signs of weakness such as raised or sunken indentations, Protection plan in place to restrict access to lain gas membrane? IF FAIL DESCRIPTION IN ACTIONS AND PHOTOS REQUIRED	Pass
Are welds complete?	Yes
Are Joints lapped and sealed in accordance with manufacturer's requirements/ specification?	Yes
Service entries seals: Top hats seal arrangements fixed around service entries? Use of Jubilee clips or Bitumastic Sealant	Pass
