CRL
CONCRETE REPAIRS LIMITED
multi-disciplined *structural* renovation

Defect Survey

Zone 4 Repair Survey

Spring Garden Return

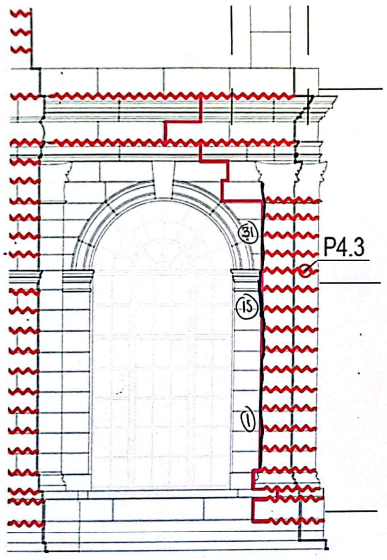
As with Zone 16 not all the zone is accessible via the scaffold, these parts have been highlighted on the drawing and will have to be surveyed later when we have access to the terrace and the roof.

The main parts of concern for this zone are a number of large cracks running up the sides of the cylinder columns in several different places, these are shown through numbers 1, 15, 16, 17, 22 and 31.
