Bridgewater, Manchester
Condition and Historic Record Survey
02.12.24

compiled by ND [snook architects]

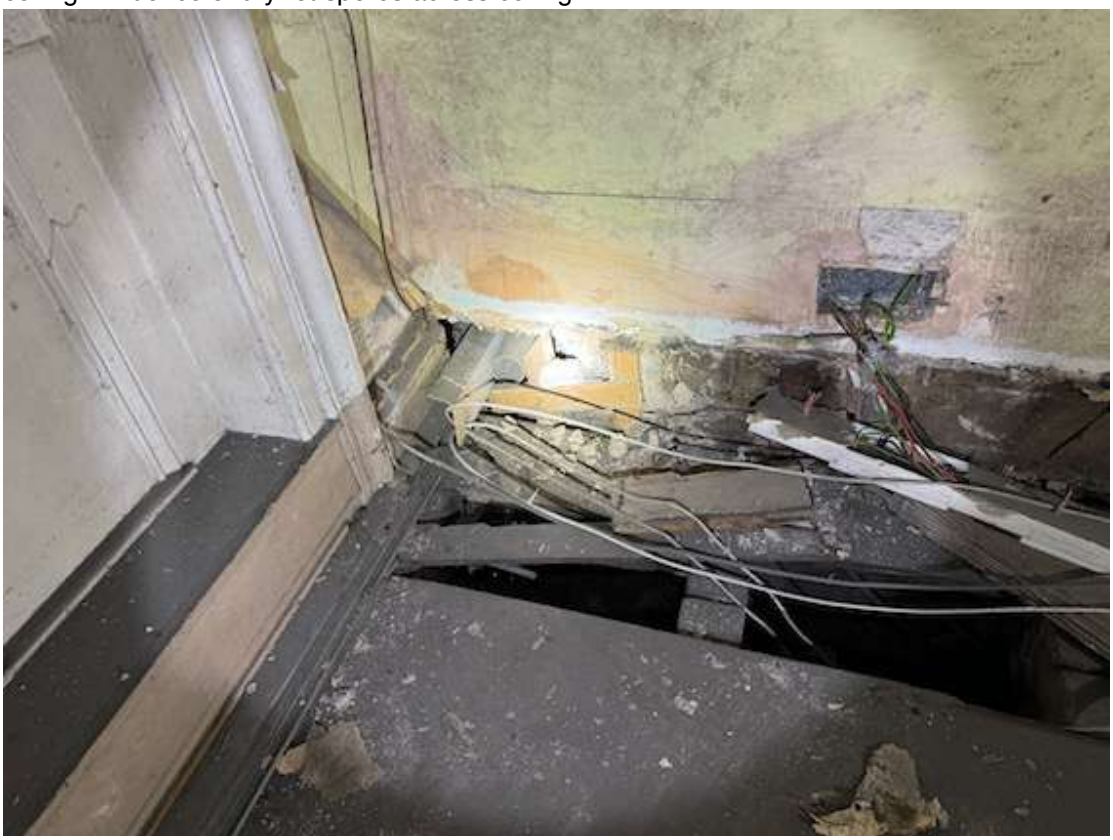
10: Room 1.25; plaster falling off wall [able to pick off by hand] evidence of dry rot spores behind plaster

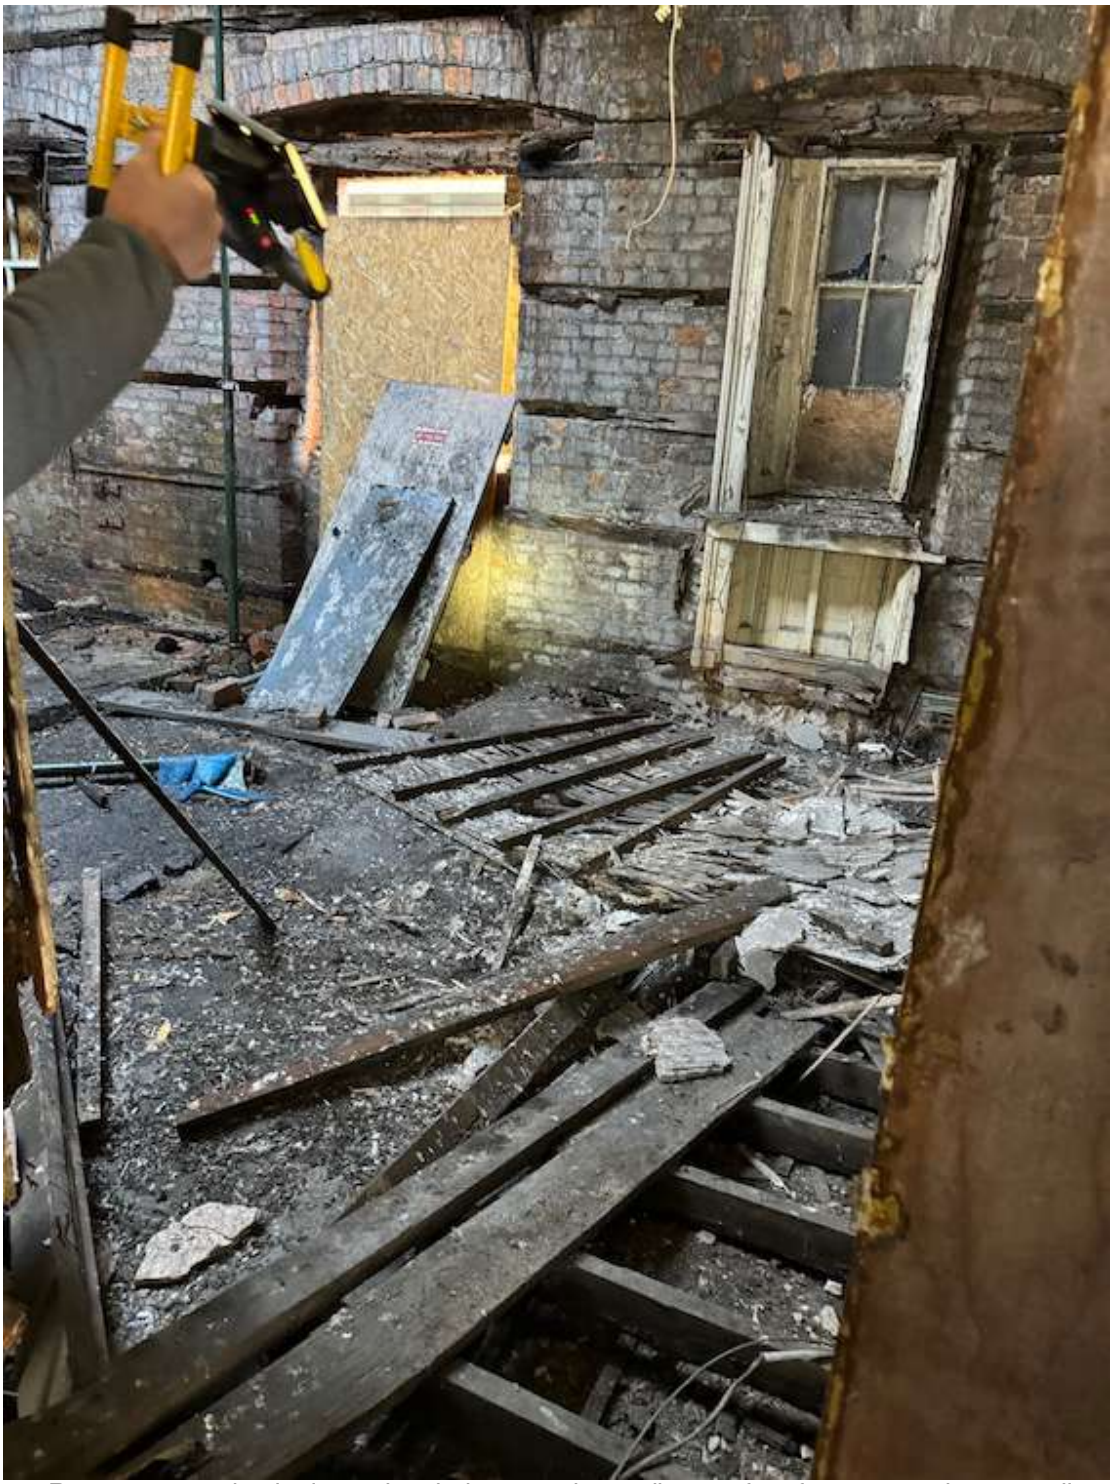
52: Room 1.20; evidence of endemic dry rot to ceiling area and roof structure

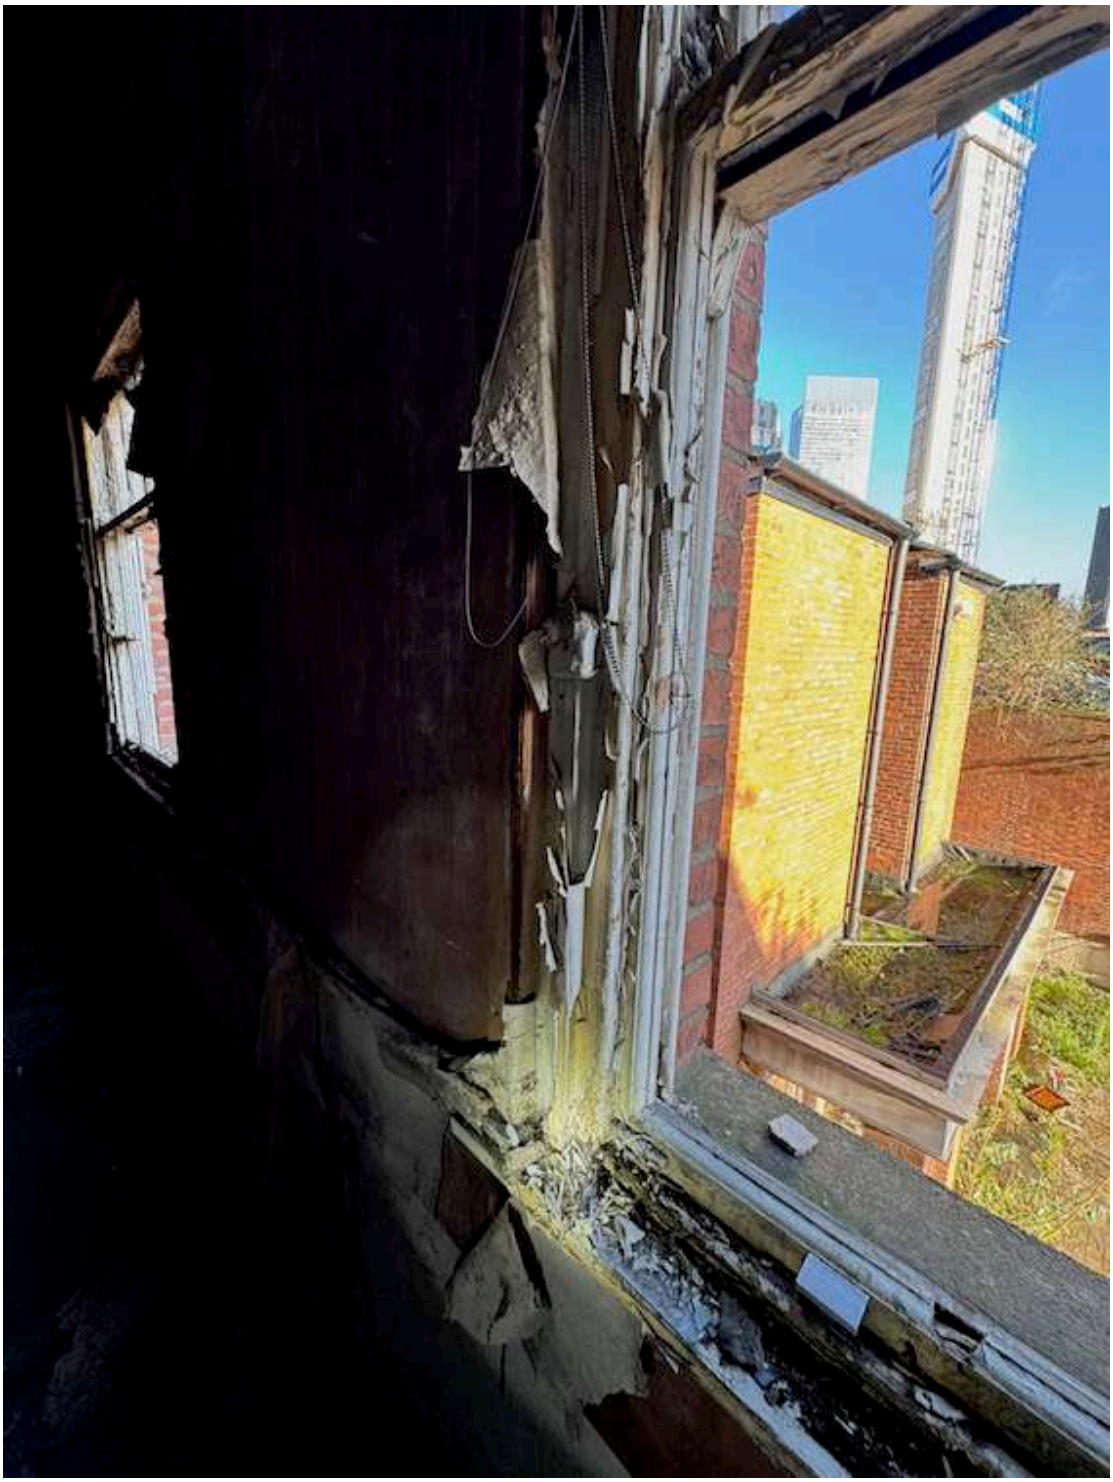
95:: Room 1.08; all trusses not supporting to to endemic dry rot; ,note dry spores throughout

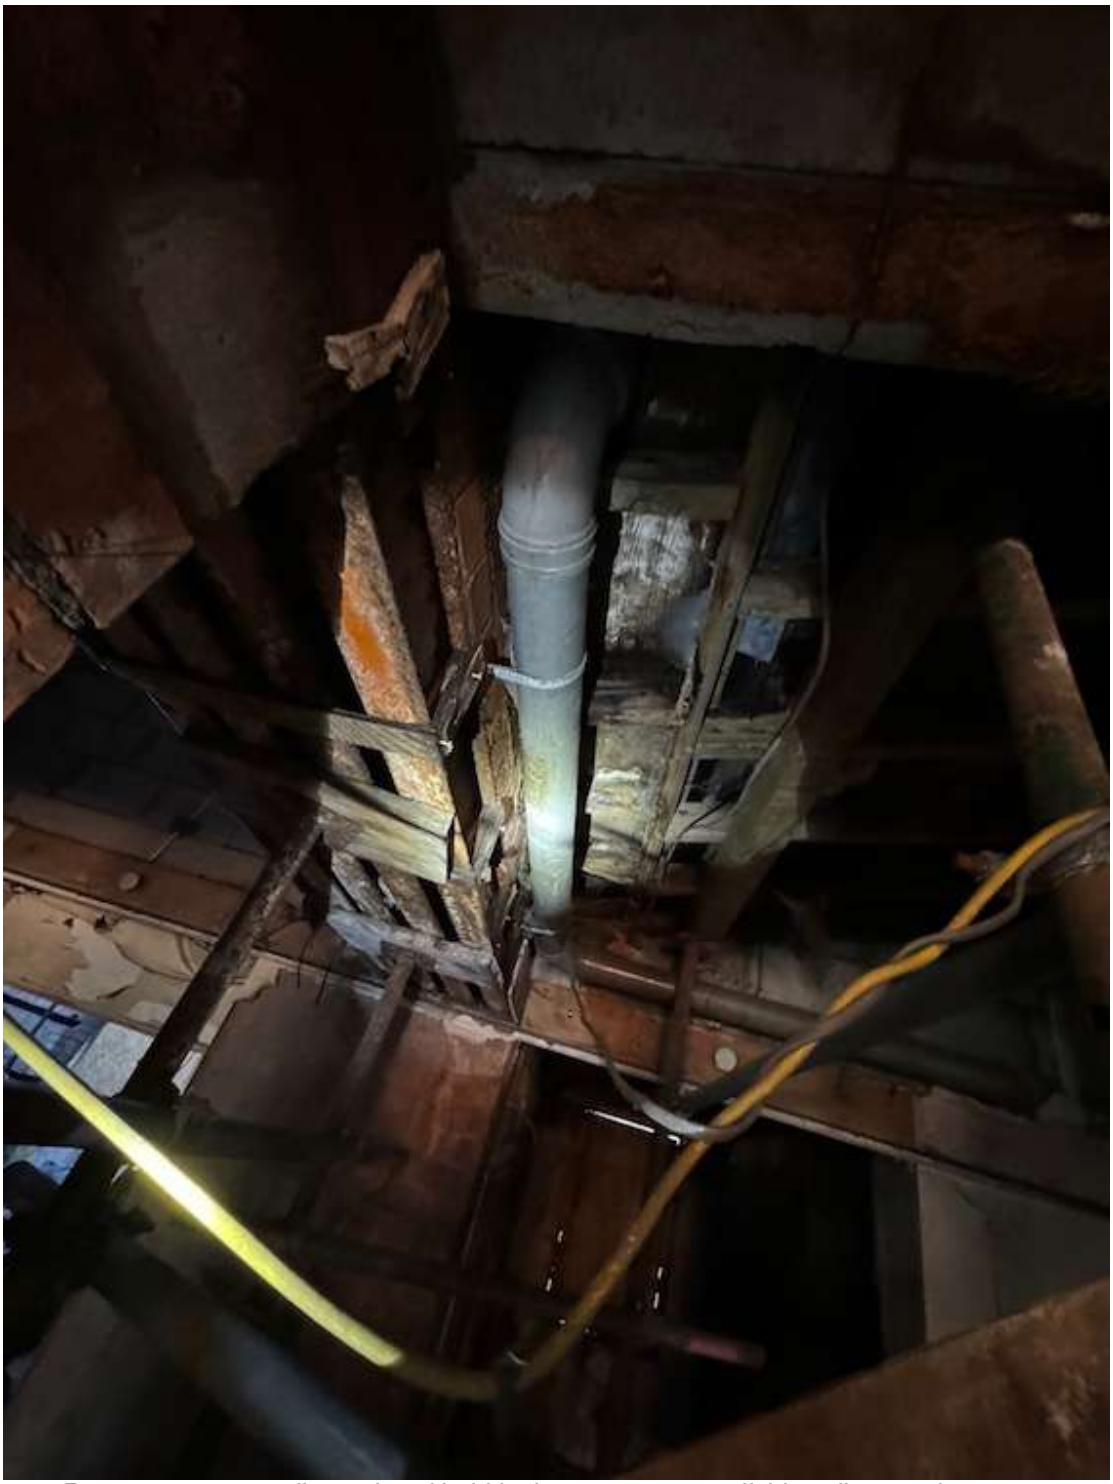
102:: Room 1.06; look back into 1.18 – note collapsed roof

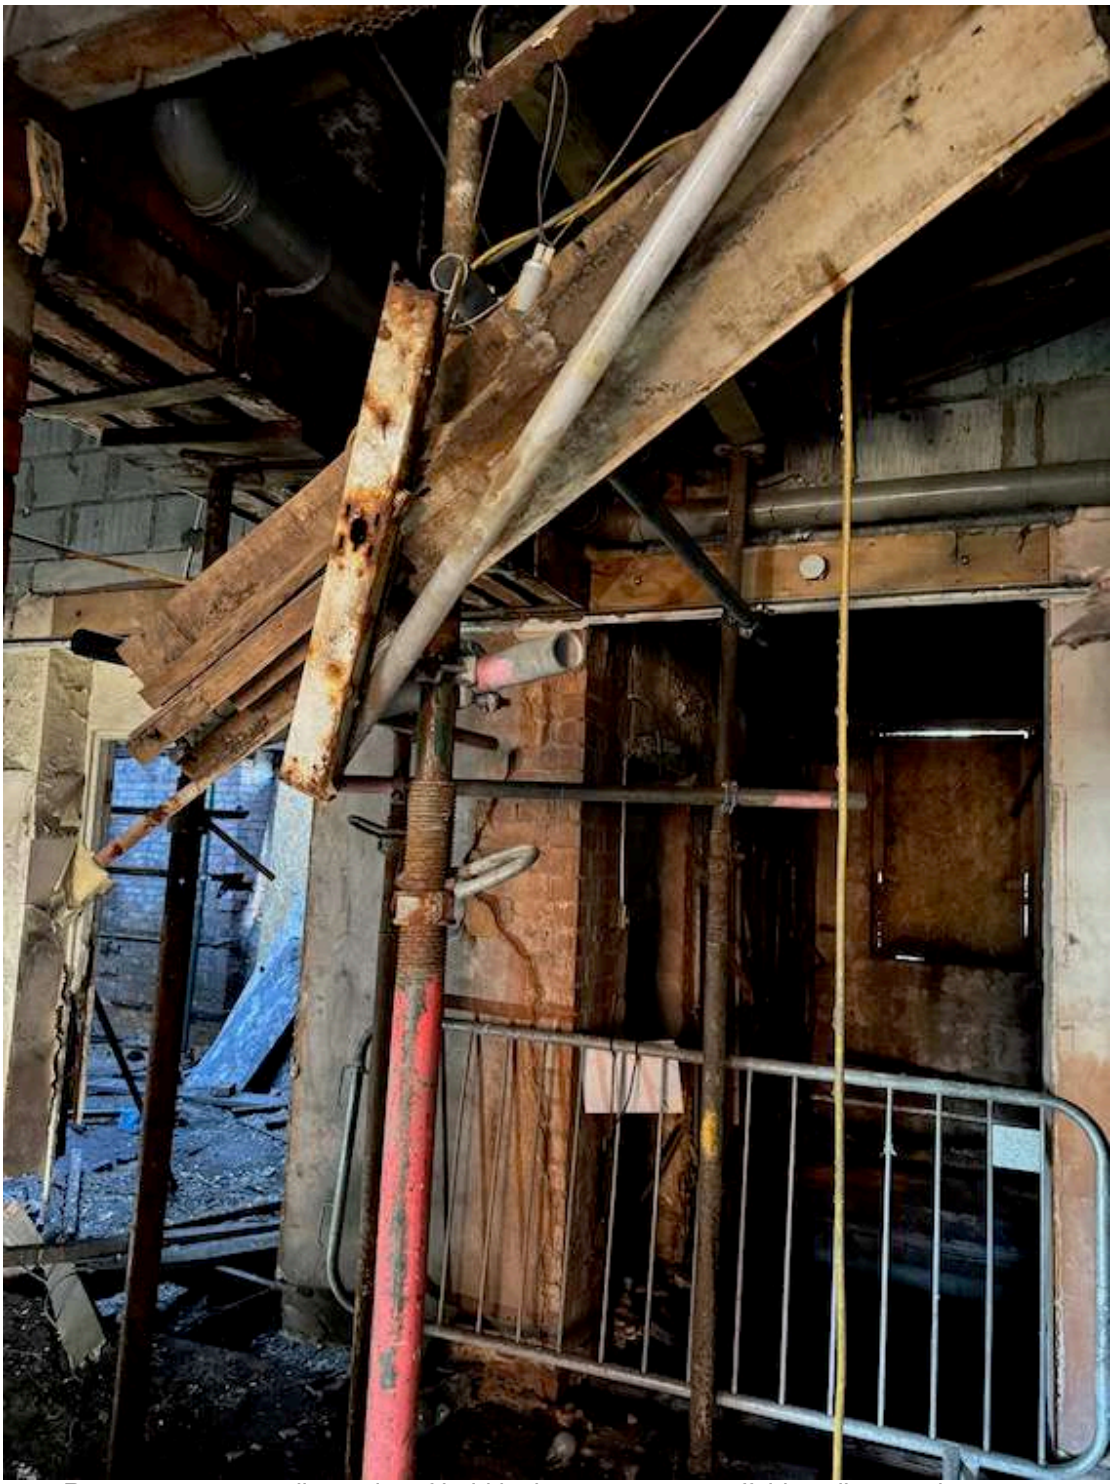
106: Room 1.06; note collapsed roof held by by temporary scaffold, walls very damp, endemic dry rot, note modern gypsum plaster

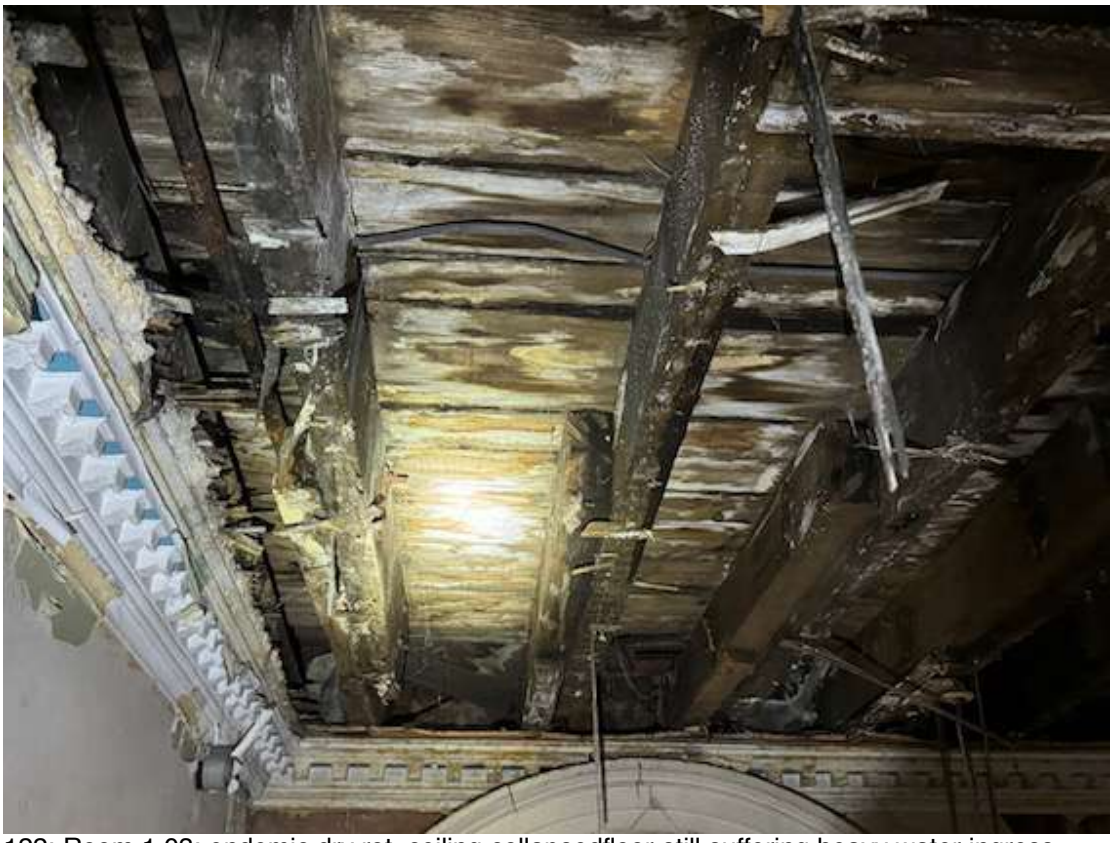
120: Room 1.03; endemic dry rot, ceiling collapsed, water ingress still evident, note dry rot in ceiling timbers,

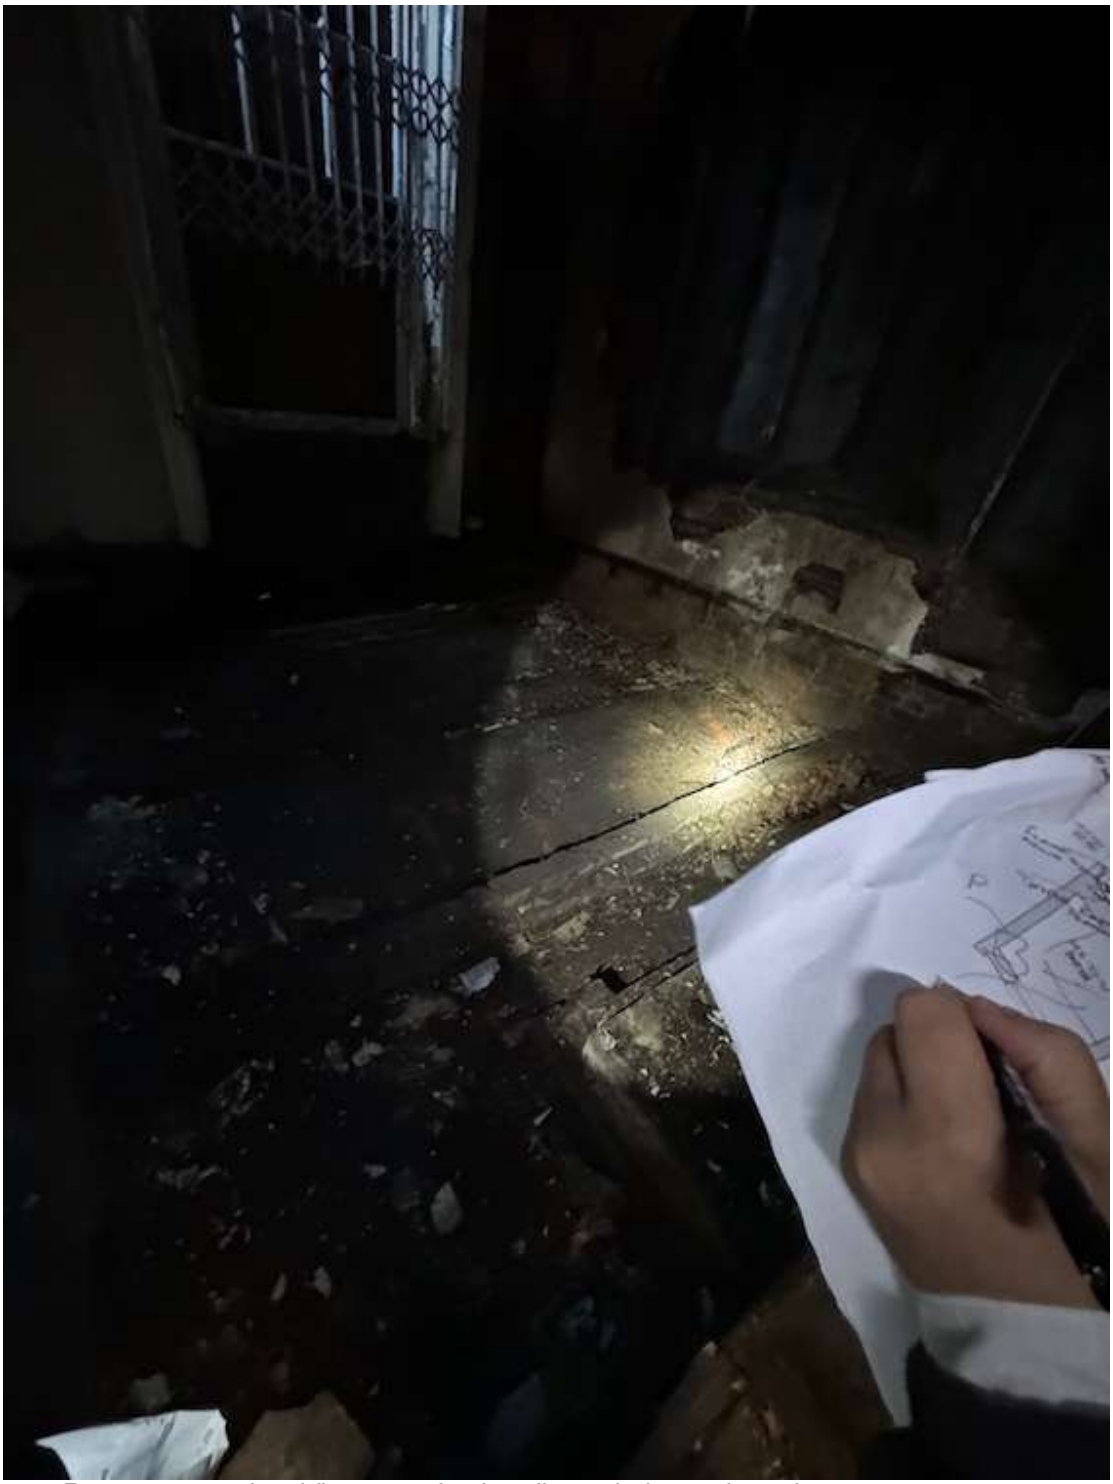
148: Room 0.02; roof and floor completely collapsed

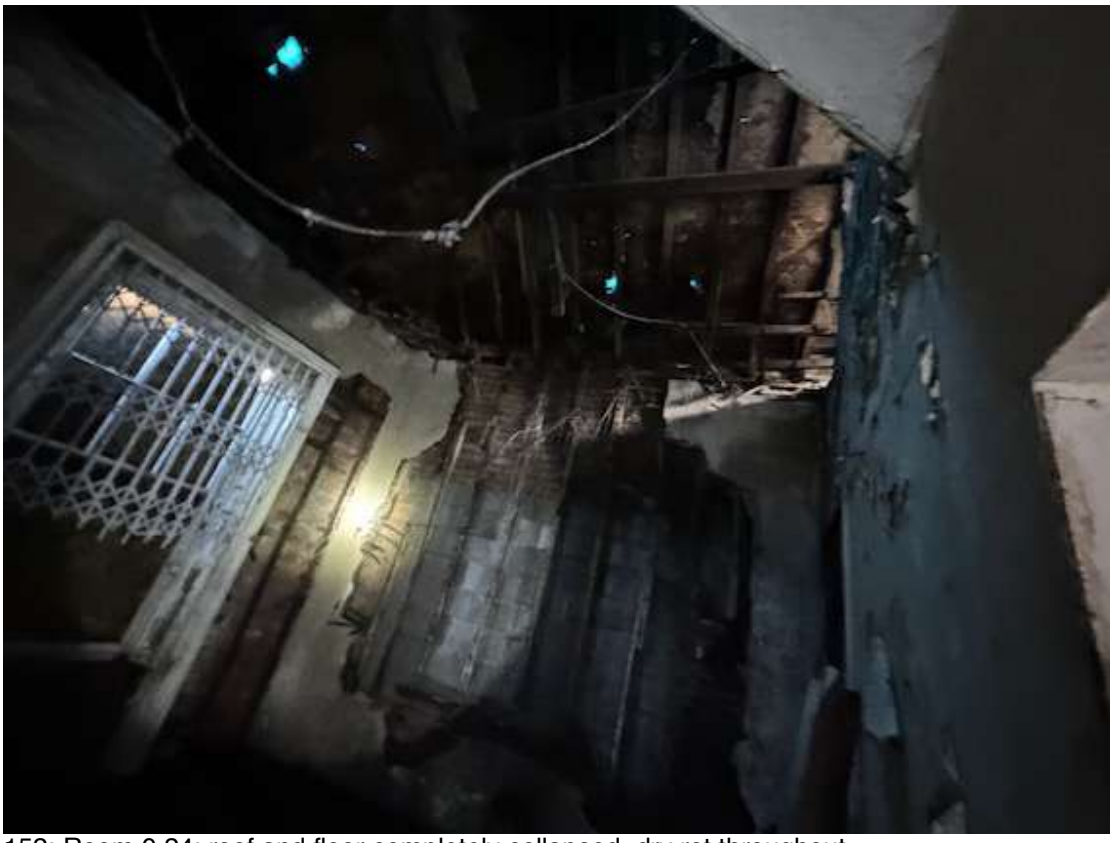
151: Room 0.24; roof and floor completely collapsed, dry rot throughout

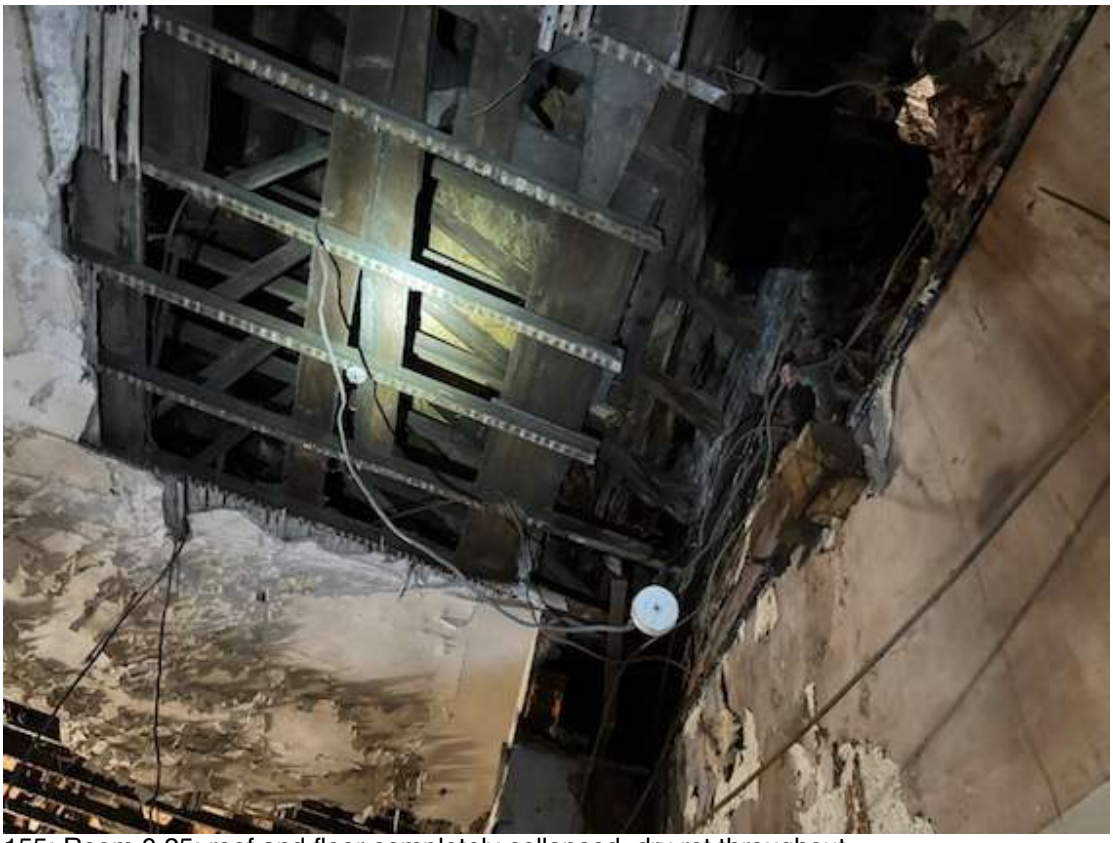
154: Room 0.25; roof and floor completely collapsed, dry rot throughout

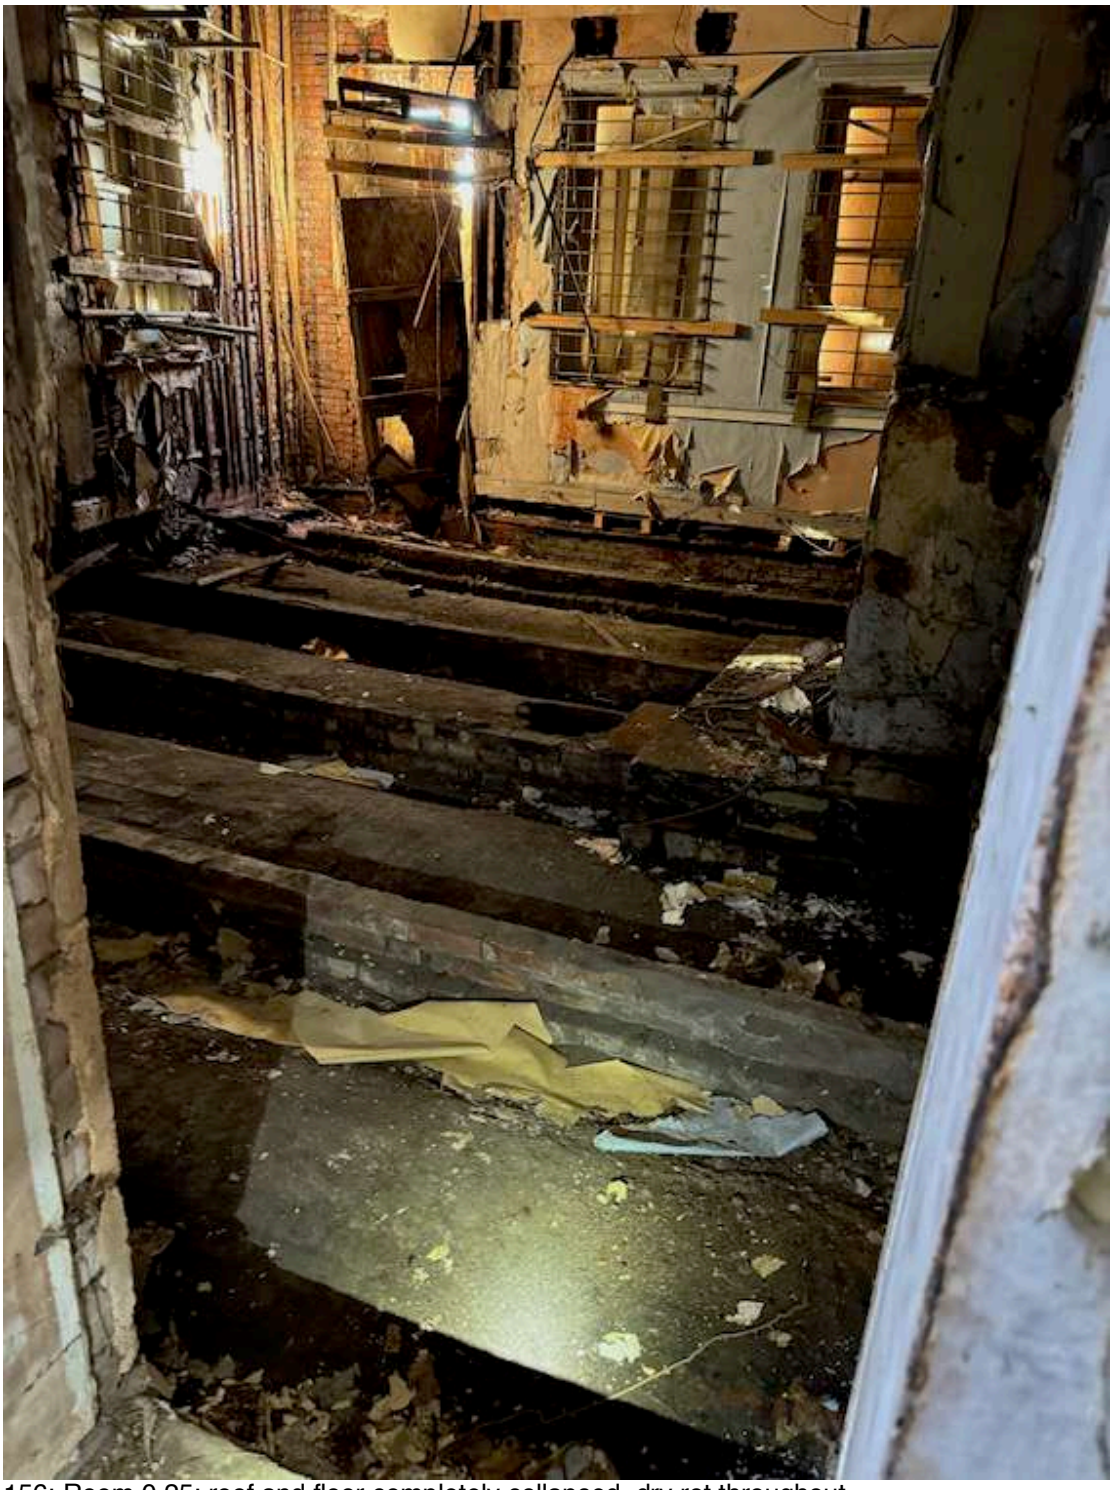
155: Room 0.25; roof and floor completely collapsed, dry rot throughout

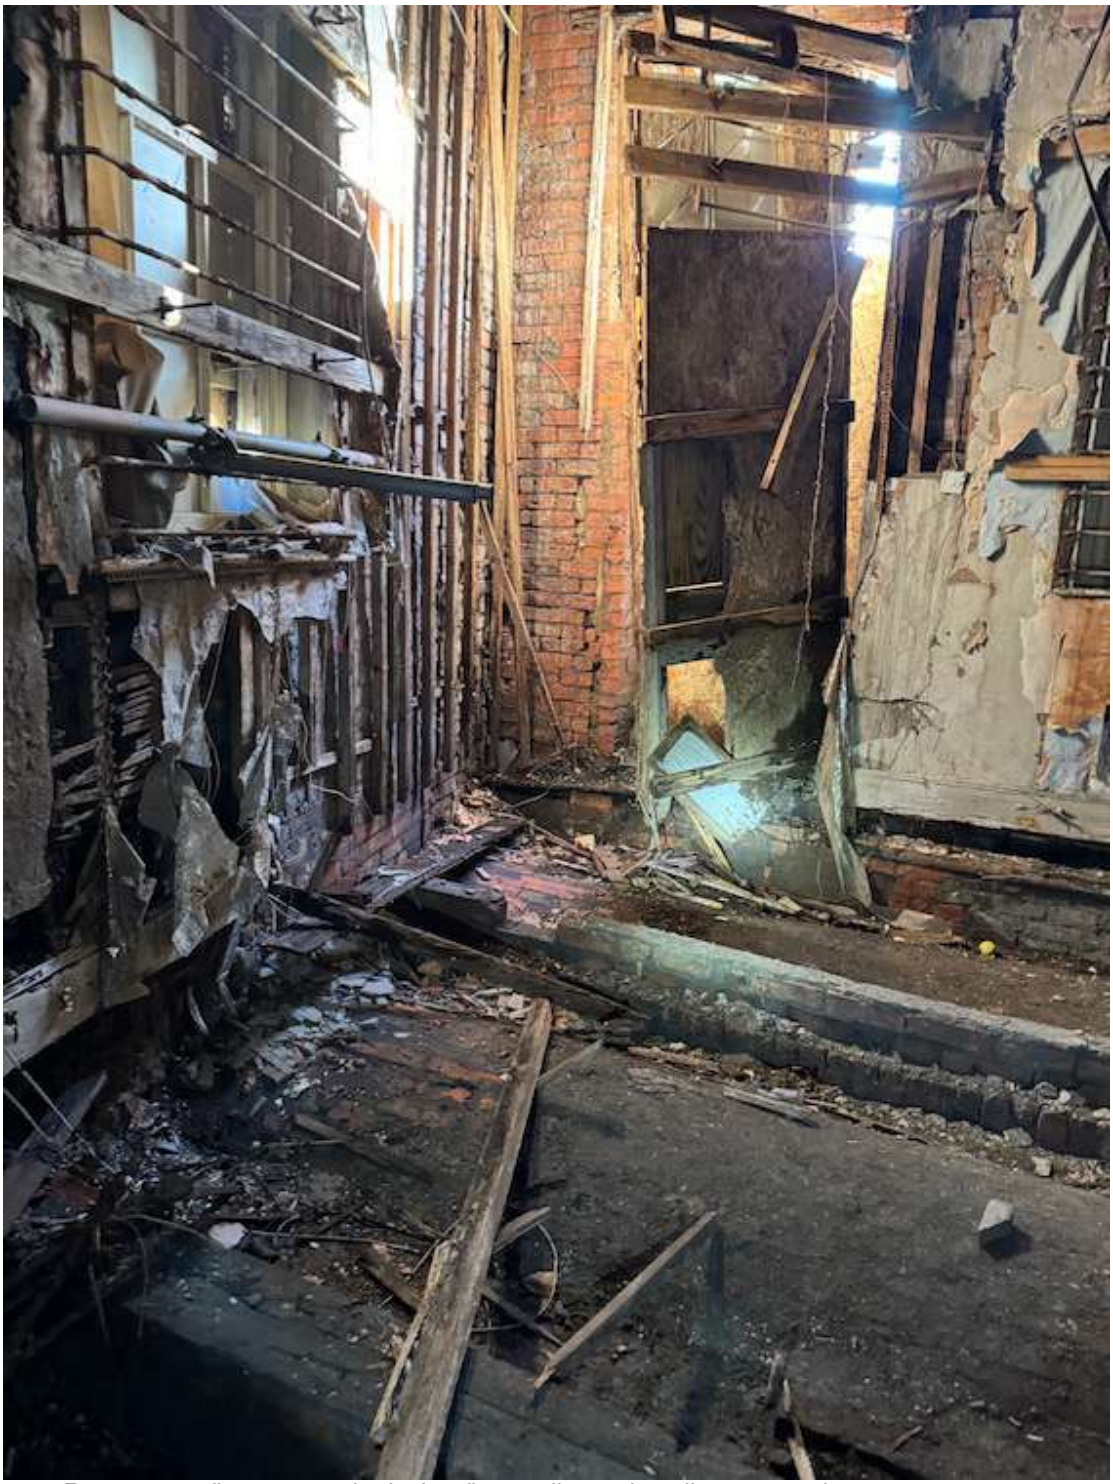
158: Room 0.25; roof and floor completely collapsed, dry rot throughout

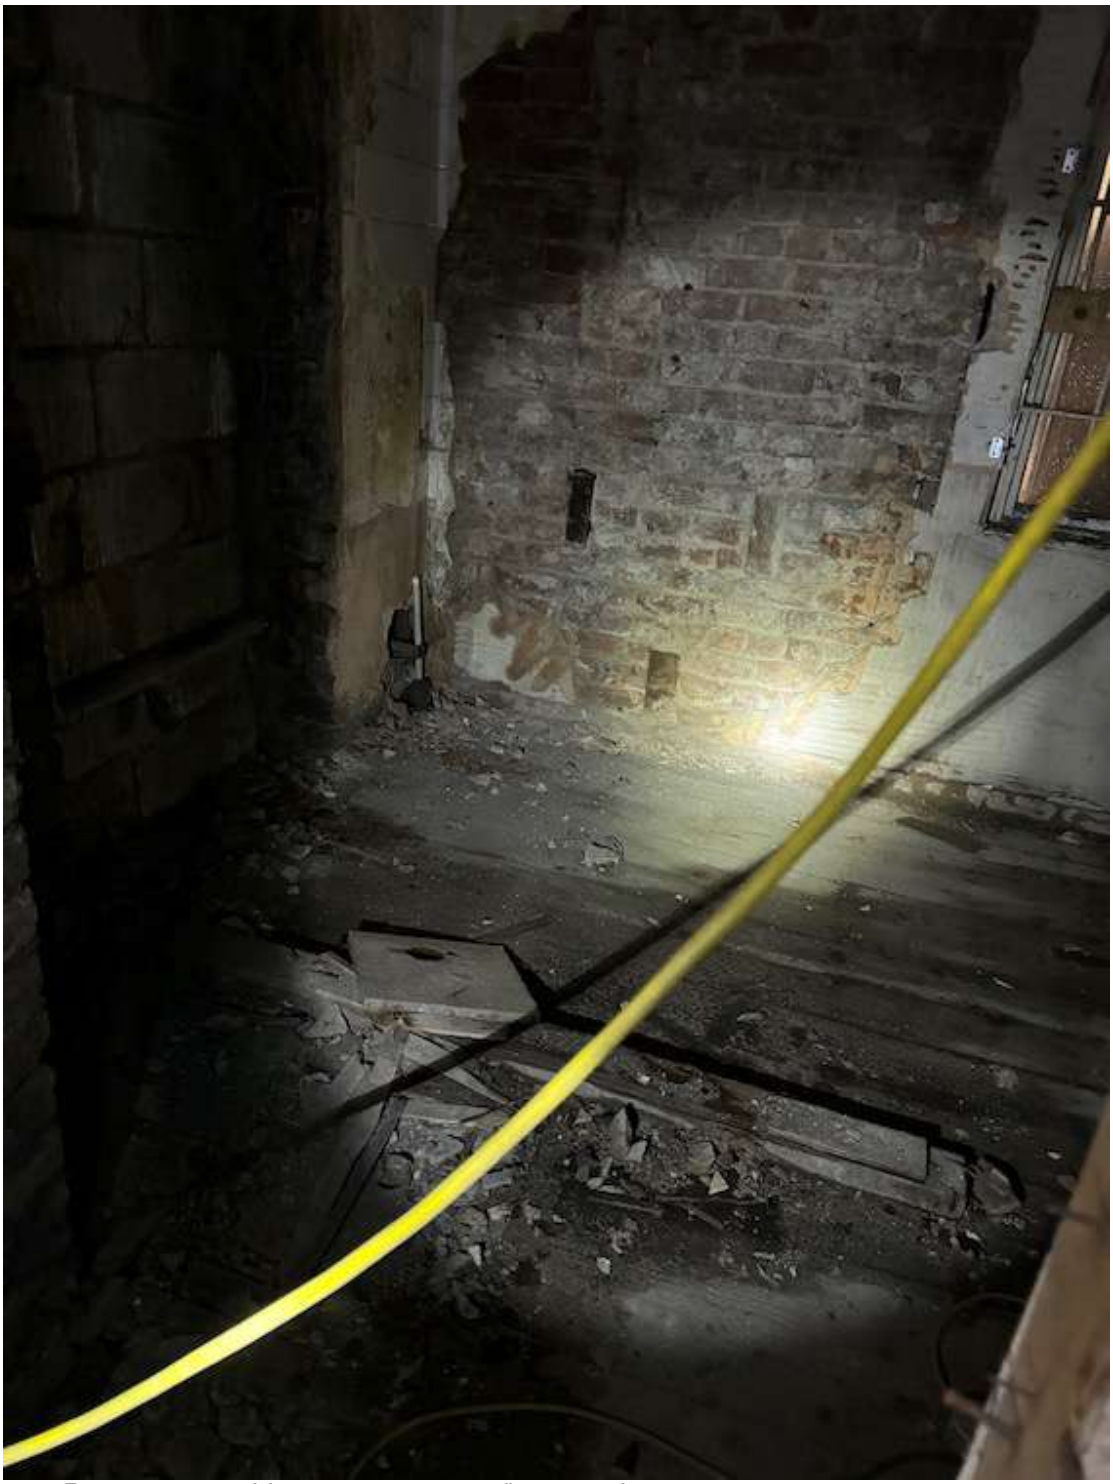
160: Room 0.25; note modern block infill

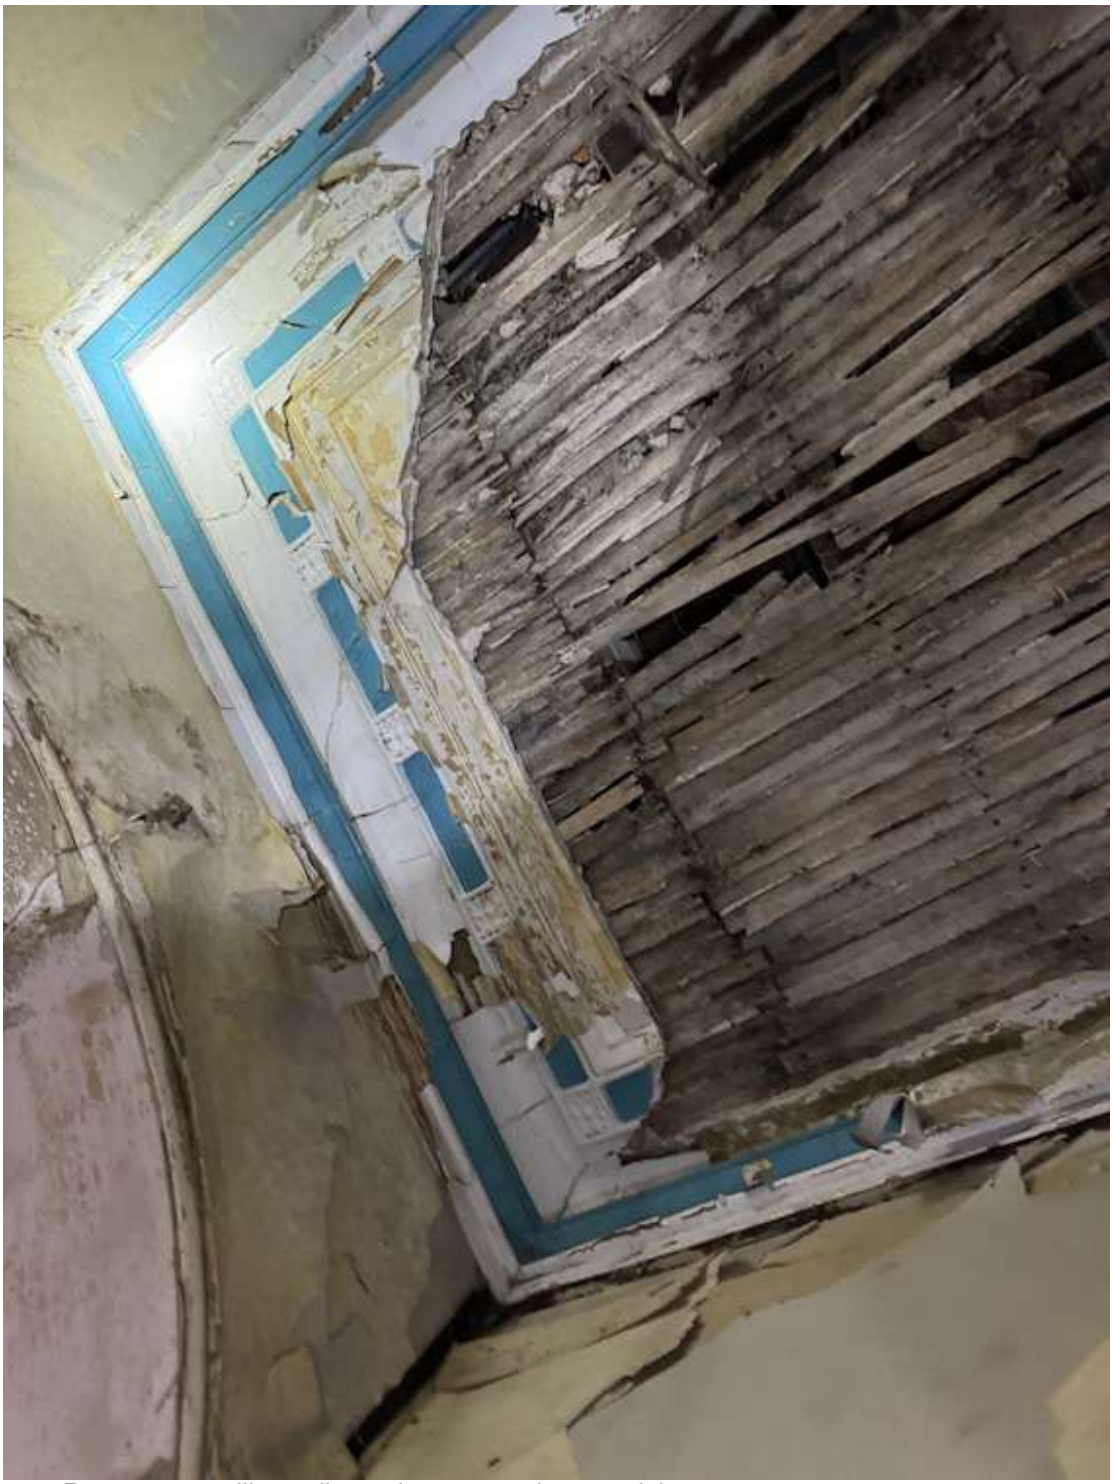
163: Room 0.25; unable to get to wg.07 – floor unsafe

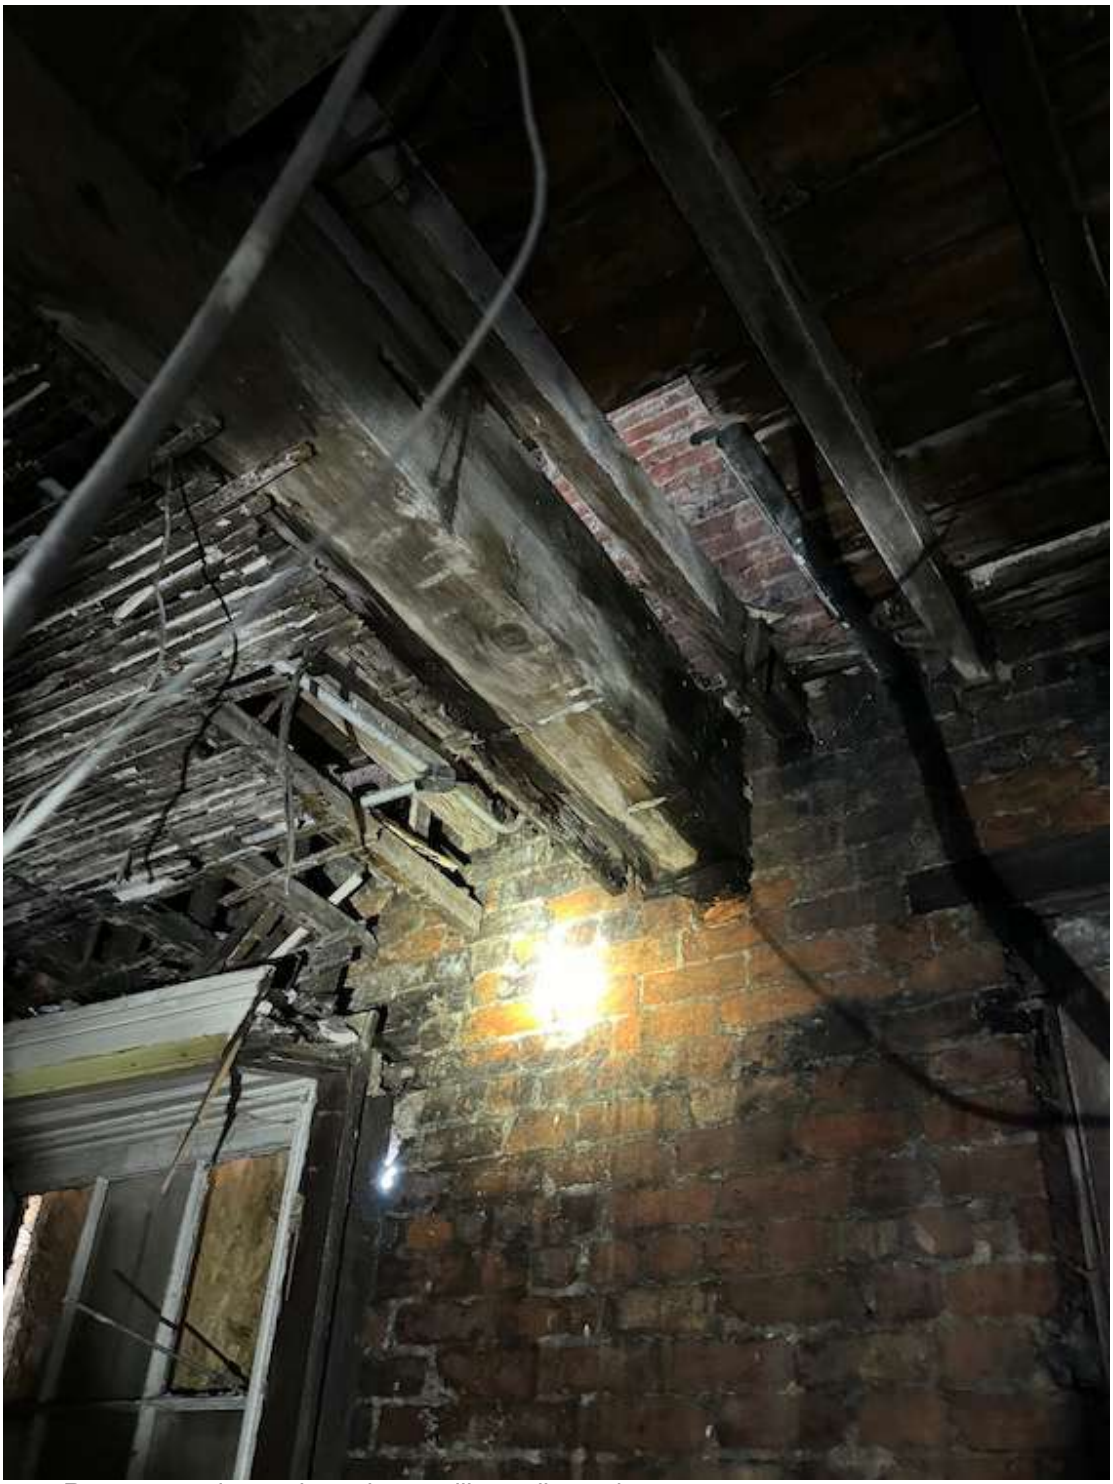
175: Room 0.23; ceiling collapsed, some cornice remaining dry rot evident to all windows and stud work from perimeter wall; evidence of endemic dry rot

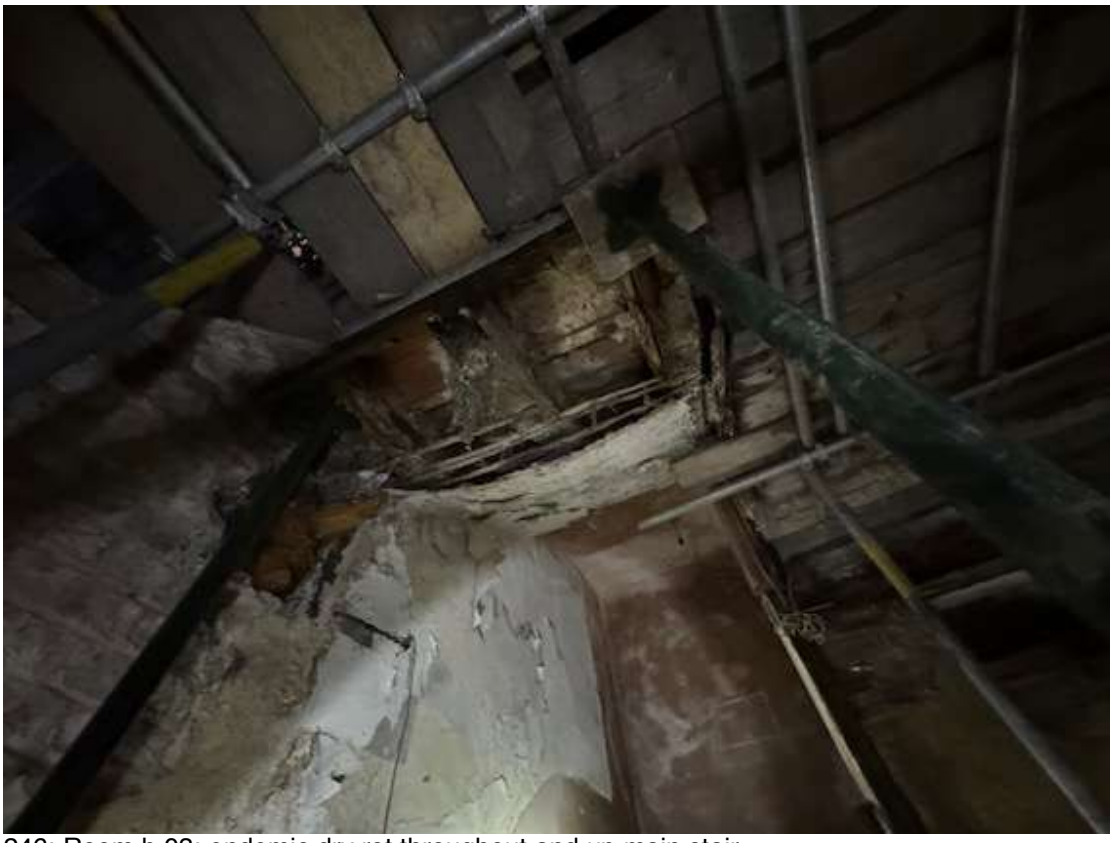
245: Room b.03; endemic dry rot throughout and up main stair
