DRAWING TITLE:
COURTYARD ELEVATION

PROJECT:
BRIDGEWATER HOUSE

PROJECT - ORIGINATOR - ZONE - LEVEL - TYPE - ROLE - NUMBER
23-8383-H-05

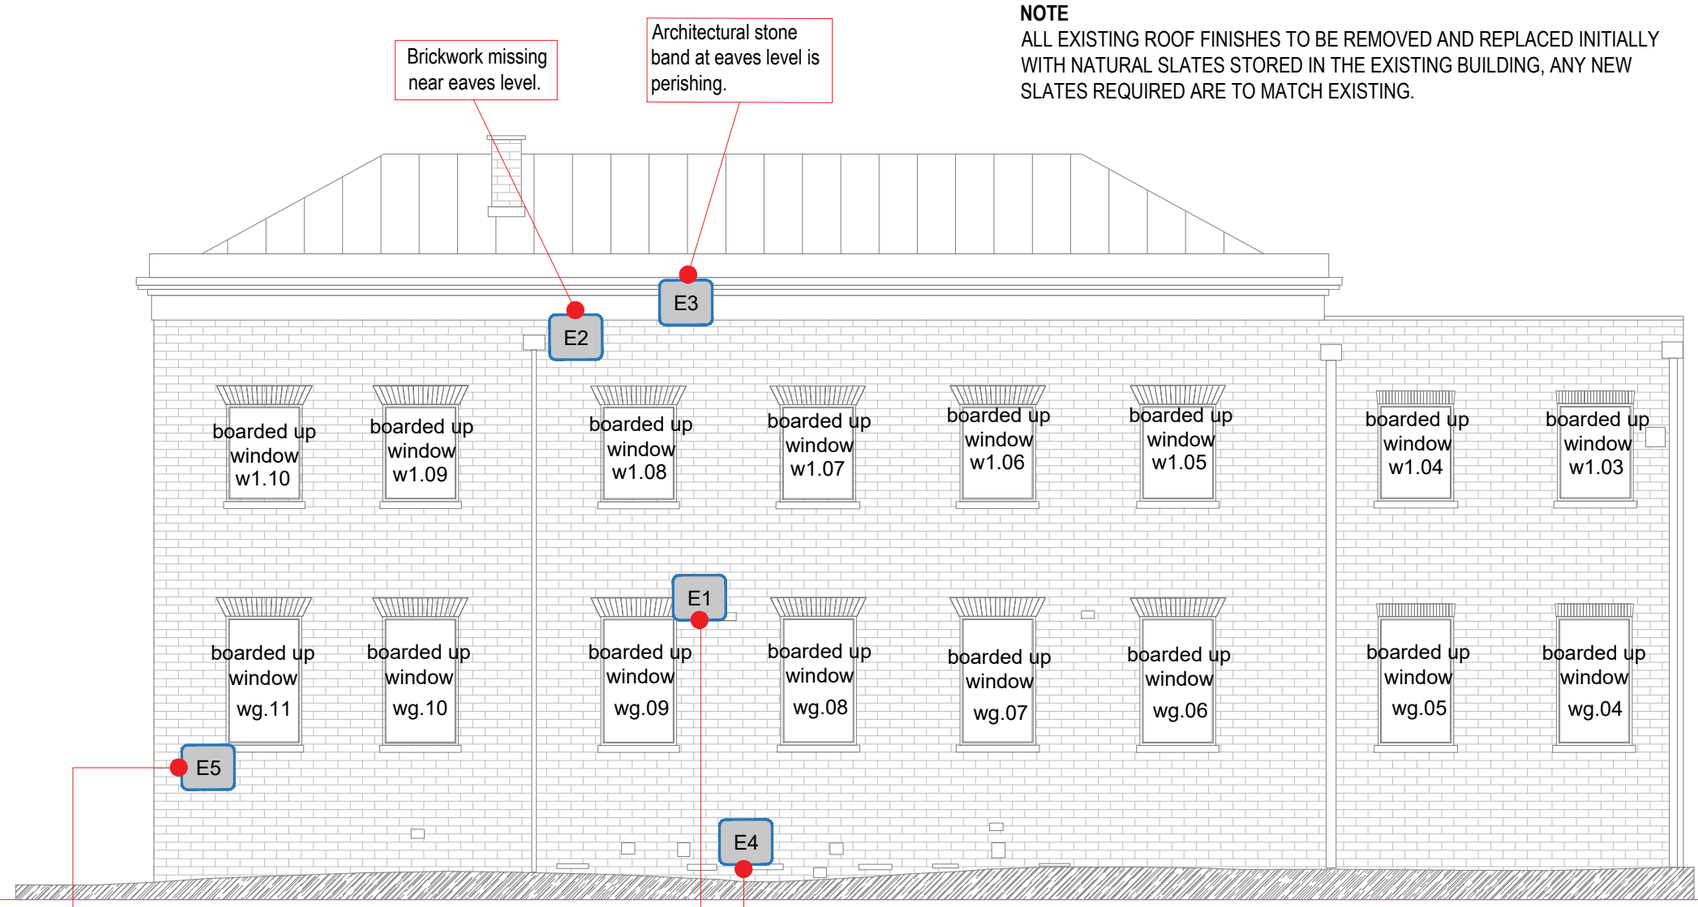
Courtyard Elevation
1:100

REF. NO.	Damage recorded: Entrance porch Roof sloping	Mansory arch dropped	Keystone moved	Movement on vousoirs	Disturbed masonry above arch	Disturbed stone reveal surround	Water stain found	Vegetation growth	corroded reinforcement	Cracks in Brickwork	Degraded mortar joints	Perished / missing Brickwork	Architectural stone band perishing	Disturbed parapet	Window sill cracked	Repair required: Rebuild Entrance porch	Wedge Pack then repoint vousoirs	Concrete repair	Rebuild arch	Reset keystone and point arch	Repoint vousoirs	Rebuild Architectural stone band	Rebuild brickwork at Eaves	Repace perished / missing bricks	Repoint masonry joints	Crack repair	Rebuild coping stone	Rebuild Facias	Dismantle and rebuild parapet	Rebuild Window sill	Comment
E1								■																	■					
E2												■												■						
E3													■									■								
E4							■				■														■					
E5										■																■

NOTE
ALL EXISTING ROOF FINISHES TO BE REMOVED AND REPLACED INITIALLY WITH NATURAL SLATES STORED IN THE EXISTING BUILDING, ANY NEW SLATES REQUIRED ARE TO MATCH EXISTING.
