Project Name: CHORLTON F5-F6

Project Date: 24/03/2025

Inspection Standard: MSCC5 Sewers & Drainage GB (SRM5 Scoring)

Section Inspection - 24/03/2025 - F5X

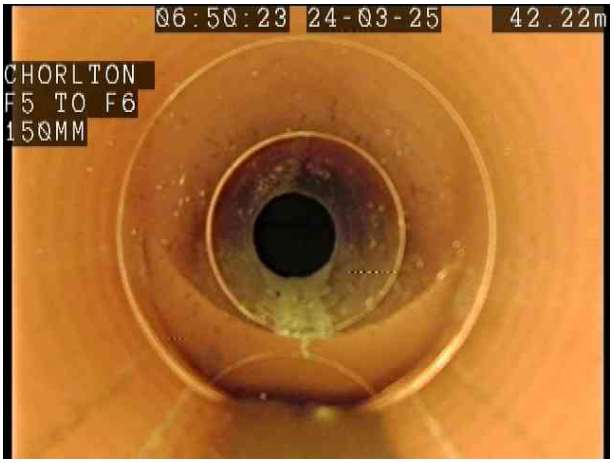
F5X_fcc375e1-f68c-4f79-bdb0-749290abdcd7_20250324_203631_503.jpg, 00:00:00, 0.00 m
Water level, 0% of the vertical dimension
