DRAWING TITLE:
GREAT JACKSON ST. ELEVATION

PROJECT:
BRIDGEWATER HOUSE

PROJECT - ORIGINATOR - ZONE - LEVEL - TYPE - ROLE - NUMBER
23-8383-H-03

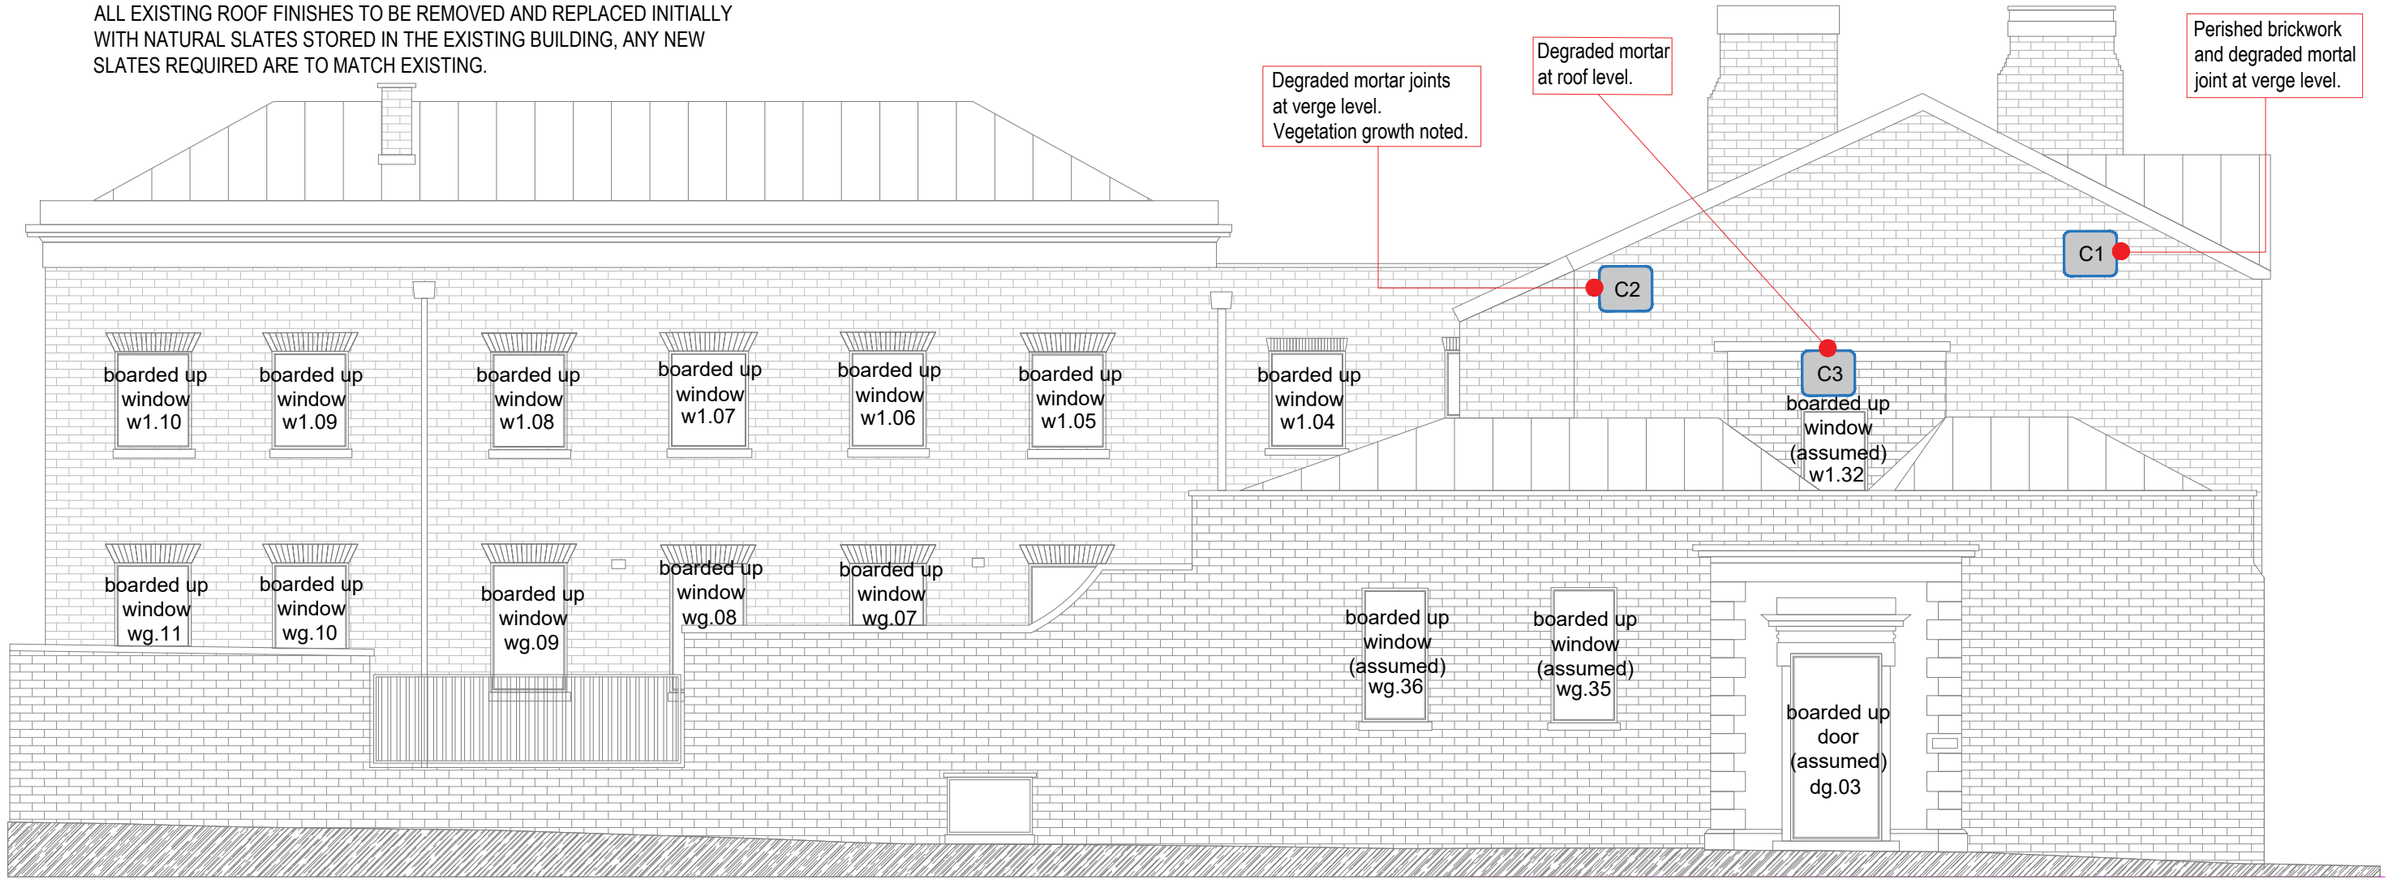
Great Jackson Street Elevation
1:100

REF. NO.	Damage recorded: Collapsed mansory arch and reeveal lintel	Mansory arch dropped	Keystone moved	Movement on vousoirs	Disturbed masonry above arch	Disturbed stone reveal surround	Vegetation growth	Cracks in Brickwork	Degraded mortar joints	Perished / missing Brickwork	Disturbed parapet	Window sill cracked	Repair required: Rebuild arched Lintel	Wedge Pack then repoint vousoirs	Rebuild arch	Reset keystone and point arch	Repoint vousoirs	Rebuild brickwork at Eaves	Repace perished / missing bricks	Repoint masonry joints	Crack repair	Rebuild coping stone	Rebuild Facias	Dismantle and rebuild parapet	Rebuild Window sill	Comment
C1									■	■									■	■						
C2							■		■											■						
C3									■											■

NOTE
ALL EXISTING ROOF FINISHES TO BE REMOVED AND REPLACED INITIALLY WITH NATURAL SLATES STORED IN THE EXISTING BUILDING, ANY NEW SLATES REQUIRED ARE TO MATCH EXISTING.
