BROWNFIELD SOLUTIONS LTD

BRWRY, Manchester

Remediation Validation Report

JEM/C5313/12304 Rev E

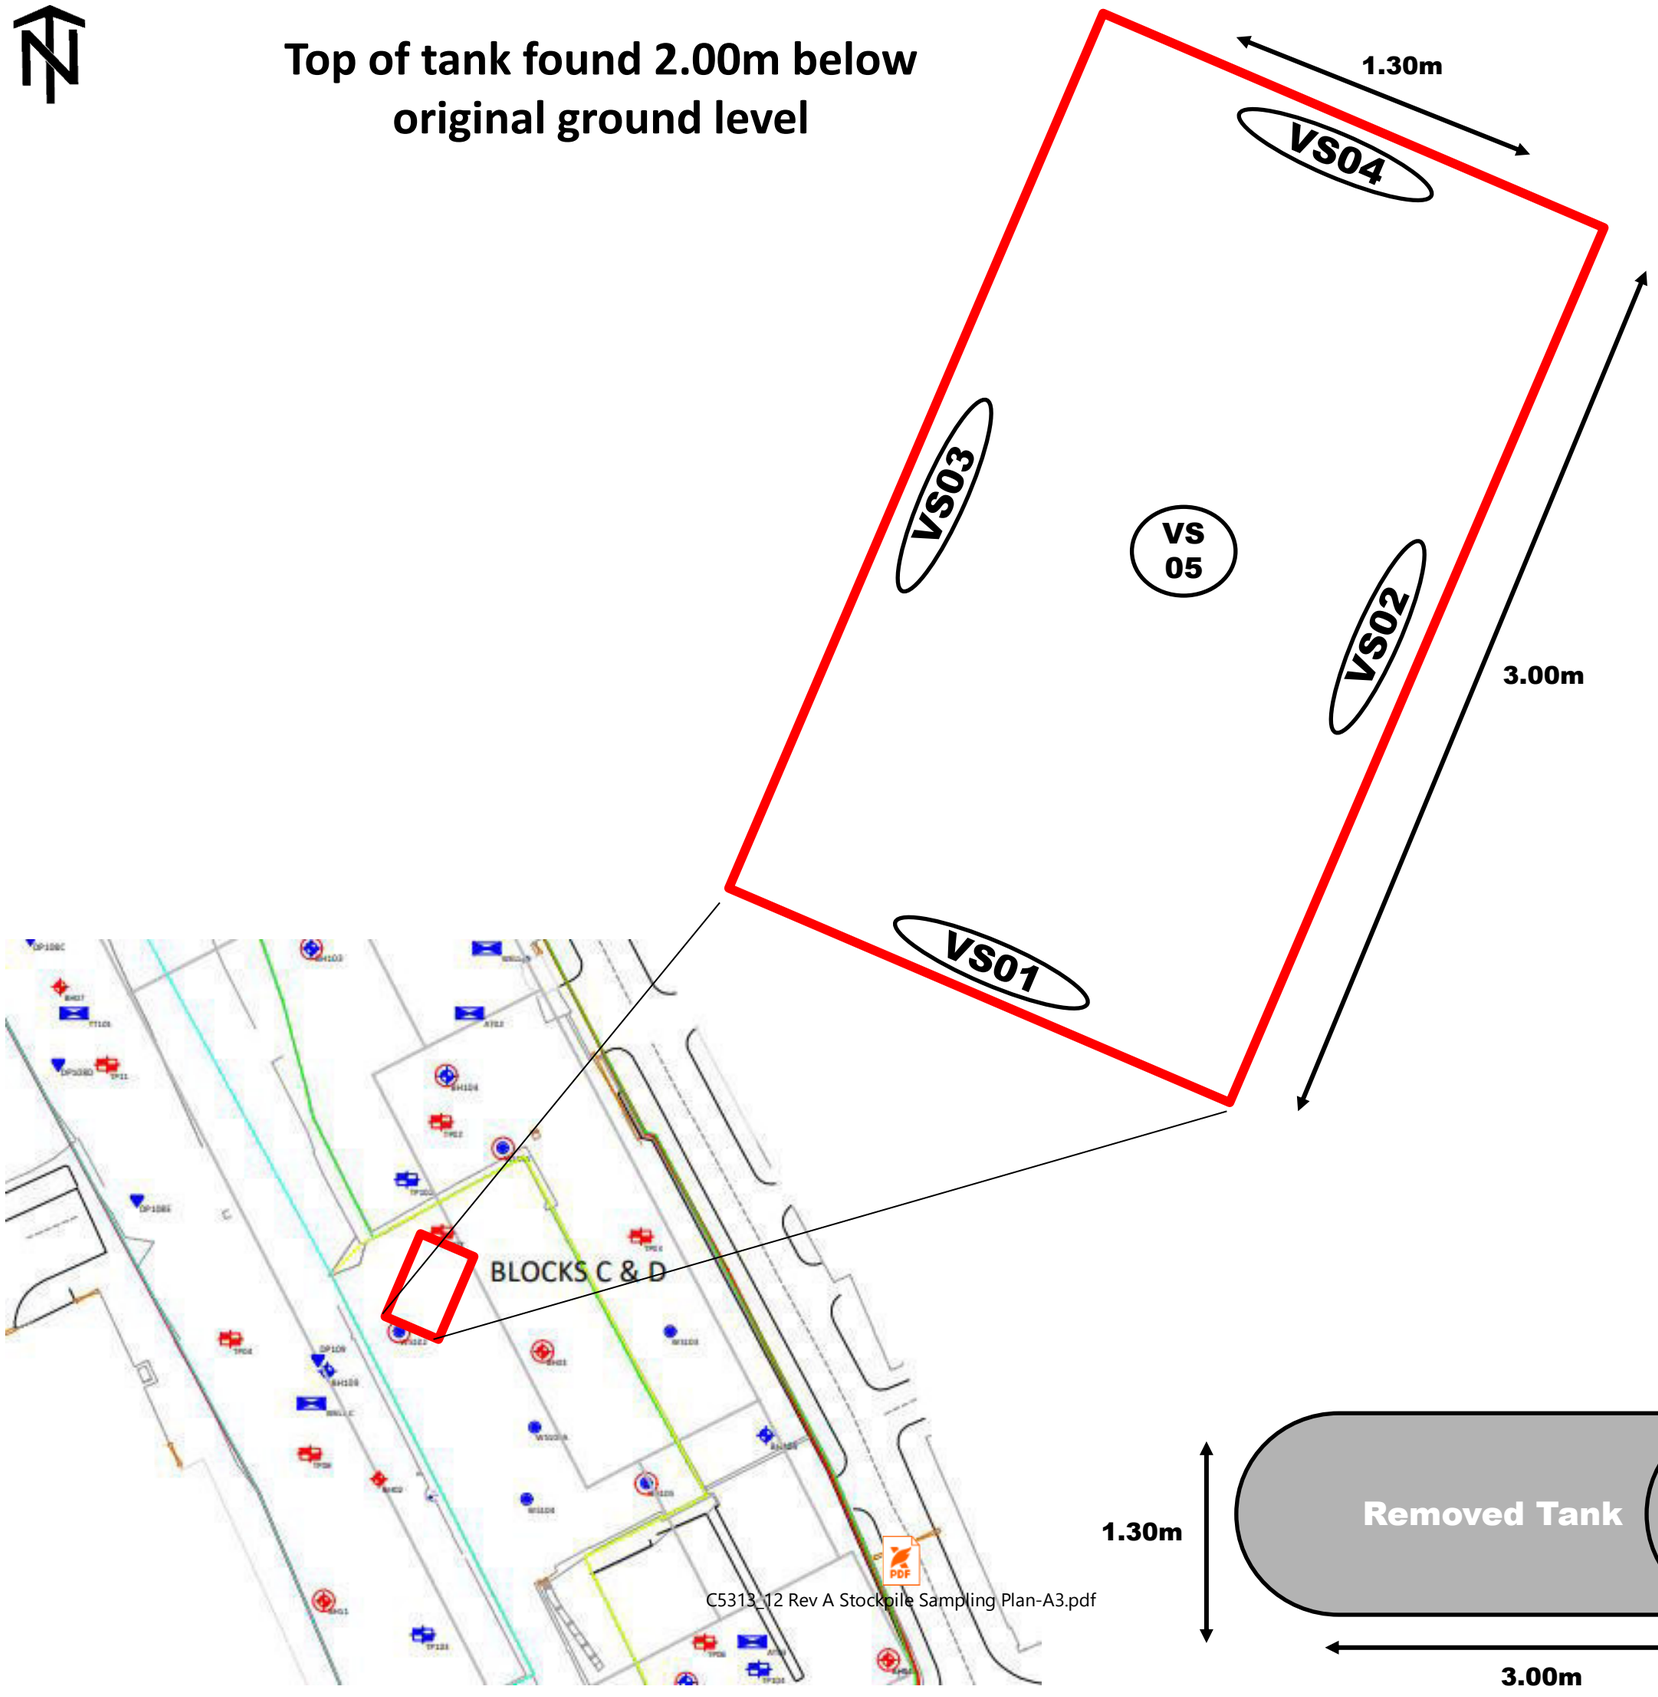
Top of tank found 2.00m below original ground level

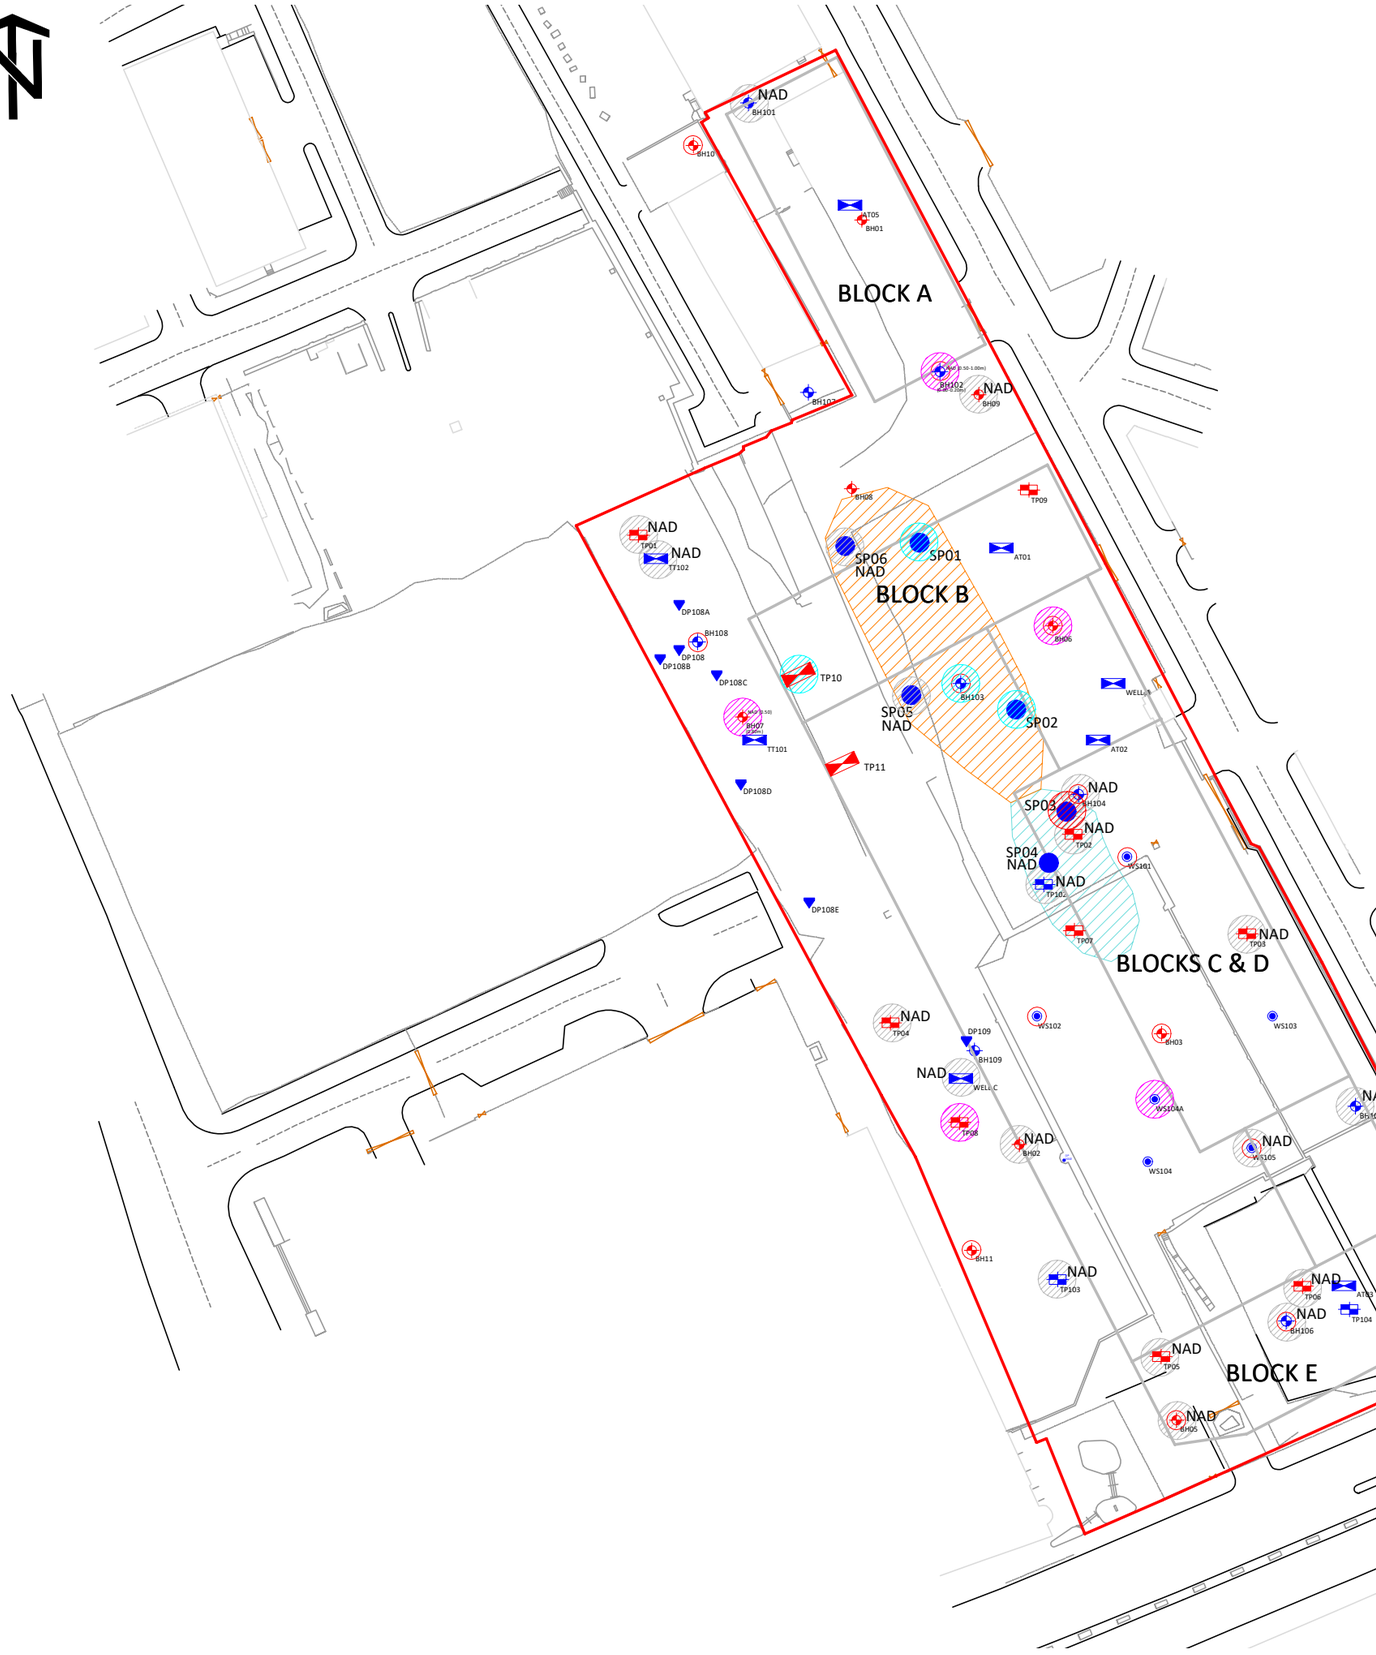
DRAWING No.	REVISION	SCALE	DATE
C5313/08	-	NTS	06/07/23

5th July 2023 – Previously Unrecorded UST (Excavation 1)
BSL attended site on 5th July 2023 to validate the removal of a tank found in Block C & D. BSL were not requested to attend site during the removal of the unrecorded UST. The area surrounding the UST was subsequently reduced in level to the same level of the base of the excavation with the excavated material re-used elsewhere onsite. No contamination was reported to BSL from the material excavated from this area. The locations and dimensions of the tank excavations and sampling locations are shown on the Tank Excavation Plan, drawing C5313/11.
