BROWNFIELD SOLUTIONS LTD

BRWRY, Manchester

Remediation Validation Report

JEM/C5313/12304 Rev D

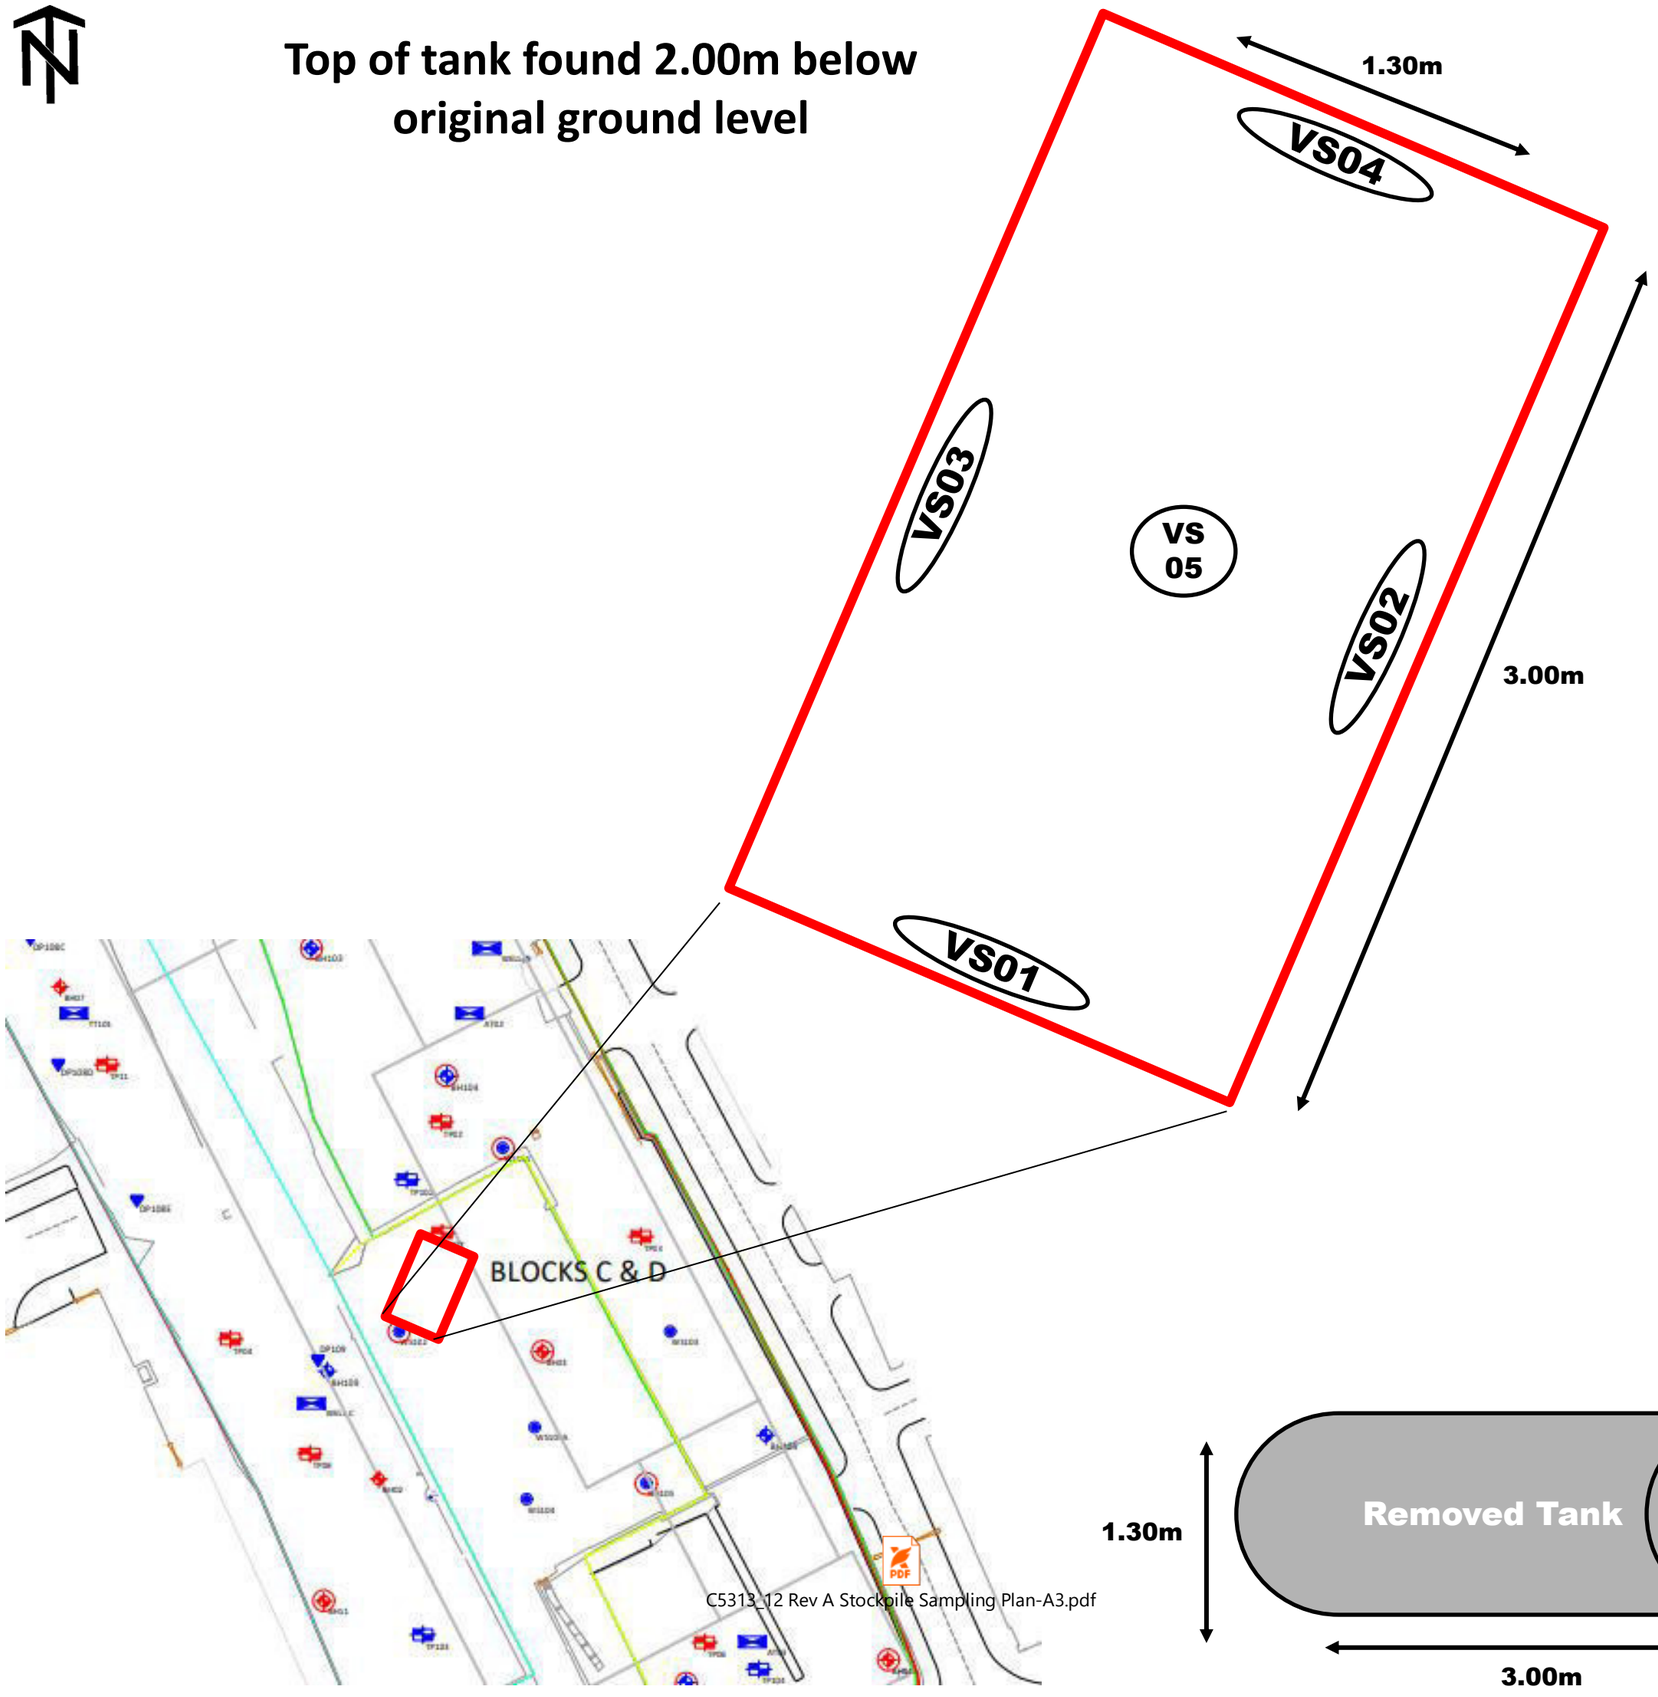
DRAWING No.	REVISION	SCALE	DATE
C5313/10	H	NTS	12/09/23

Top of tank found 2.00m below original ground level
