Phase I Geoenvironmental Site Assessment
Land off Barnhill Street/Raby Street, Moss Side, Manchester

Reference: 18-145-R1-4
Date: July 2025

PHASE I GEOENVIRONMENTAL SITE ASSESSMENT

Caddick Construction Ltd / Mosscare St Vincent's Housing Group Ltd

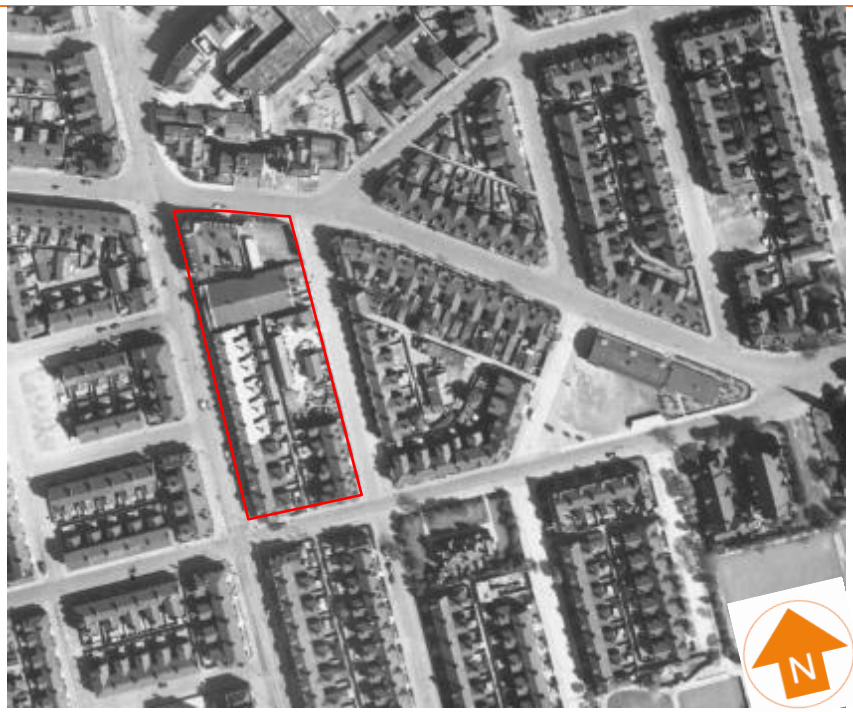
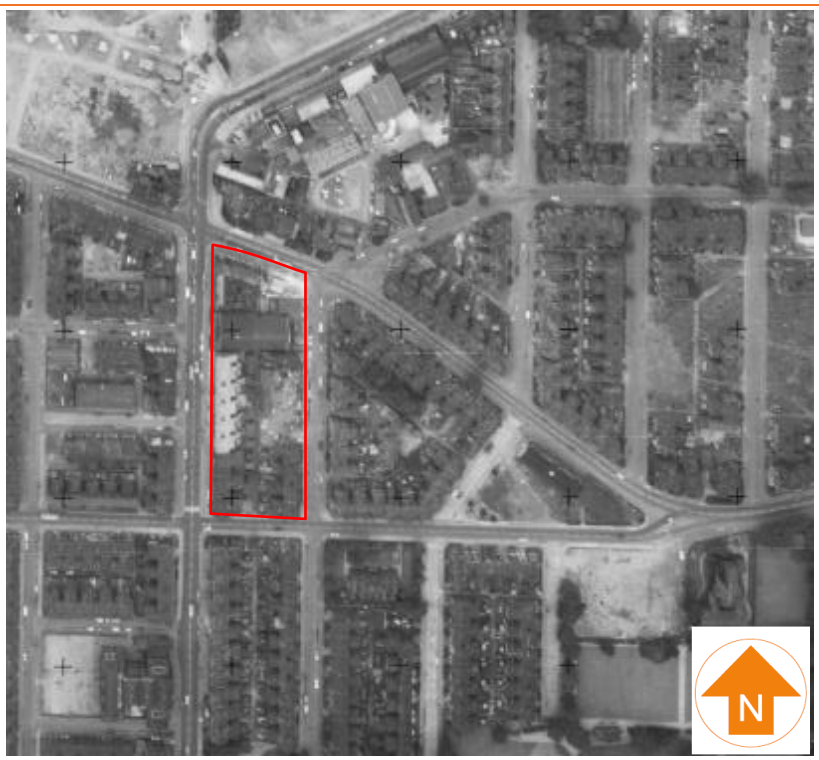
PLATE 1 – Historic England 1946 Residential housing extended along the western boundary with the picture house and potential commercial buildings in the north. Potential industrial yard with associated structures in the central eastern sector.	
PLATE 2 – Historic England 1969 Residential housing extended along the western boundary with picture house and commercial buildings in the north. Industrial yard with associated structures in the central eastern sector (layout change in east compared to 1946 imagery; with suspected demolition and alteration to former structures present).
