GENERAL UTILITIES NORTHWEST
UNIT 1 BOUNDARY PARK LIVERPOOL RD, IRLAM
Tel. 0161 776 0011
craig.morris@generalutilitiesnorth.co.uk

Project Name:	354 WILBRAHM RD URBAN REGEN
Project Description:	CCTV AND CLEAN
Project Date:	08/03/2025
Inspection Standard:	MSCC5 Sewers & Drainage GB (SRM5 Scoring)

Section Inspection - 08/03/2025 - F4X

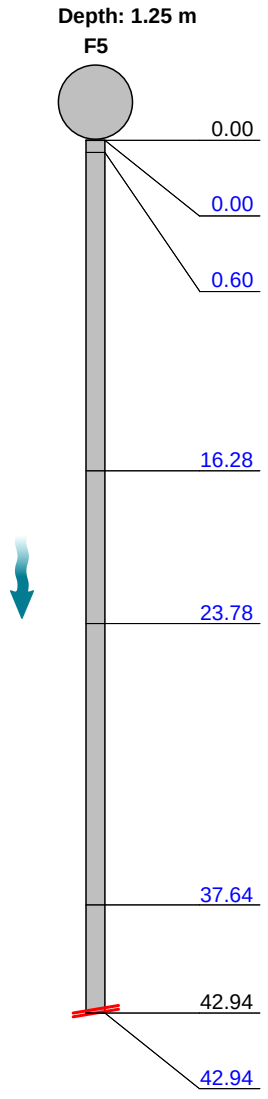
Position [m]	Code	Observation	MPEG	Photo	Grade
0.00	MH	Start node, manhole, reference: F5	00:00:00		
0.00	WL	Water level, 5% of the vertical dimension	00:00:03		
0.60	GP	General photograph taken at this point	00:00:07	F5X_5d8d476e-17bf-4731-9495	
16.28	GP	General photograph taken at this point	00:03:43	F5X_bdea6d63-edda-42a9-9cd	
23.78	GP	General photograph taken at this point	00:06:35	F5X_c81512c7-6804-4821-b5b	
37.64	GP	General photograph taken at this point	00:08:51	F5X_d8a88044-f194-4533-bfe0-	
42.94	JN	Junction at 6 o'clock, 150mm dia: BACK DROP	00:09:45	F5X_74377e2a-5e64-4912-80d	
42.94	SA	Survey abandoned: CACK DROP MH IN VIEW	00:09:50

F5X_74377e2a-5e64-4912-80d7-09d03a36e3cf_20250308_095557_724.jpg, 00:09:45, 42.94 m
Junction at 6 o'clock, 150mm dia, BACK DROP

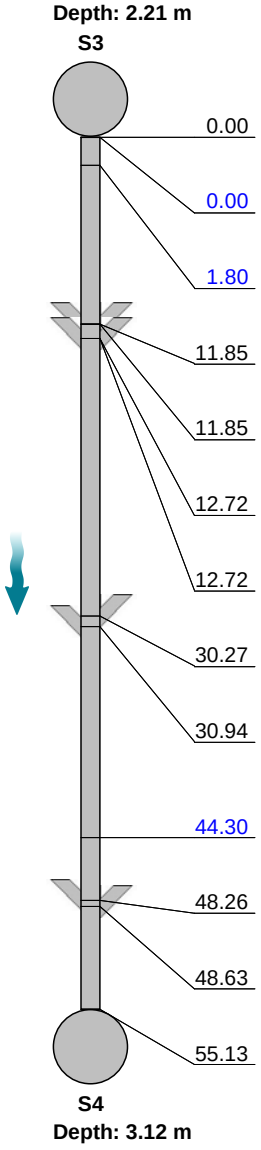
1.80	GP	General photograph taken at this point	00:00:27	S3X_e1326e2b-88f1-4b60-aca9	
11.85	CN	Connection other than junction at 11 o'clock, 150mm dia	00:01:55

11.85	CN	Connection other than junction at 1 o'clock, 150mm dia	00:01:57		
12.72	CN	Connection other than junction at 11 o'clock, 150mm dia	00:02:08		
12.72	CN	Connection other than junction at 1 o'clock, 150mm dia	00:02:09

30.27	CN	Connection other than junction at 11 o'clock, 150mm dia	00:03:56		
30.94	CN	Connection other than junction at 1 o'clock, 150mm dia	00:04:05		
44.30	GP	General photograph taken at this point	00:05:01	S3X_76502c9d-d4c7-409f-b4df-

48.26	CN	Connection other than junction at 1 o'clock, 150mm dia	00:05:22		
48.63	CN	Connection other than junction at 11 o'clock, 150mm dia	00:05:30		
55.13	MHF	Finish node, manhole, reference: S4	00:06:04
