CONDITION 7(c) DRAINAGE VERIFICATION REPORT

Victoria Riverside, Dantzic Street

Far East Consortium

12/09/2024

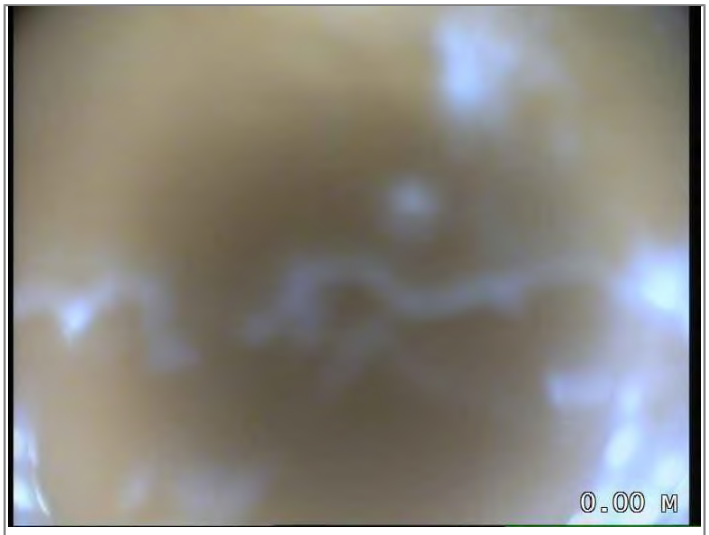
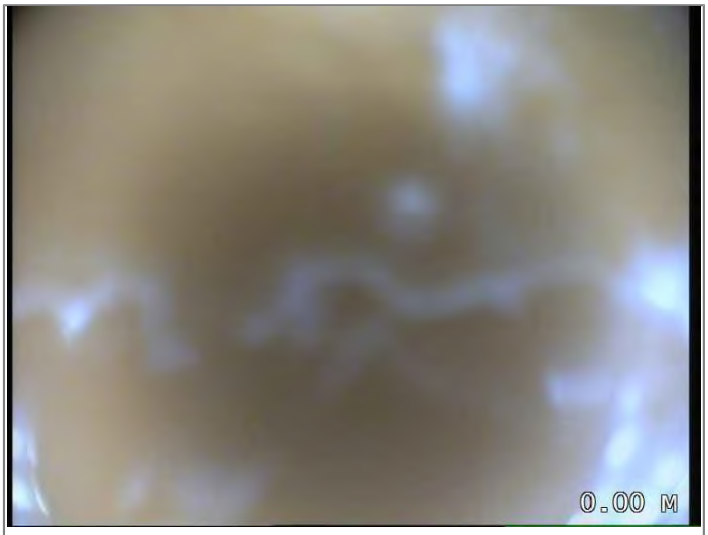
Line of drain/sewer deviates left - Remark: JOINS CARRIER

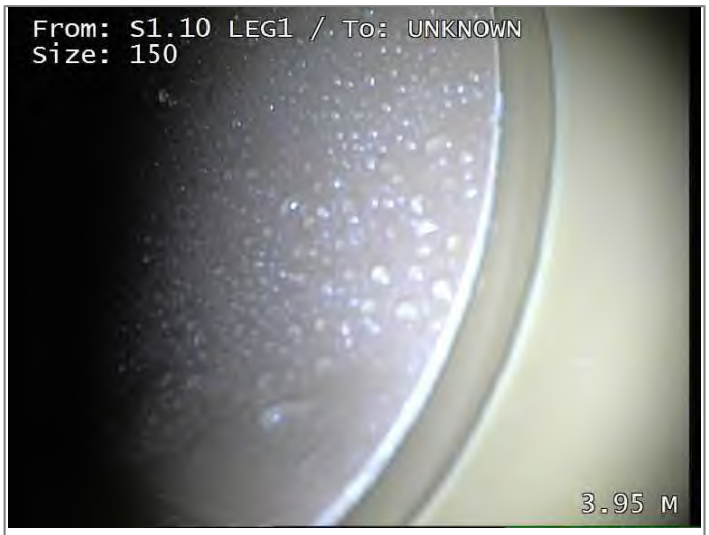
Line of drain/sewer deviates left

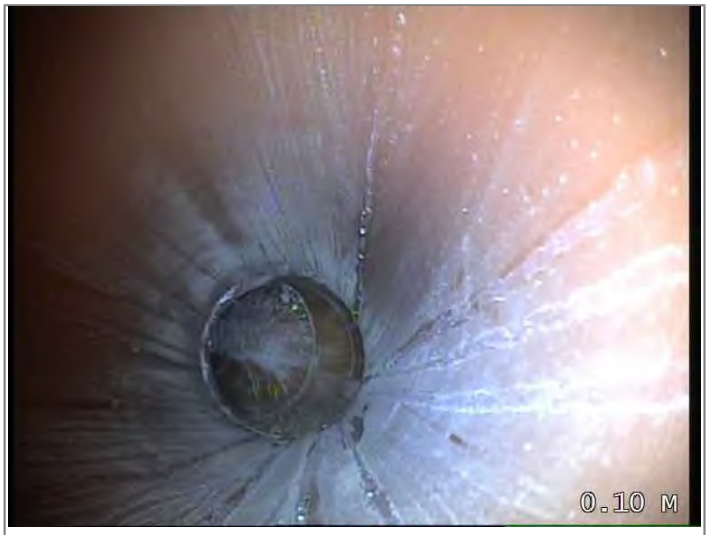
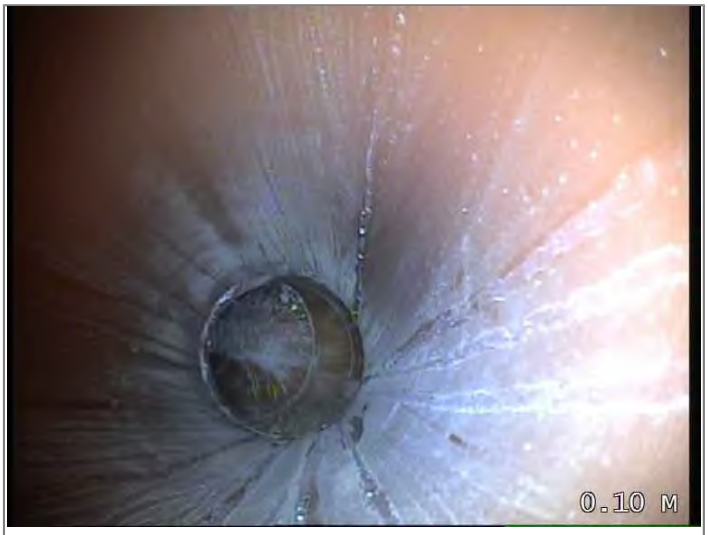
Line of drain/sewer deviates left - Remark: CARRIER S1.10-S1.12

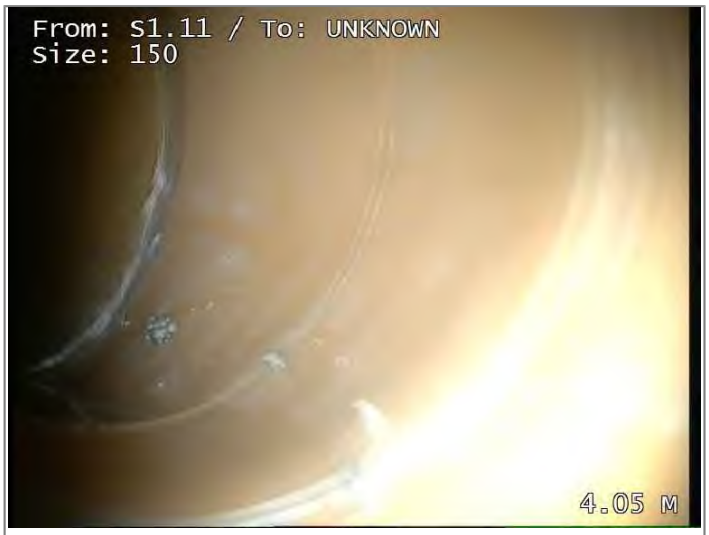
Start node type, manhole, reference S1.11

Line of drain/sewer deviates left

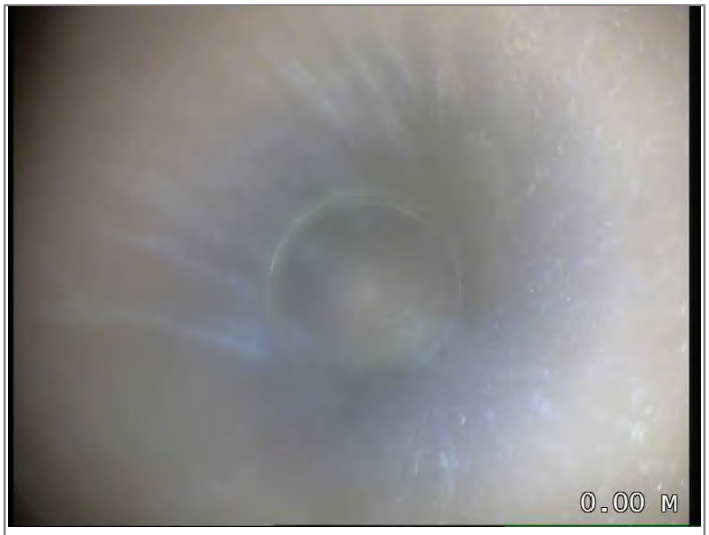
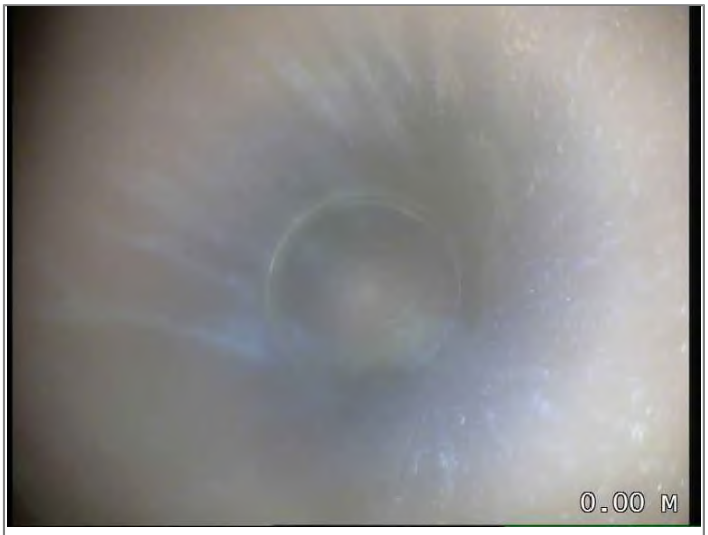
Line of drain/sewer deviates right - Remark: S1.11-S1.12 CARRIER

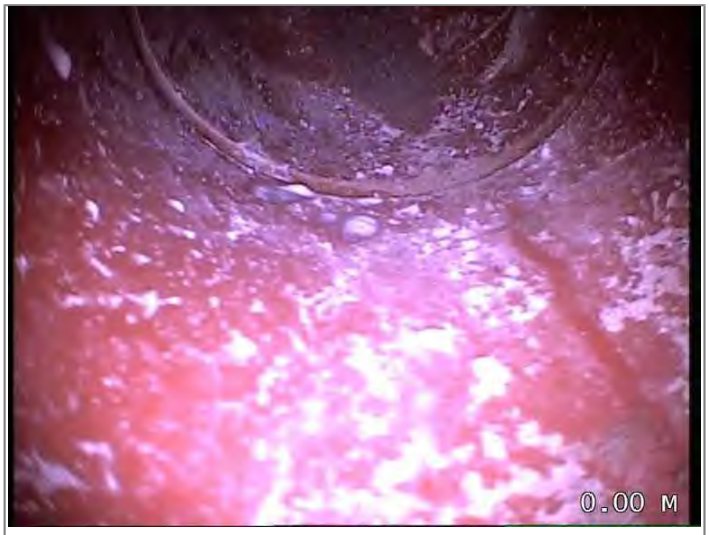
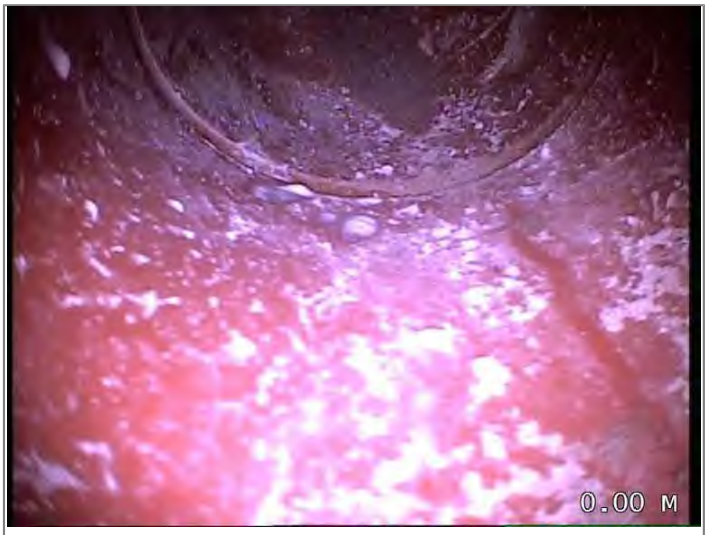
Line of drain/sewer deviates right - Remark: S1.11-S1.12 CARRIER

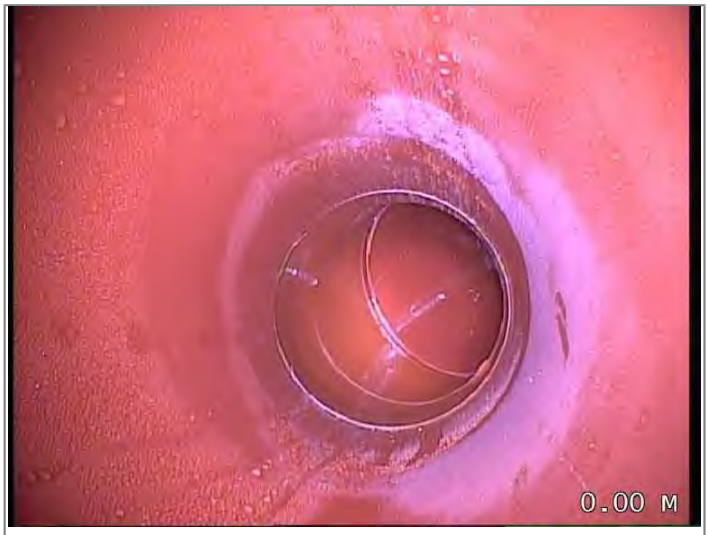
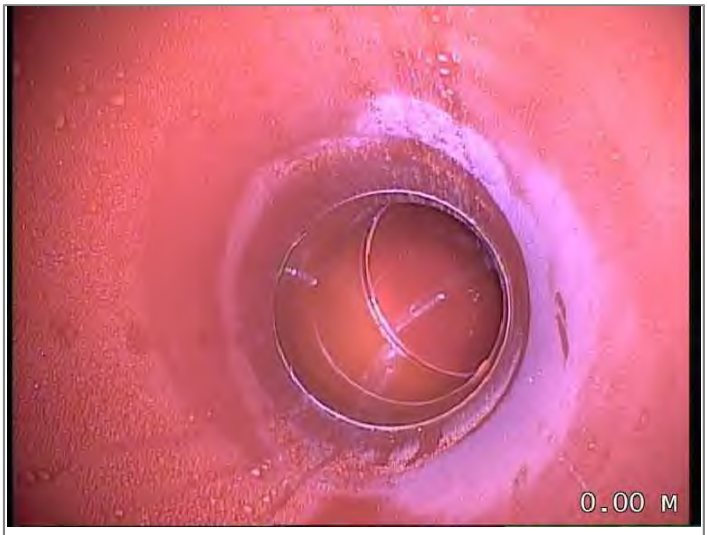
Line of drain/sewer deviates right - Remark: S1.11-S1.12 CARRIER

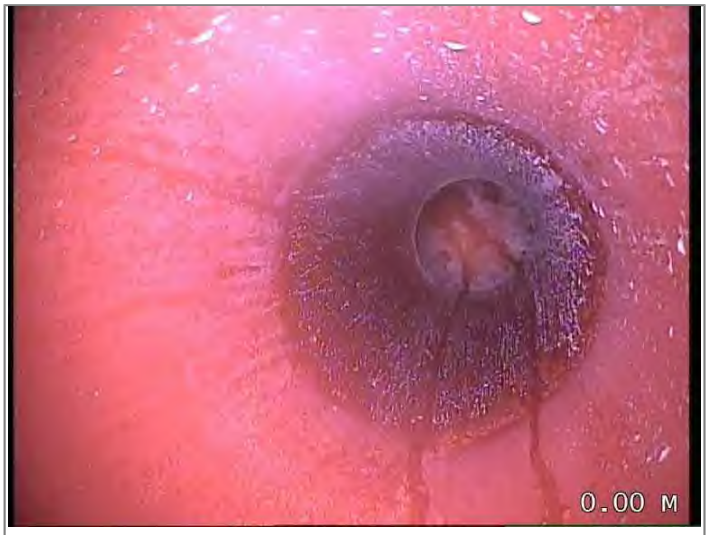
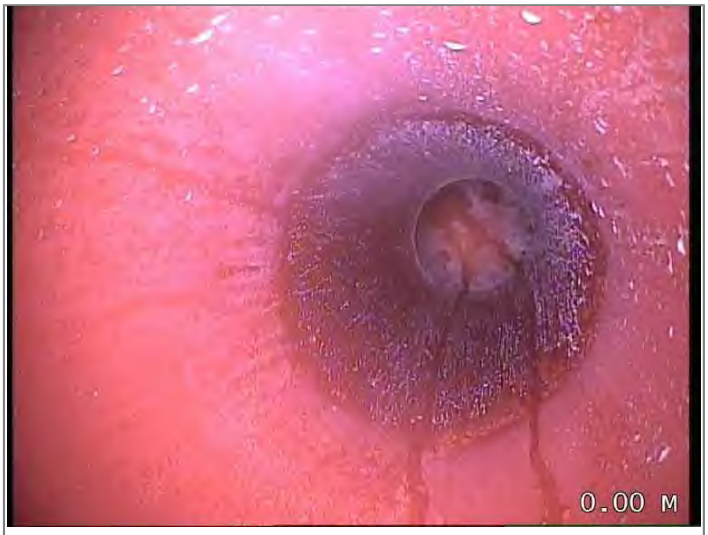
Line of drain/sewer deviates right - Remark: S1.11-S1.12 CARRIER

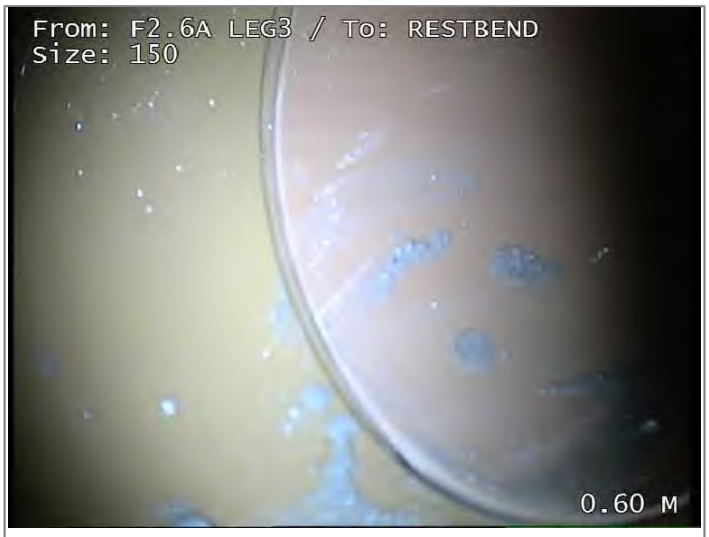
Line of drain/sewer deviates right

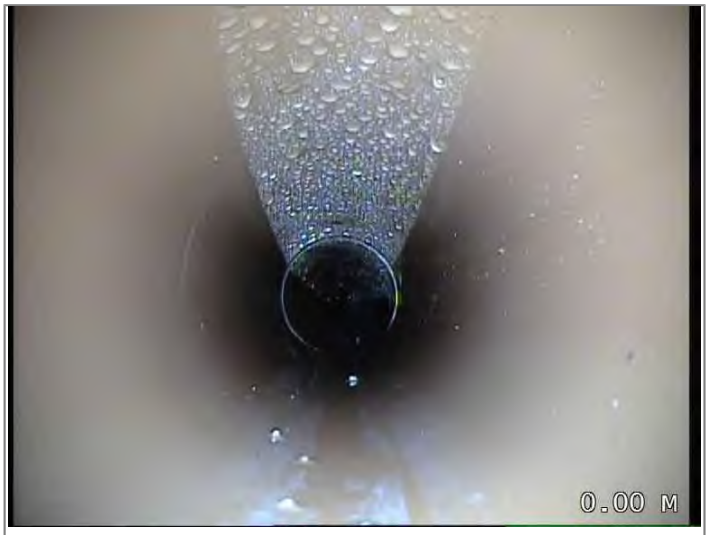
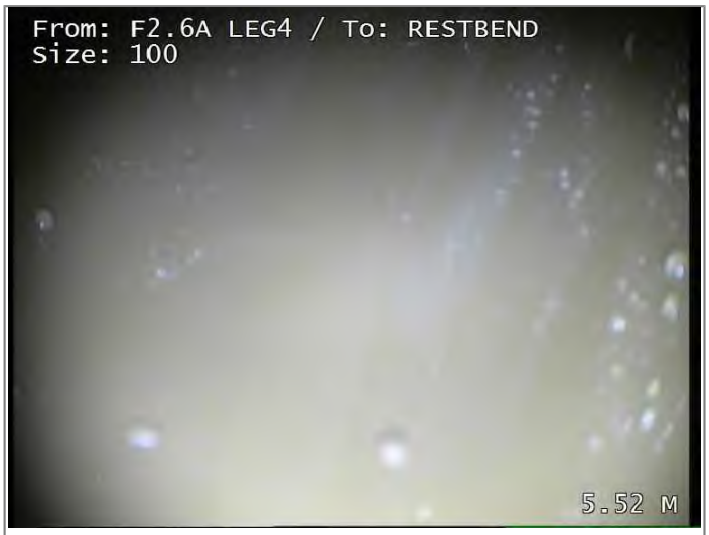
Start node type, manhole, reference F2.6A LEG4

Water level 05% height/diameter

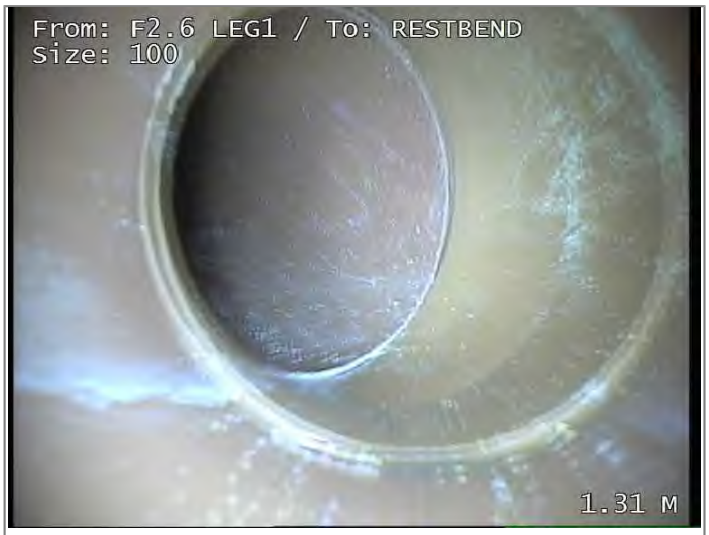
Start node type, manhole, reference F2.6 LEG1

Water level 05% height/diameter

Line of drain/sewer deviates left

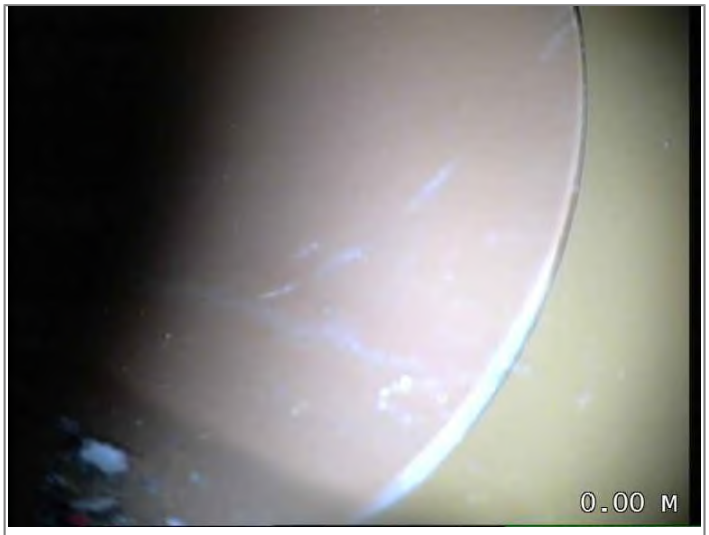
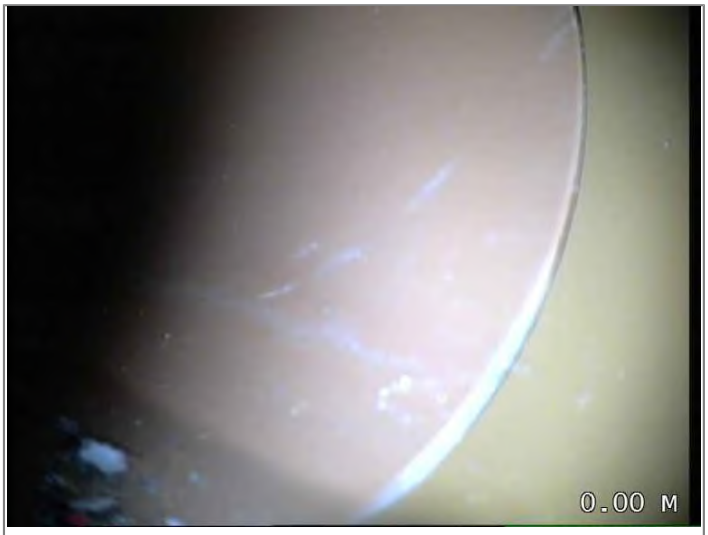
Start node type, manhole, reference F2.6 LEG2

Water level 05% height/diameter

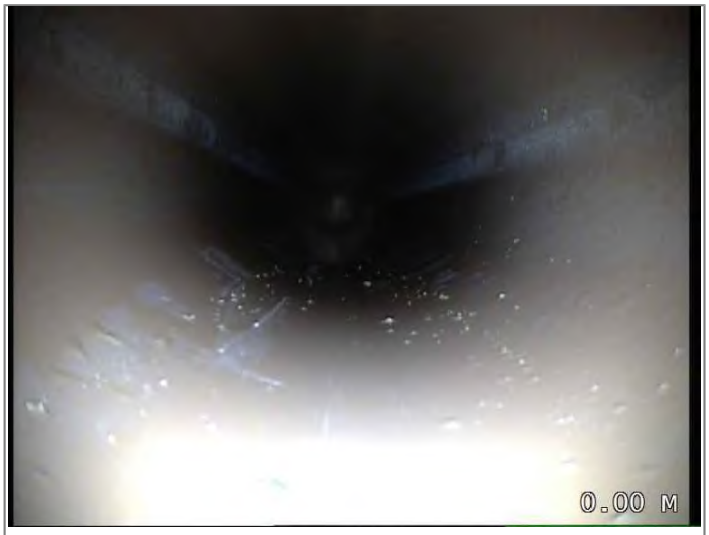
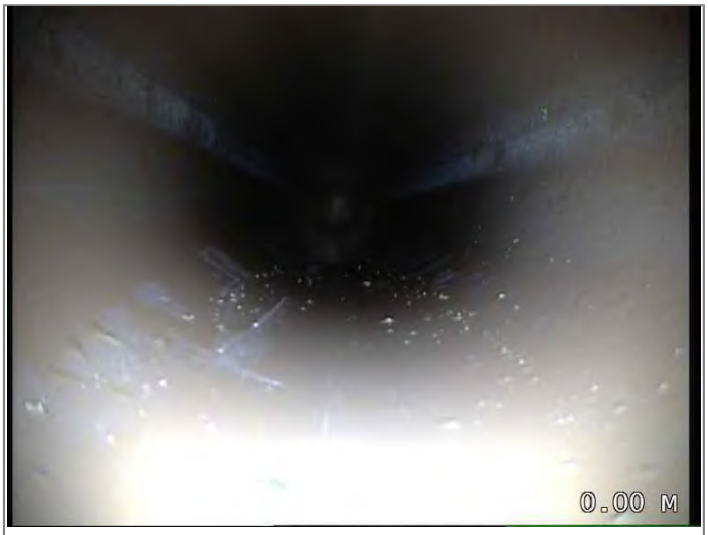
Start node type, manhole, reference F2.6

Water level 05% height/diameter

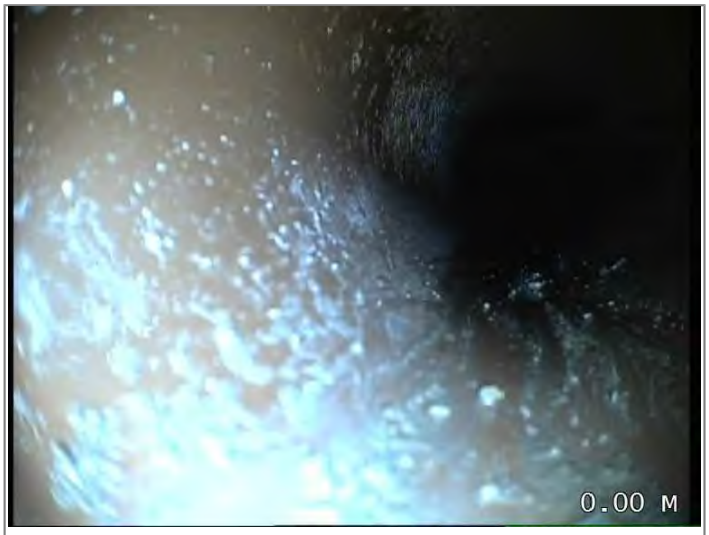
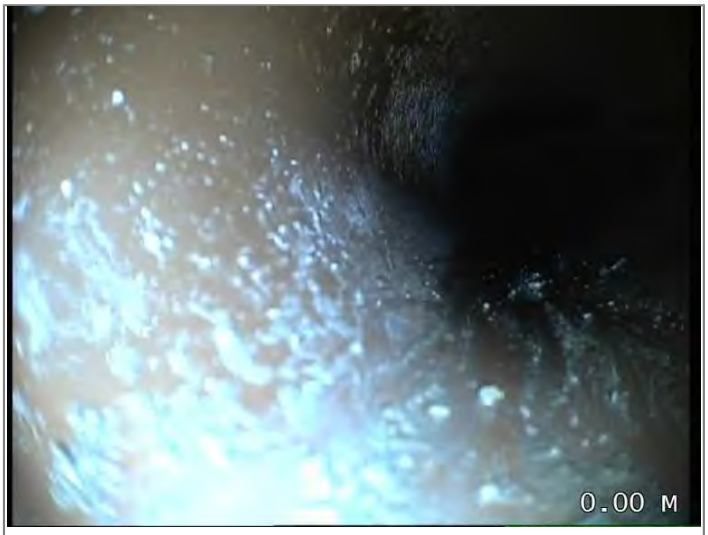
Start node type, manhole, reference F2.11 LEG1

Water level 05% height/diameter

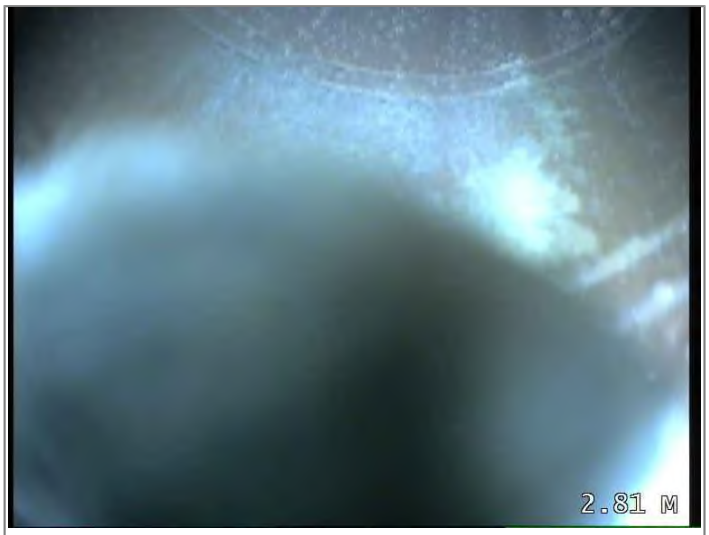
Start node type, manhole, reference F2.11 LEG3

Water level 05% height/diameter

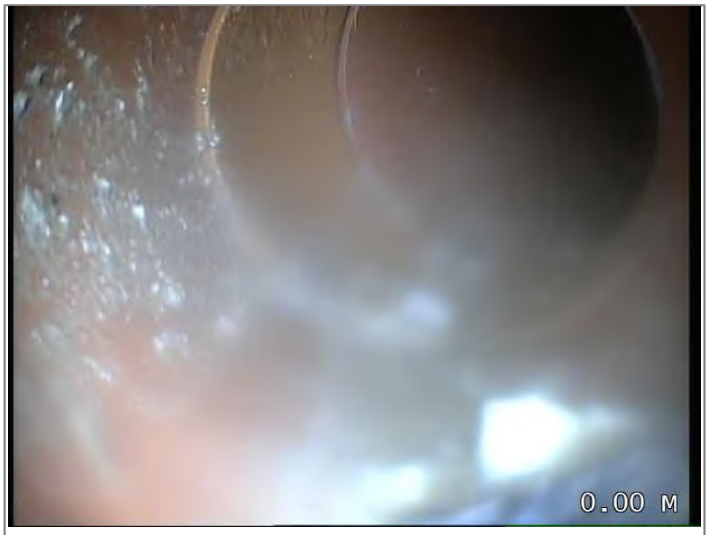
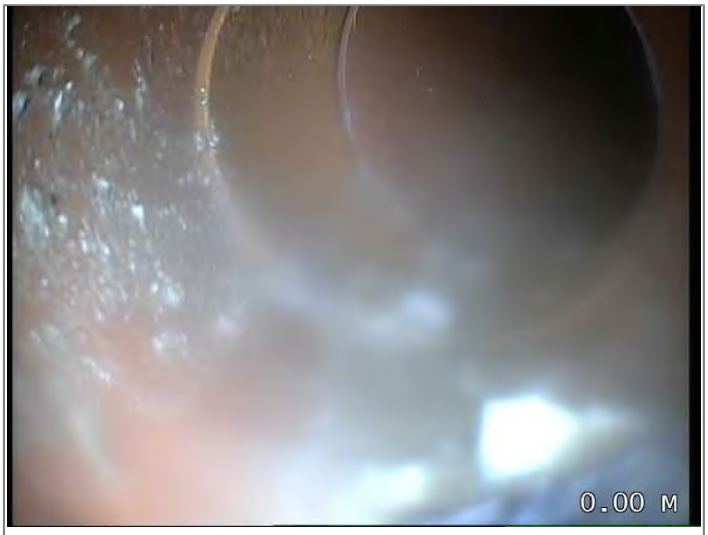
Start node type, manhole, reference F2.10A LEG1

Water level 05% height/diameter

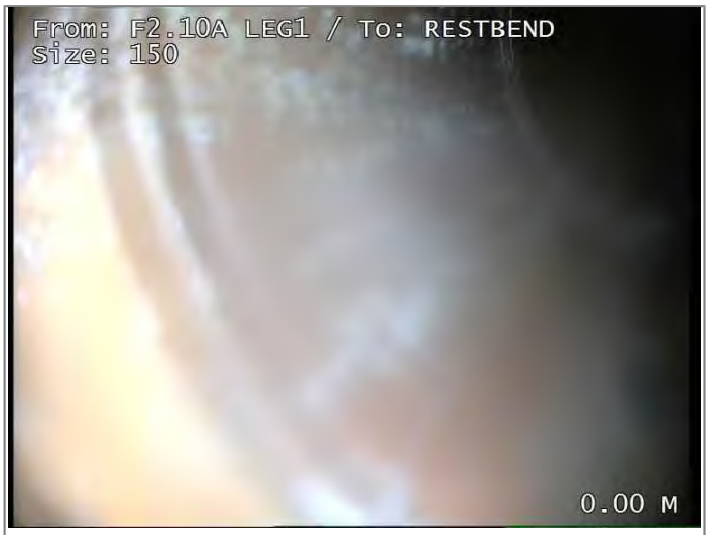
Dimensions of drain/sewer changes to 100mm

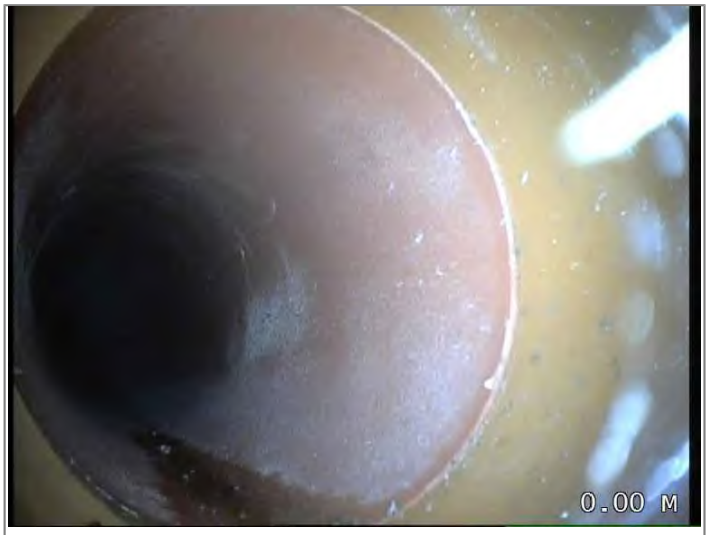
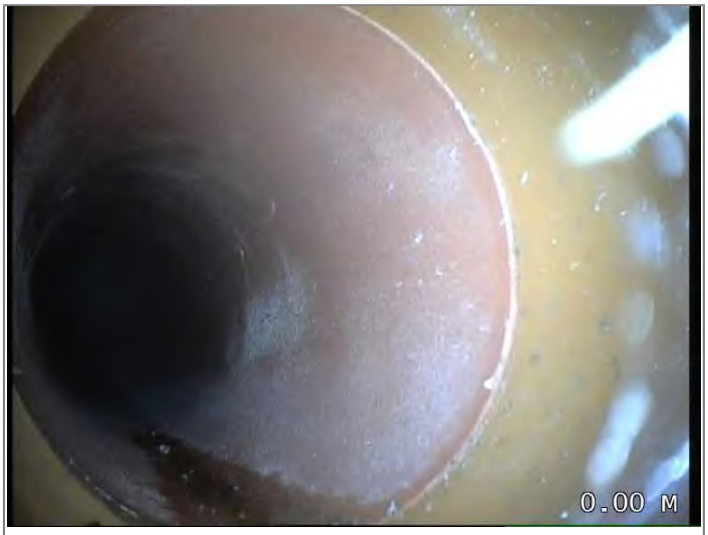
Start node type, manhole, reference F2.16A LEG2

Water level 05% height/diameter

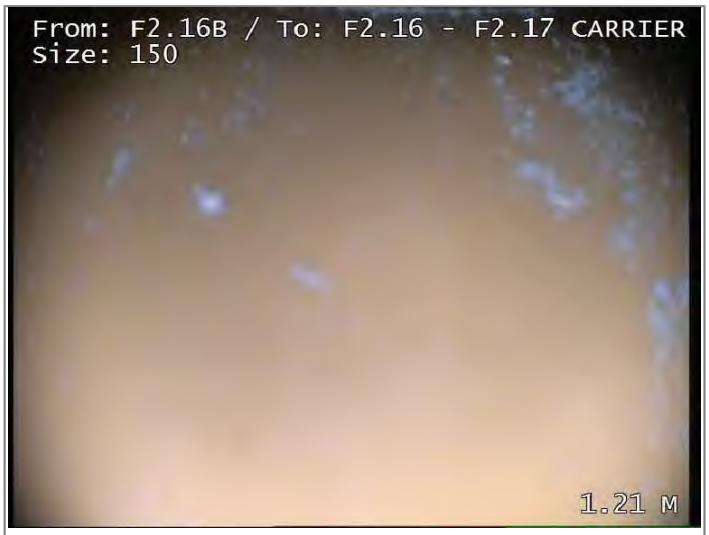
Start node type, manhole, reference F2.16B

Water level 05% height/diameter

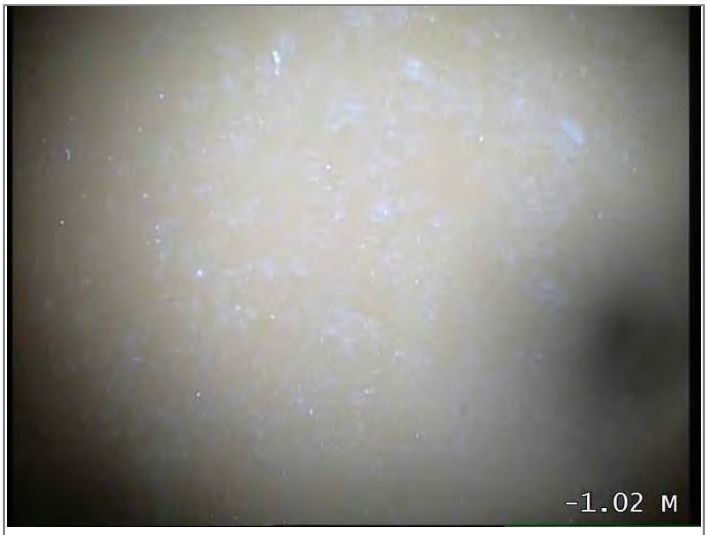
Start node type, manhole, reference F2.16B

Water level 05% height/diameter

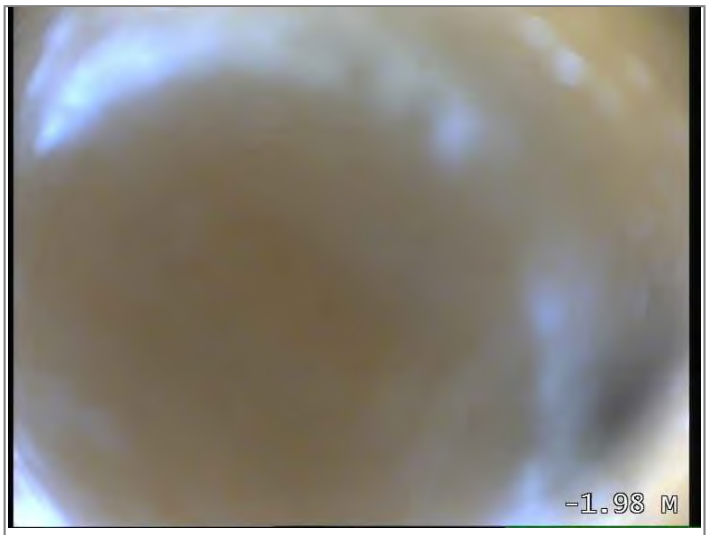
Start node type, manhole, reference F2.16B LEG2

Water level 05% height/diameter

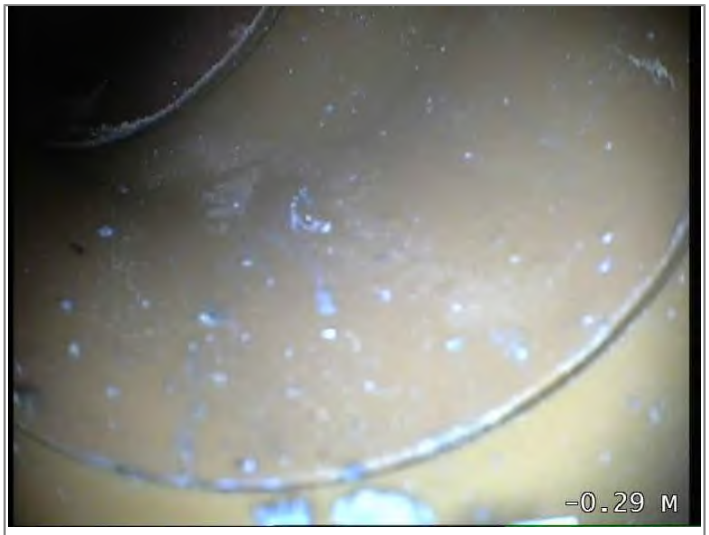
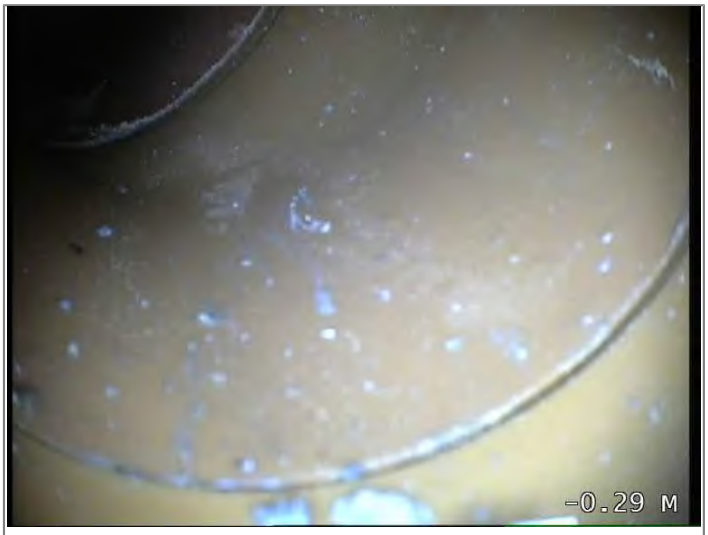
Start node type, manhole, reference F2.17A LEG3

Water level 05% height/diameter

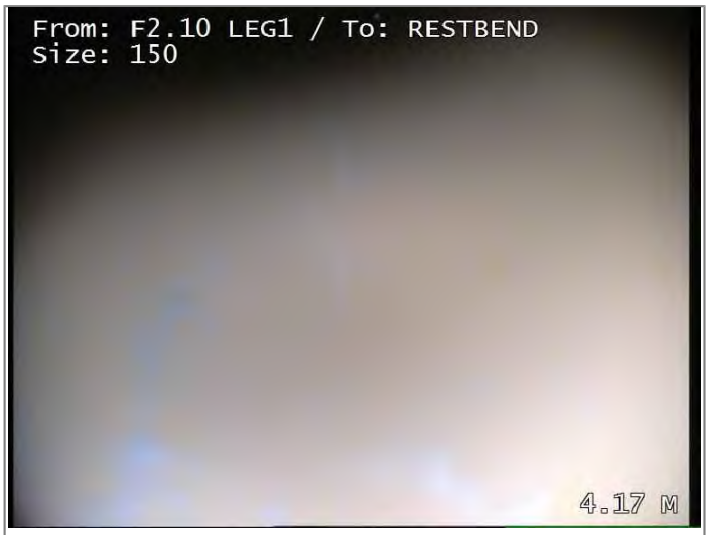
Start node type, manhole, reference F2.10 LEG1

Water level 05% height/diameter

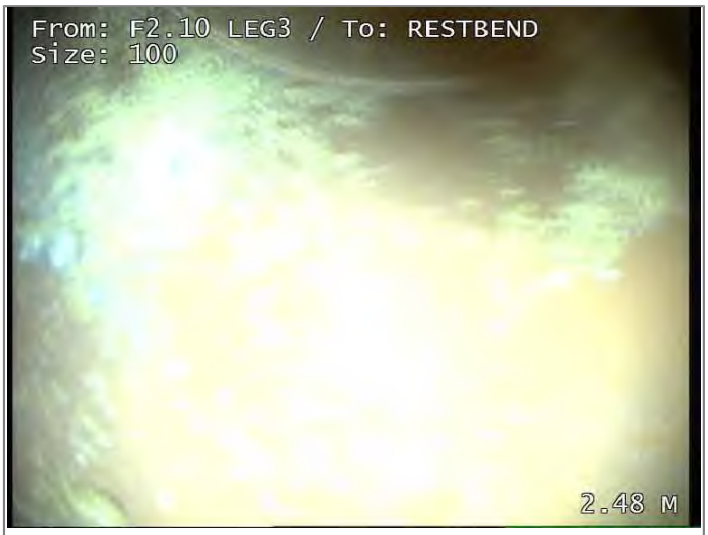
Line of drain/sewer deviates left

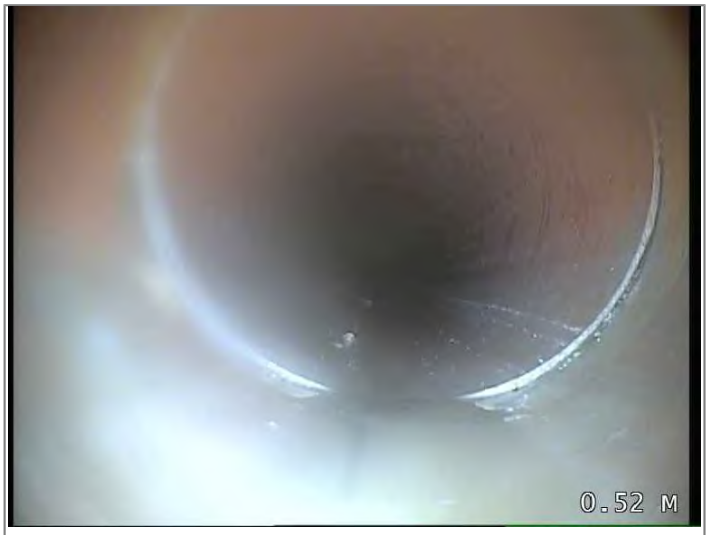
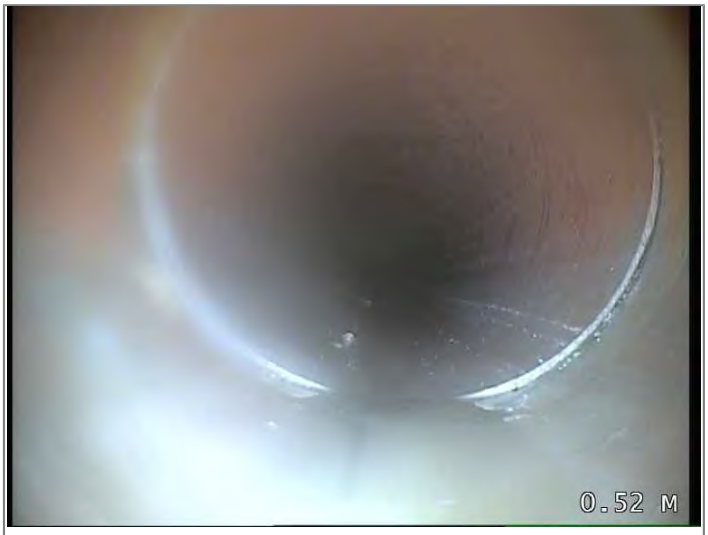
Start node type, manhole, reference F2.13

Water level 05% height/diameter

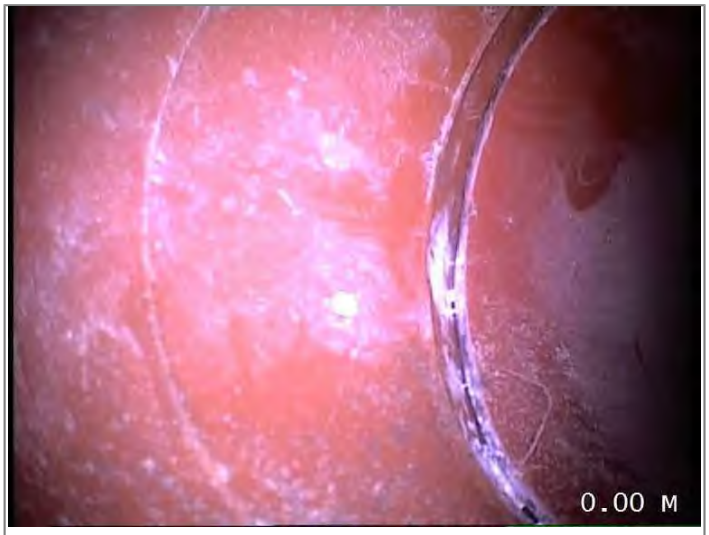
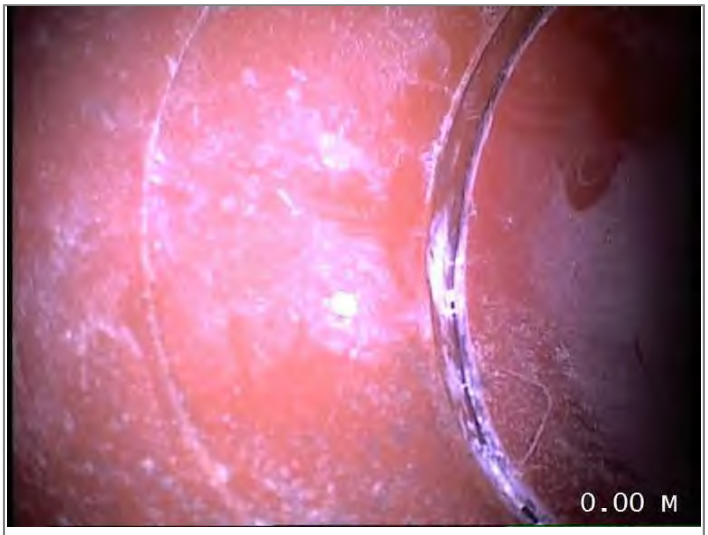
Start node type, manhole, reference S1.2 LEG1

Water level 05% height/diameter

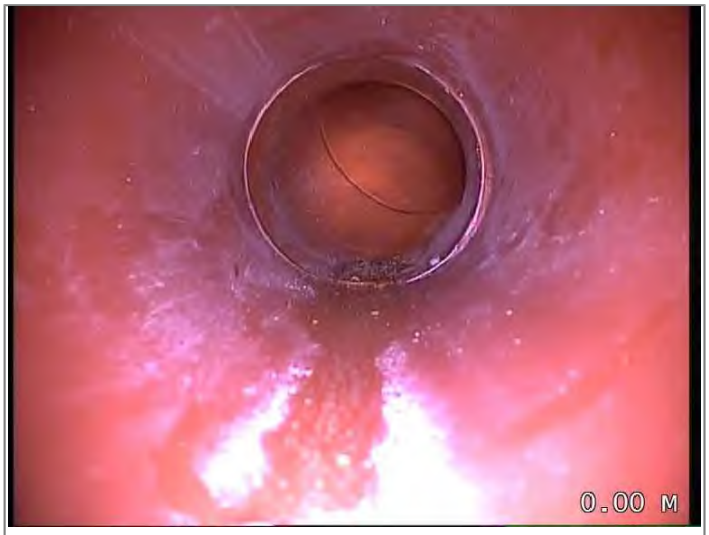
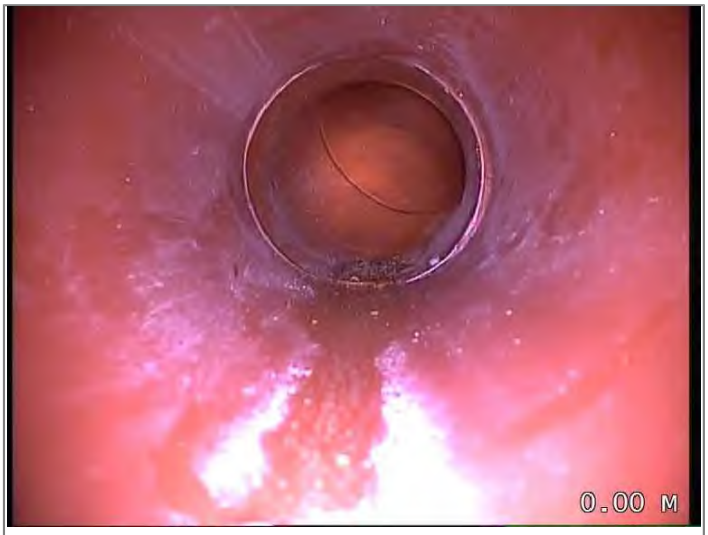
Start node type, manhole, reference F1.17 LEG2

Water level 05% height/diameter

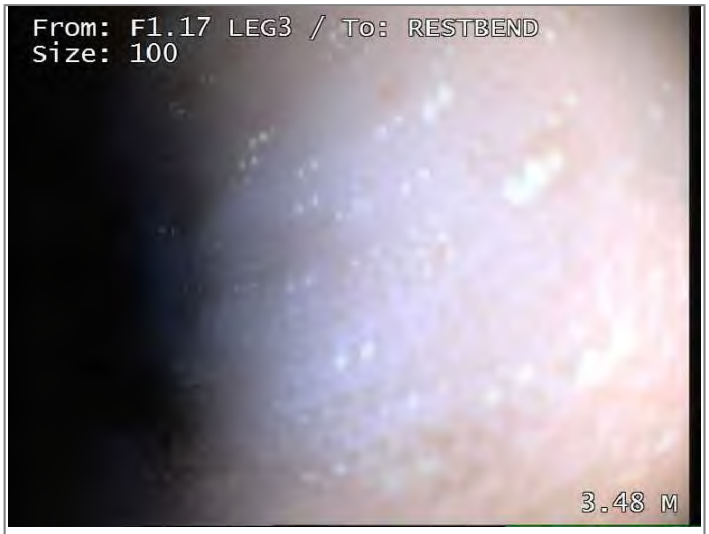
Start node type, manhole, reference F1.17 LEG3

Water level 05% height/diameter

Line of drain/sewer deviates left

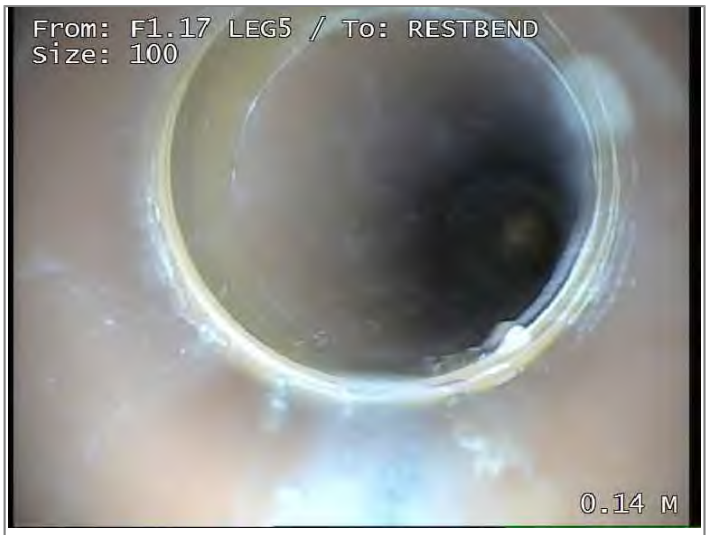
Start node type, manhole, reference F1.17 LEG5

Water level 05% height/diameter

Line of drain/sewer deviates right

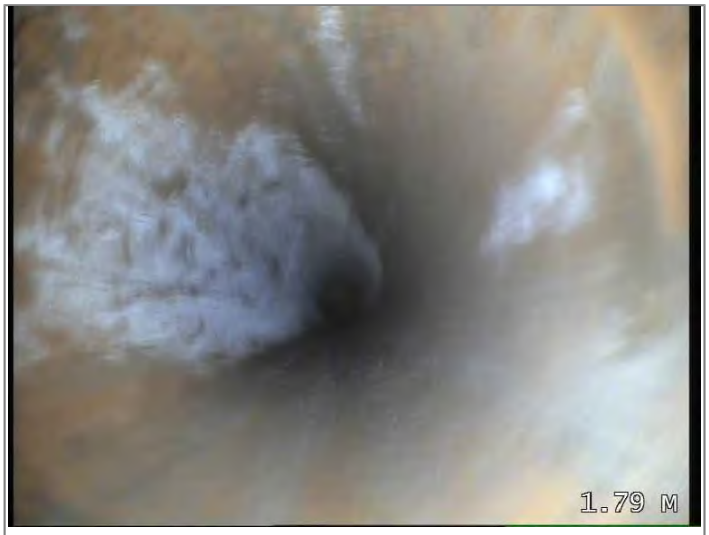
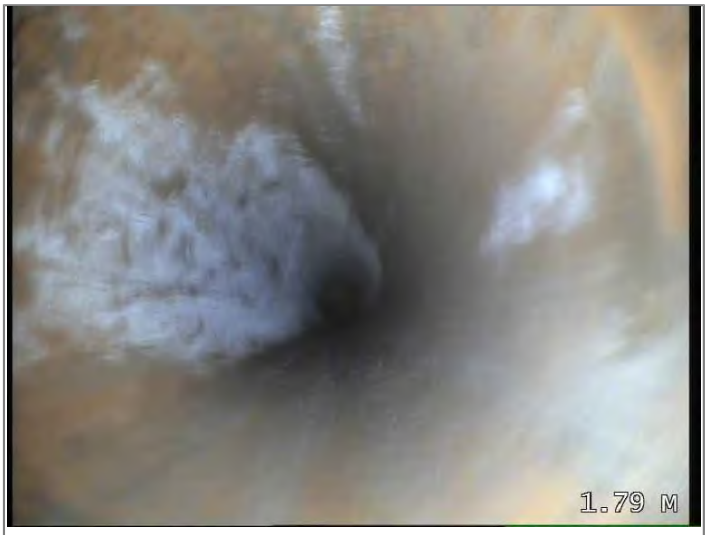
Start node type, manhole, reference F1.26 LEG4

Water level 05% height/diameter

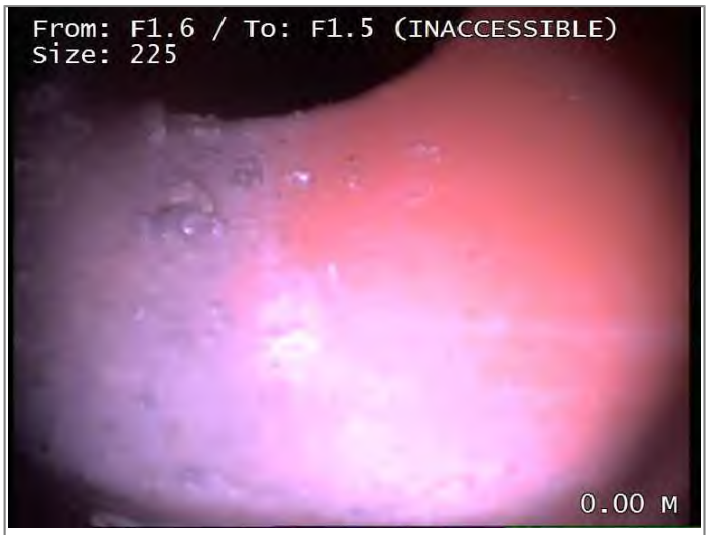
Dimensions of drain/sewer changes to 150mm

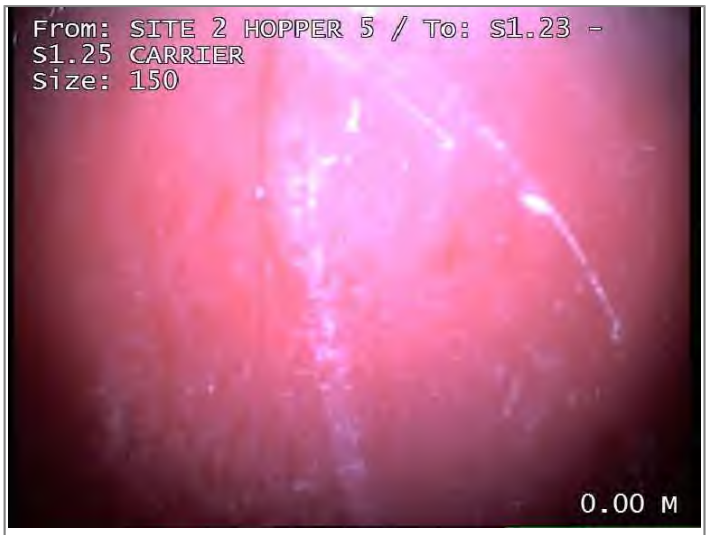
Line of drain/sewer deviates down

Line of drain/sewer deviates right - Remark: RESTBEND

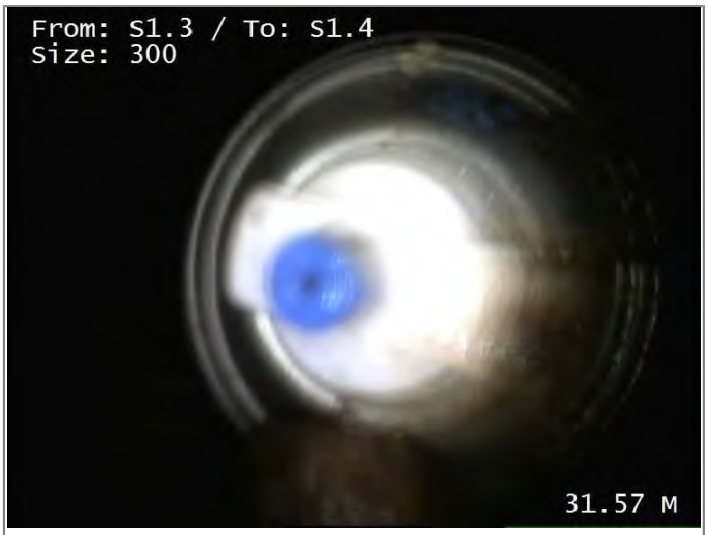
General photograph taken at this point - Remark: LINE PAINT CAN IN DRAIN

UNABLE TO PUSH FURTHER

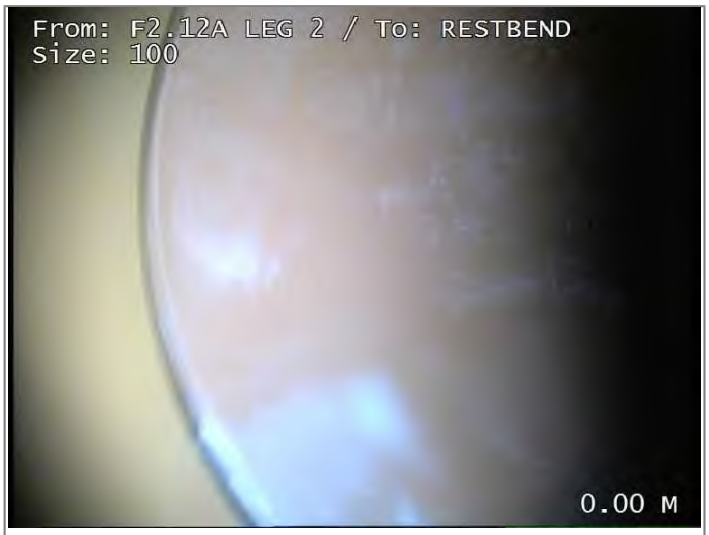
Line of drain/sewer deviates right

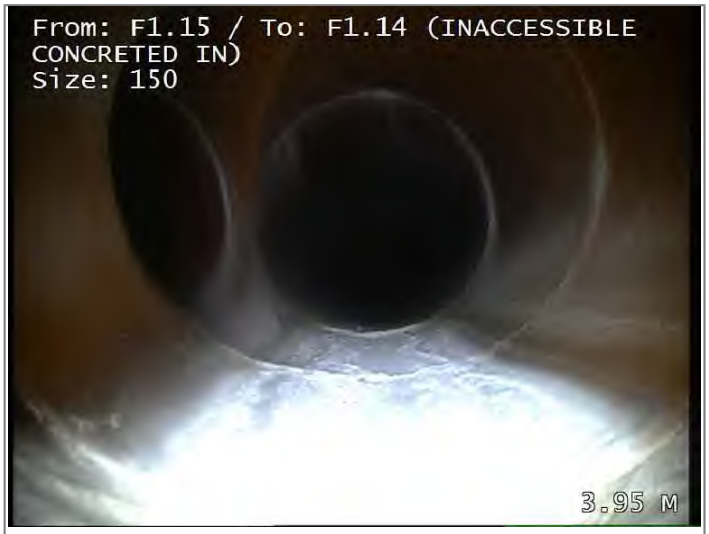
Start node type, manhole, reference F1.15

Line of drain/sewer deviates left

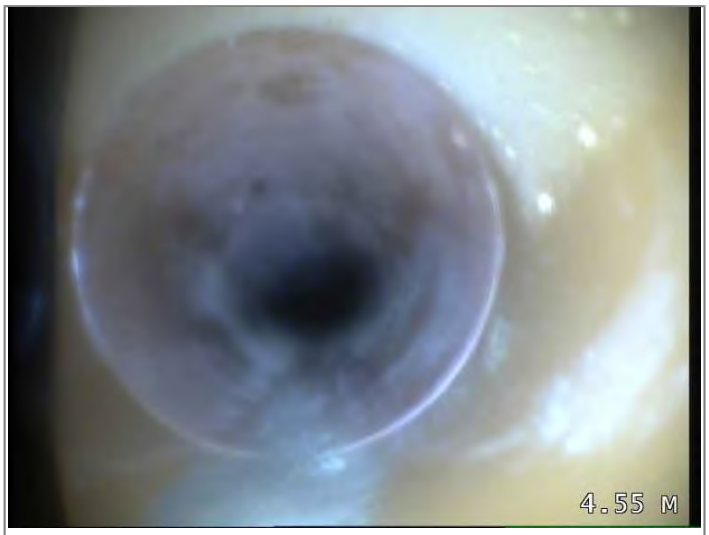
Start node type, manhole, reference F1.15 LEG 1

Connection other than junction at 9 o'clock, diameter 100mm

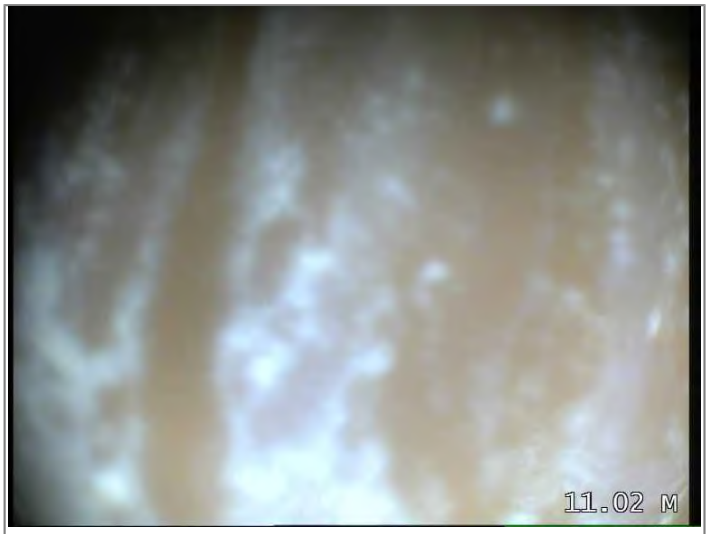
Line of drain/sewer deviates up

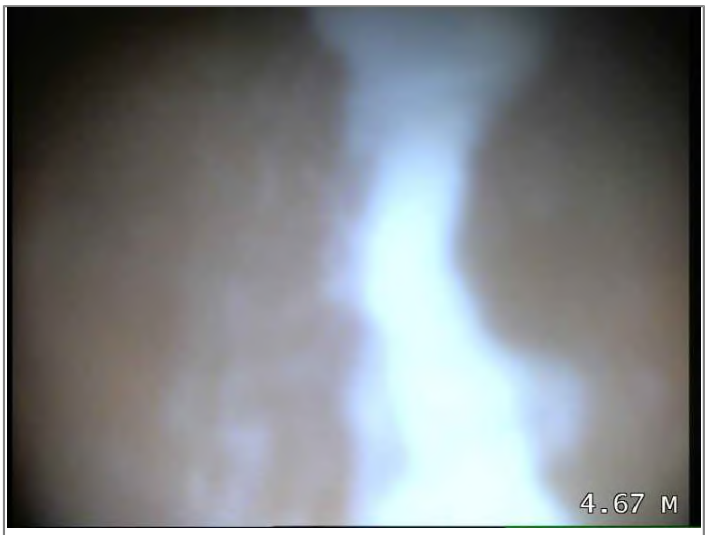
Line of drain/sewer deviates right

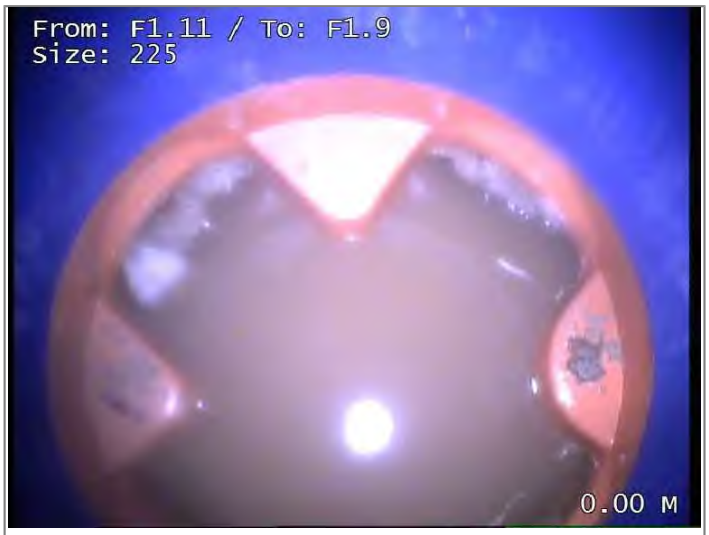
Settled deposits hard or compacted 100% cross-sectional area loss - Remark: CONCRETE

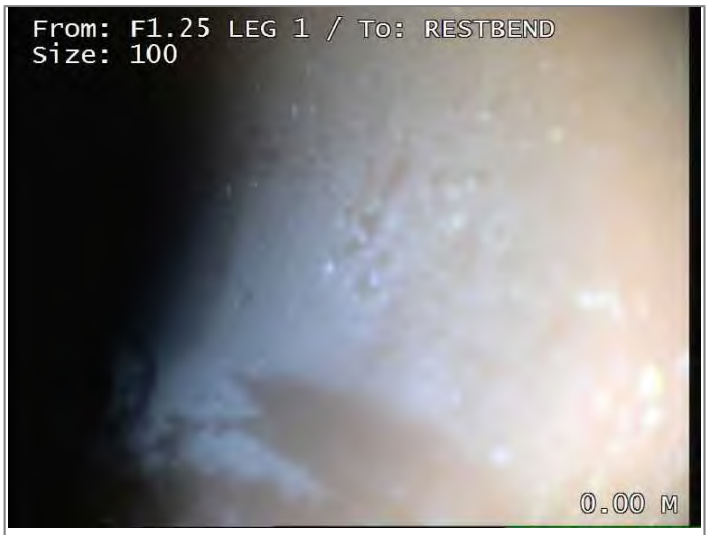
Line of drain/sewer deviates left

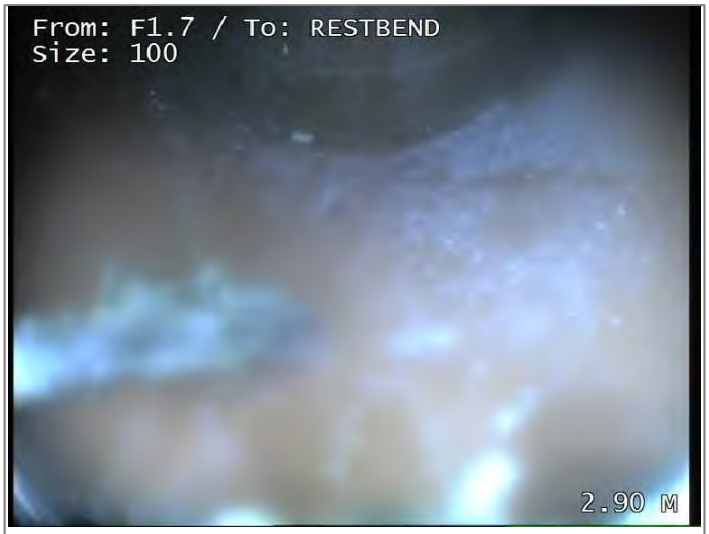
Line of drain/sewer deviates right

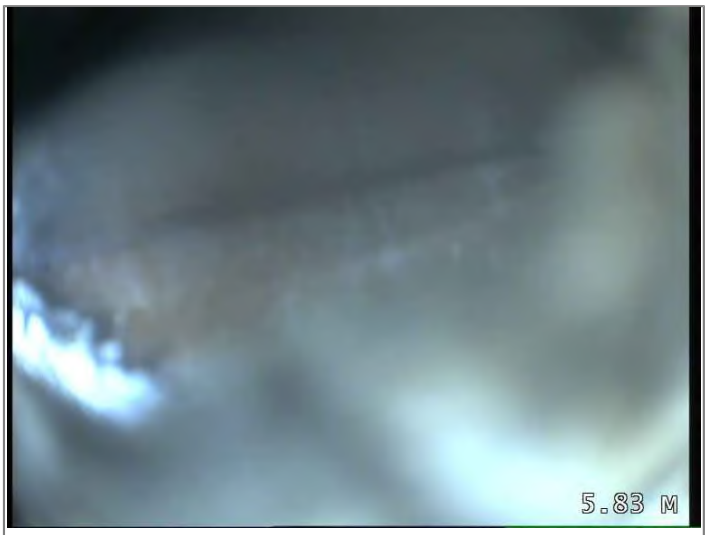
Line of drain/sewer deviates left
