CONDITION 7(c) DRAINAGE VERIFICATION REPORT

Victoria Riverside, Dantzic Street

Far East Consortium

12/09/2024

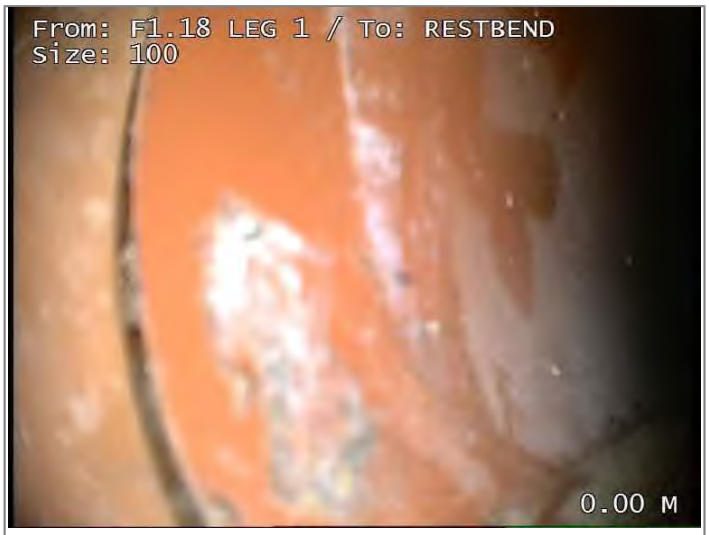
Line of drain/sewer deviates right

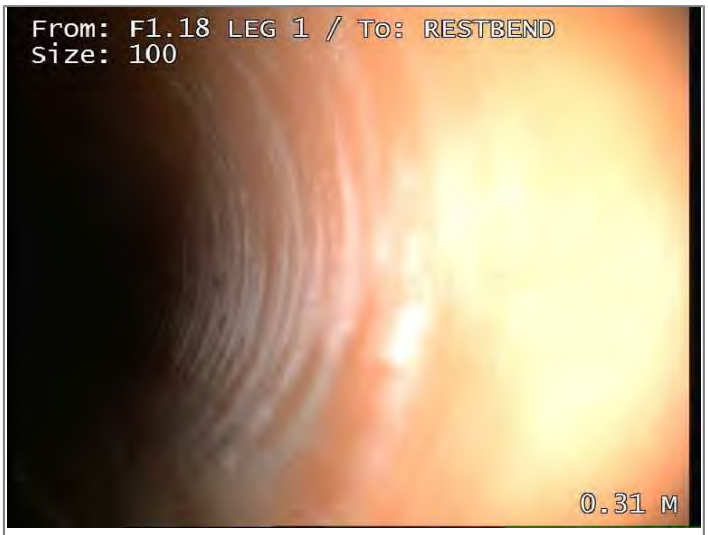
Line of drain/sewer deviates left

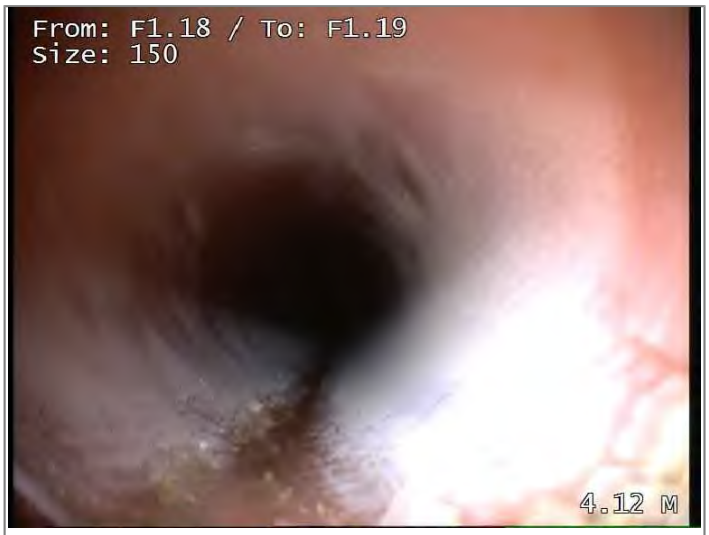
Connection other than junction at 3 o'clock, diameter 100mm
