CIS Tower, Miller Street, Manchester. M60 0AL.

CIS Tower Refurbishment.

Recording Strategy and Photographic Audit of internal & external features.

APPENDIX 27 – LEVEL 21. INTERNAL.

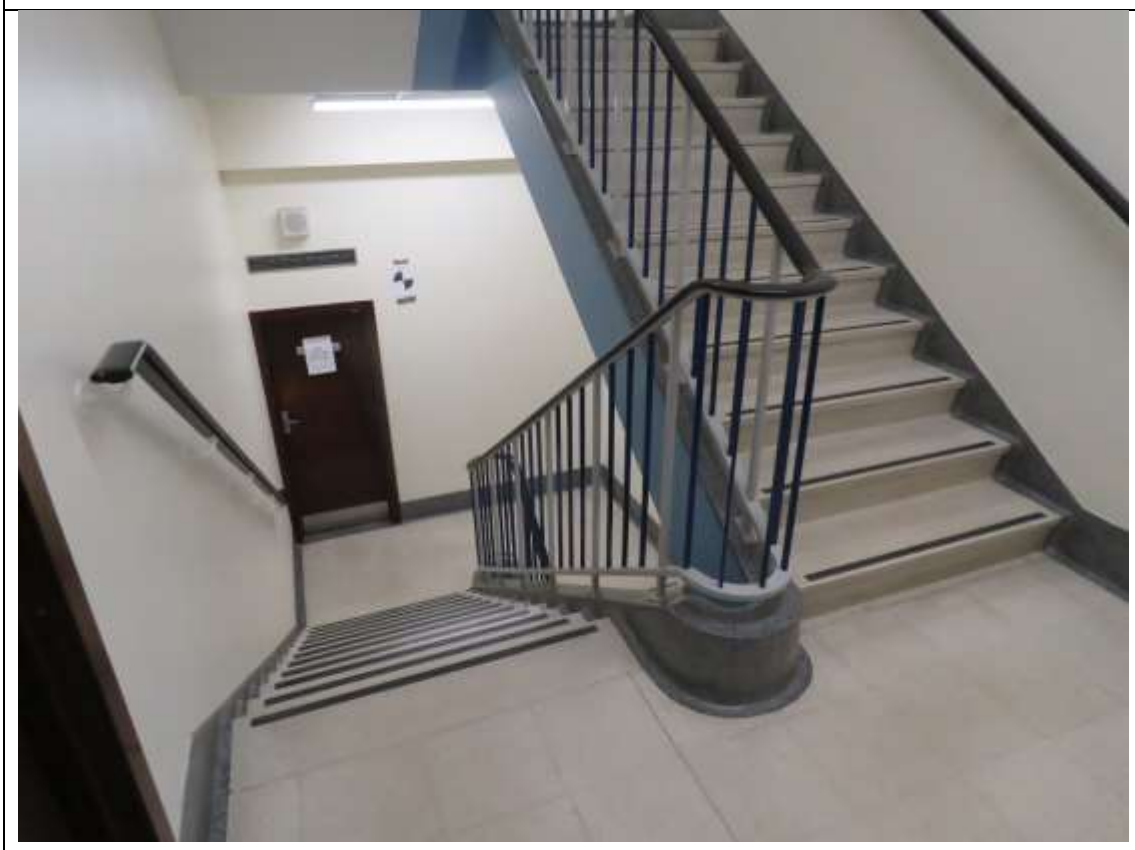
21-01 View through lift lobby looking north.

21-02 View north towards Miller Street as you enter the office space.

21-03 View south across office space.

21-04 View of inserted partition adjacent to the corridor leading to the west stairwell.

21-05 View within partitioned room to east end of the floor.

21-06 View within east stairwell.

21-07 View within female WC looking towards the vanity unit and original glazed screen to the left hand side.

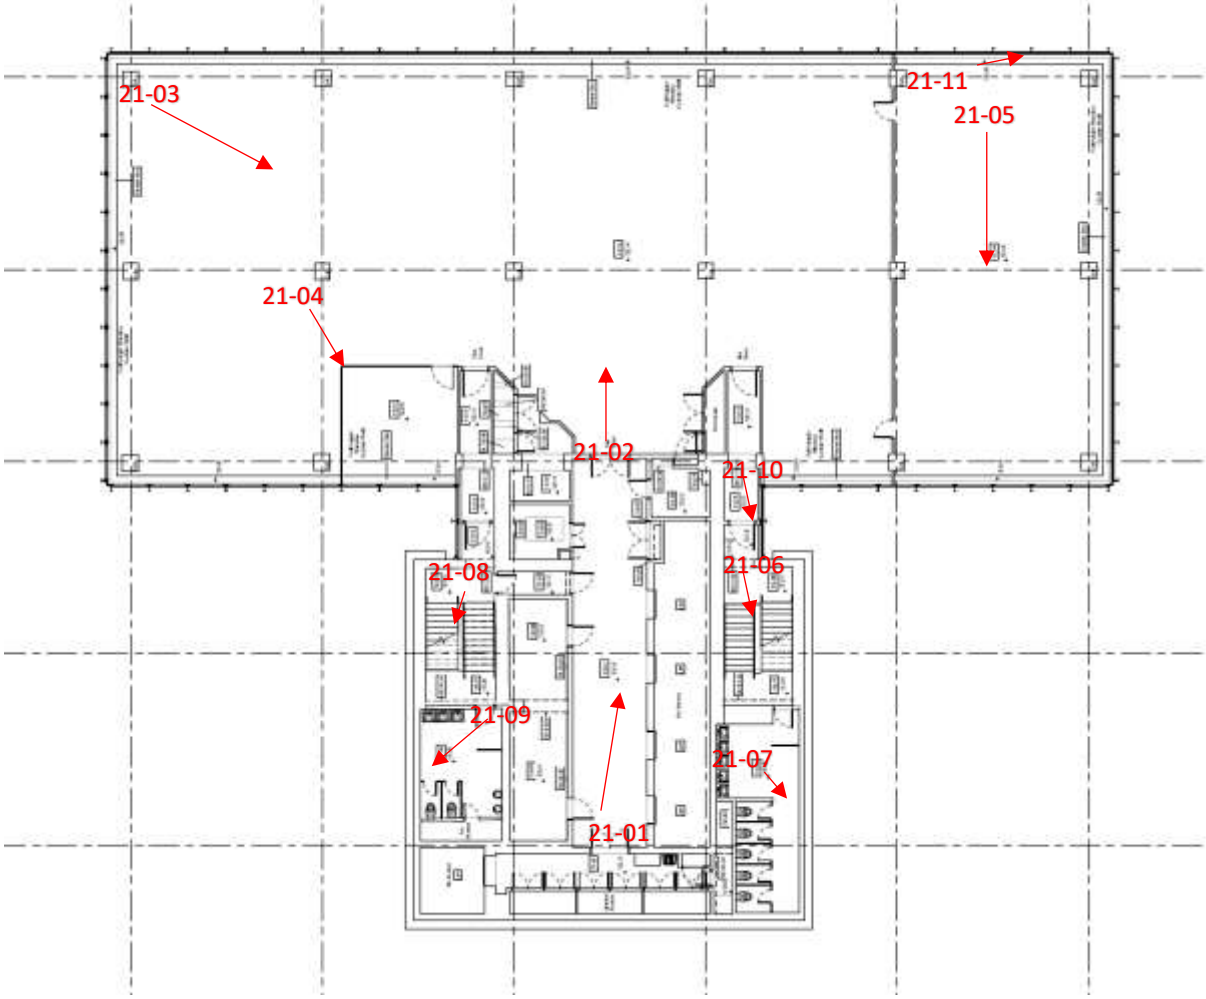
21-08 View within west stairwell.

21-09 View within men's WC with original glazed screen and non-original sink, fixtures, fittings, wall finishes and vinyl floor covering.

21-10 View along corridor between office space and the east stairwell.

21-11 View of curtain walling and Weathermaster.
