Project Name: CHORLTON WILBRAHAM ROAD FOUL

Project Date: 14/10/2024

Inspection Standard: MSCC5 Sewers & Drainage GB (SRM5 Scoring)

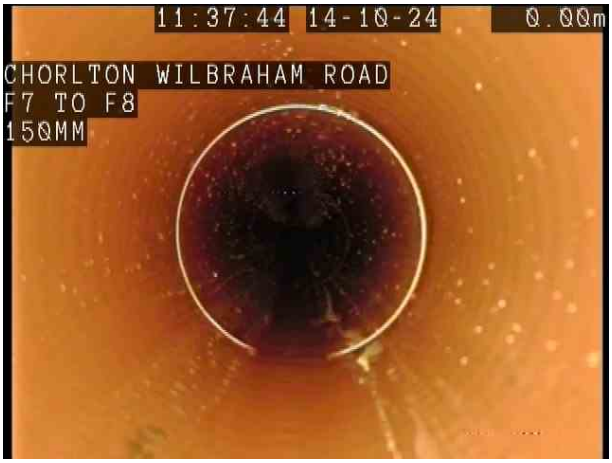
Position [m]	Code	Observation	MPEG	Photo	Grade
0.00	MH	Start node, manhole, reference: F7			
0.00	WL	Water level, 0% of the vertical dimension	00:00:00	F7X_7ac0dae5-2b16-446b-8d1	
19.68	MHF	Finish node, manhole, reference: F8	00:01:32

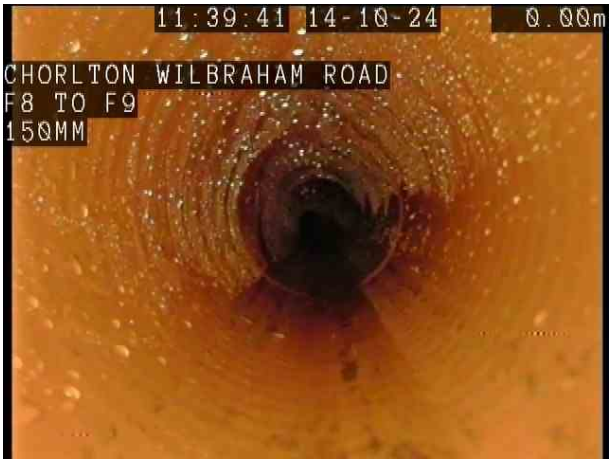
F8X_b9a79234-771e-4b02-9343-4801078c968d_20241014_205018_827.jpg, 00:00:00, 0.00 m
Water level, 0% of the vertical dimension
