MANCHESTER DIGITAL CAMPUS

e3p Phase I and II Geo-Environmental Site Assessment

PHASE I AND PHASE II GEO-ENVIRONMENTAL SITE ASSESSMENT

Central Retail Park
Great Ancoats St,
Manchester
M4 6DH

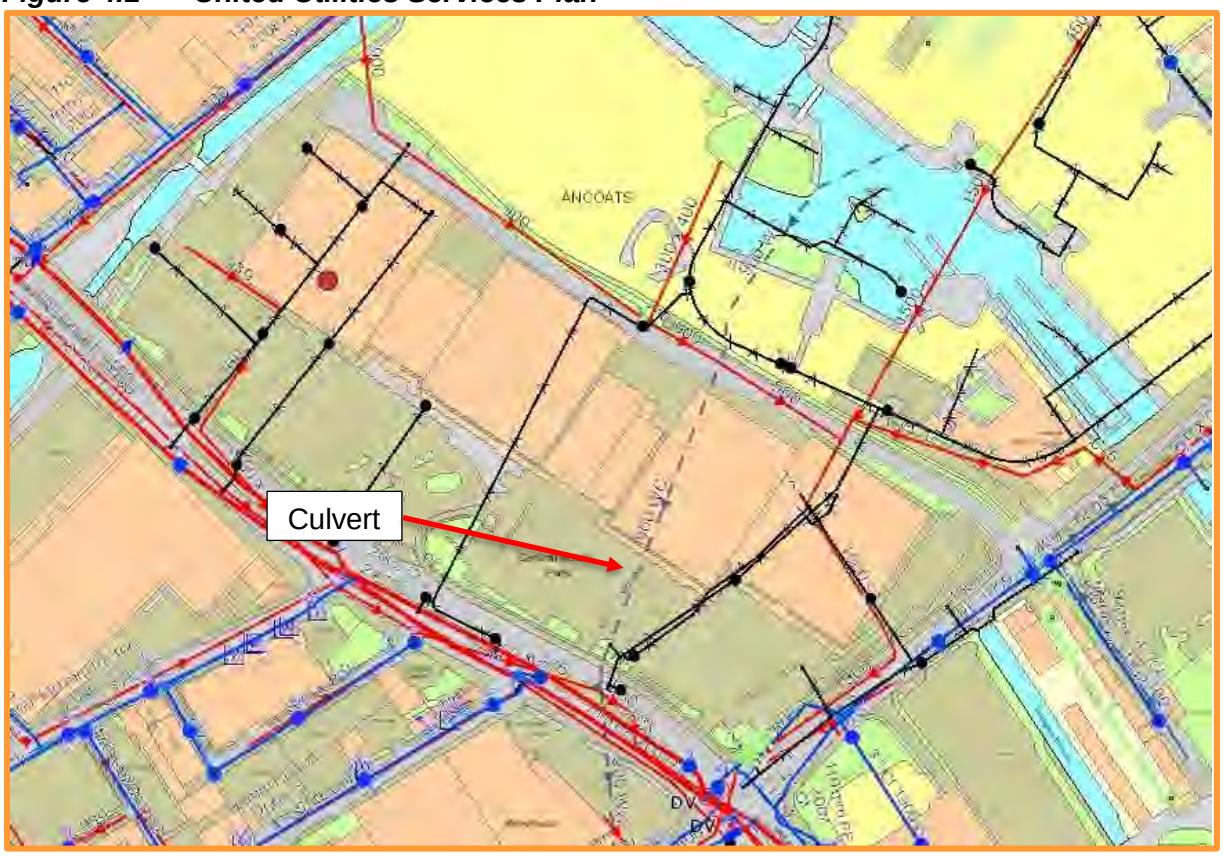
Figure 4.1 United Utilities Services Plan

United Utilities plans indicate that a surface watercourse passes beneath the subject site through a 900mm diameter pipe. Information obtained from Hidden Manchester Map indicates that this is the culverted Newton Brook. A excerpt of the United Utilities services plan is presented as Figure 4.1.

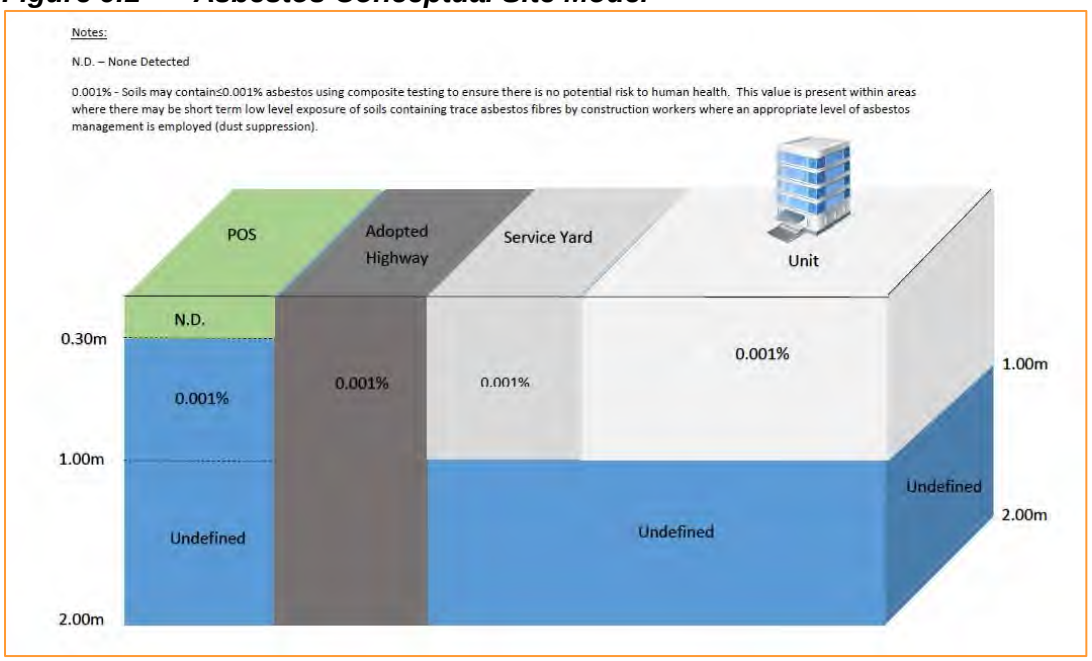
Figure 9.1 Asbestos Conceptual Site Model

Loose chrysotile fibres and elevated concentrations of lead have been identified within a single location beneath the subject site. Given the nature of the site further impacted areas may also be present and it is more than probable that the general Made Ground will be impacted on a site wide basis by inorganic heavy metals, PAH and trace asbestos fibres which may pose a potential chronic risk to health of the critical receptor (future residents) via a direct exposure pathway.

With regard to the identified asbestos impact, data suggests that a 300mm cover system would also be appropriate to mitigate the risk to future end users. However, should bulk fragments of greater concentrations be identified then additional mitigation may be required. E3P has developed a development specific Asbestos Conceptual Site Model based on the principles of CIRIA 773 (*Asbestos in soil and made ground: a guide to understanding and managing risks*) to show how asbestos impacted soils may be managed on-site. This is presented in Figure 9.1.

To mitigate the risk to construction workers associated with asbestos and lead, it is recommended that all works are completed in line with industry best practice so that control measures to manage dust and personal exposure are carefully implemented in accordance with an agreed Remediation and Enabling Works Strategy.

The specific design and installation process for the appropriate cover systems will require definition within the Site Remediation & Enabling Works Strategy, however industry best practice (as outlined within BRE 465 *Cover systems for land regeneration - thickness of cover systems for contaminated land)* would suggest that a 300mm clean cover within areas of POS.

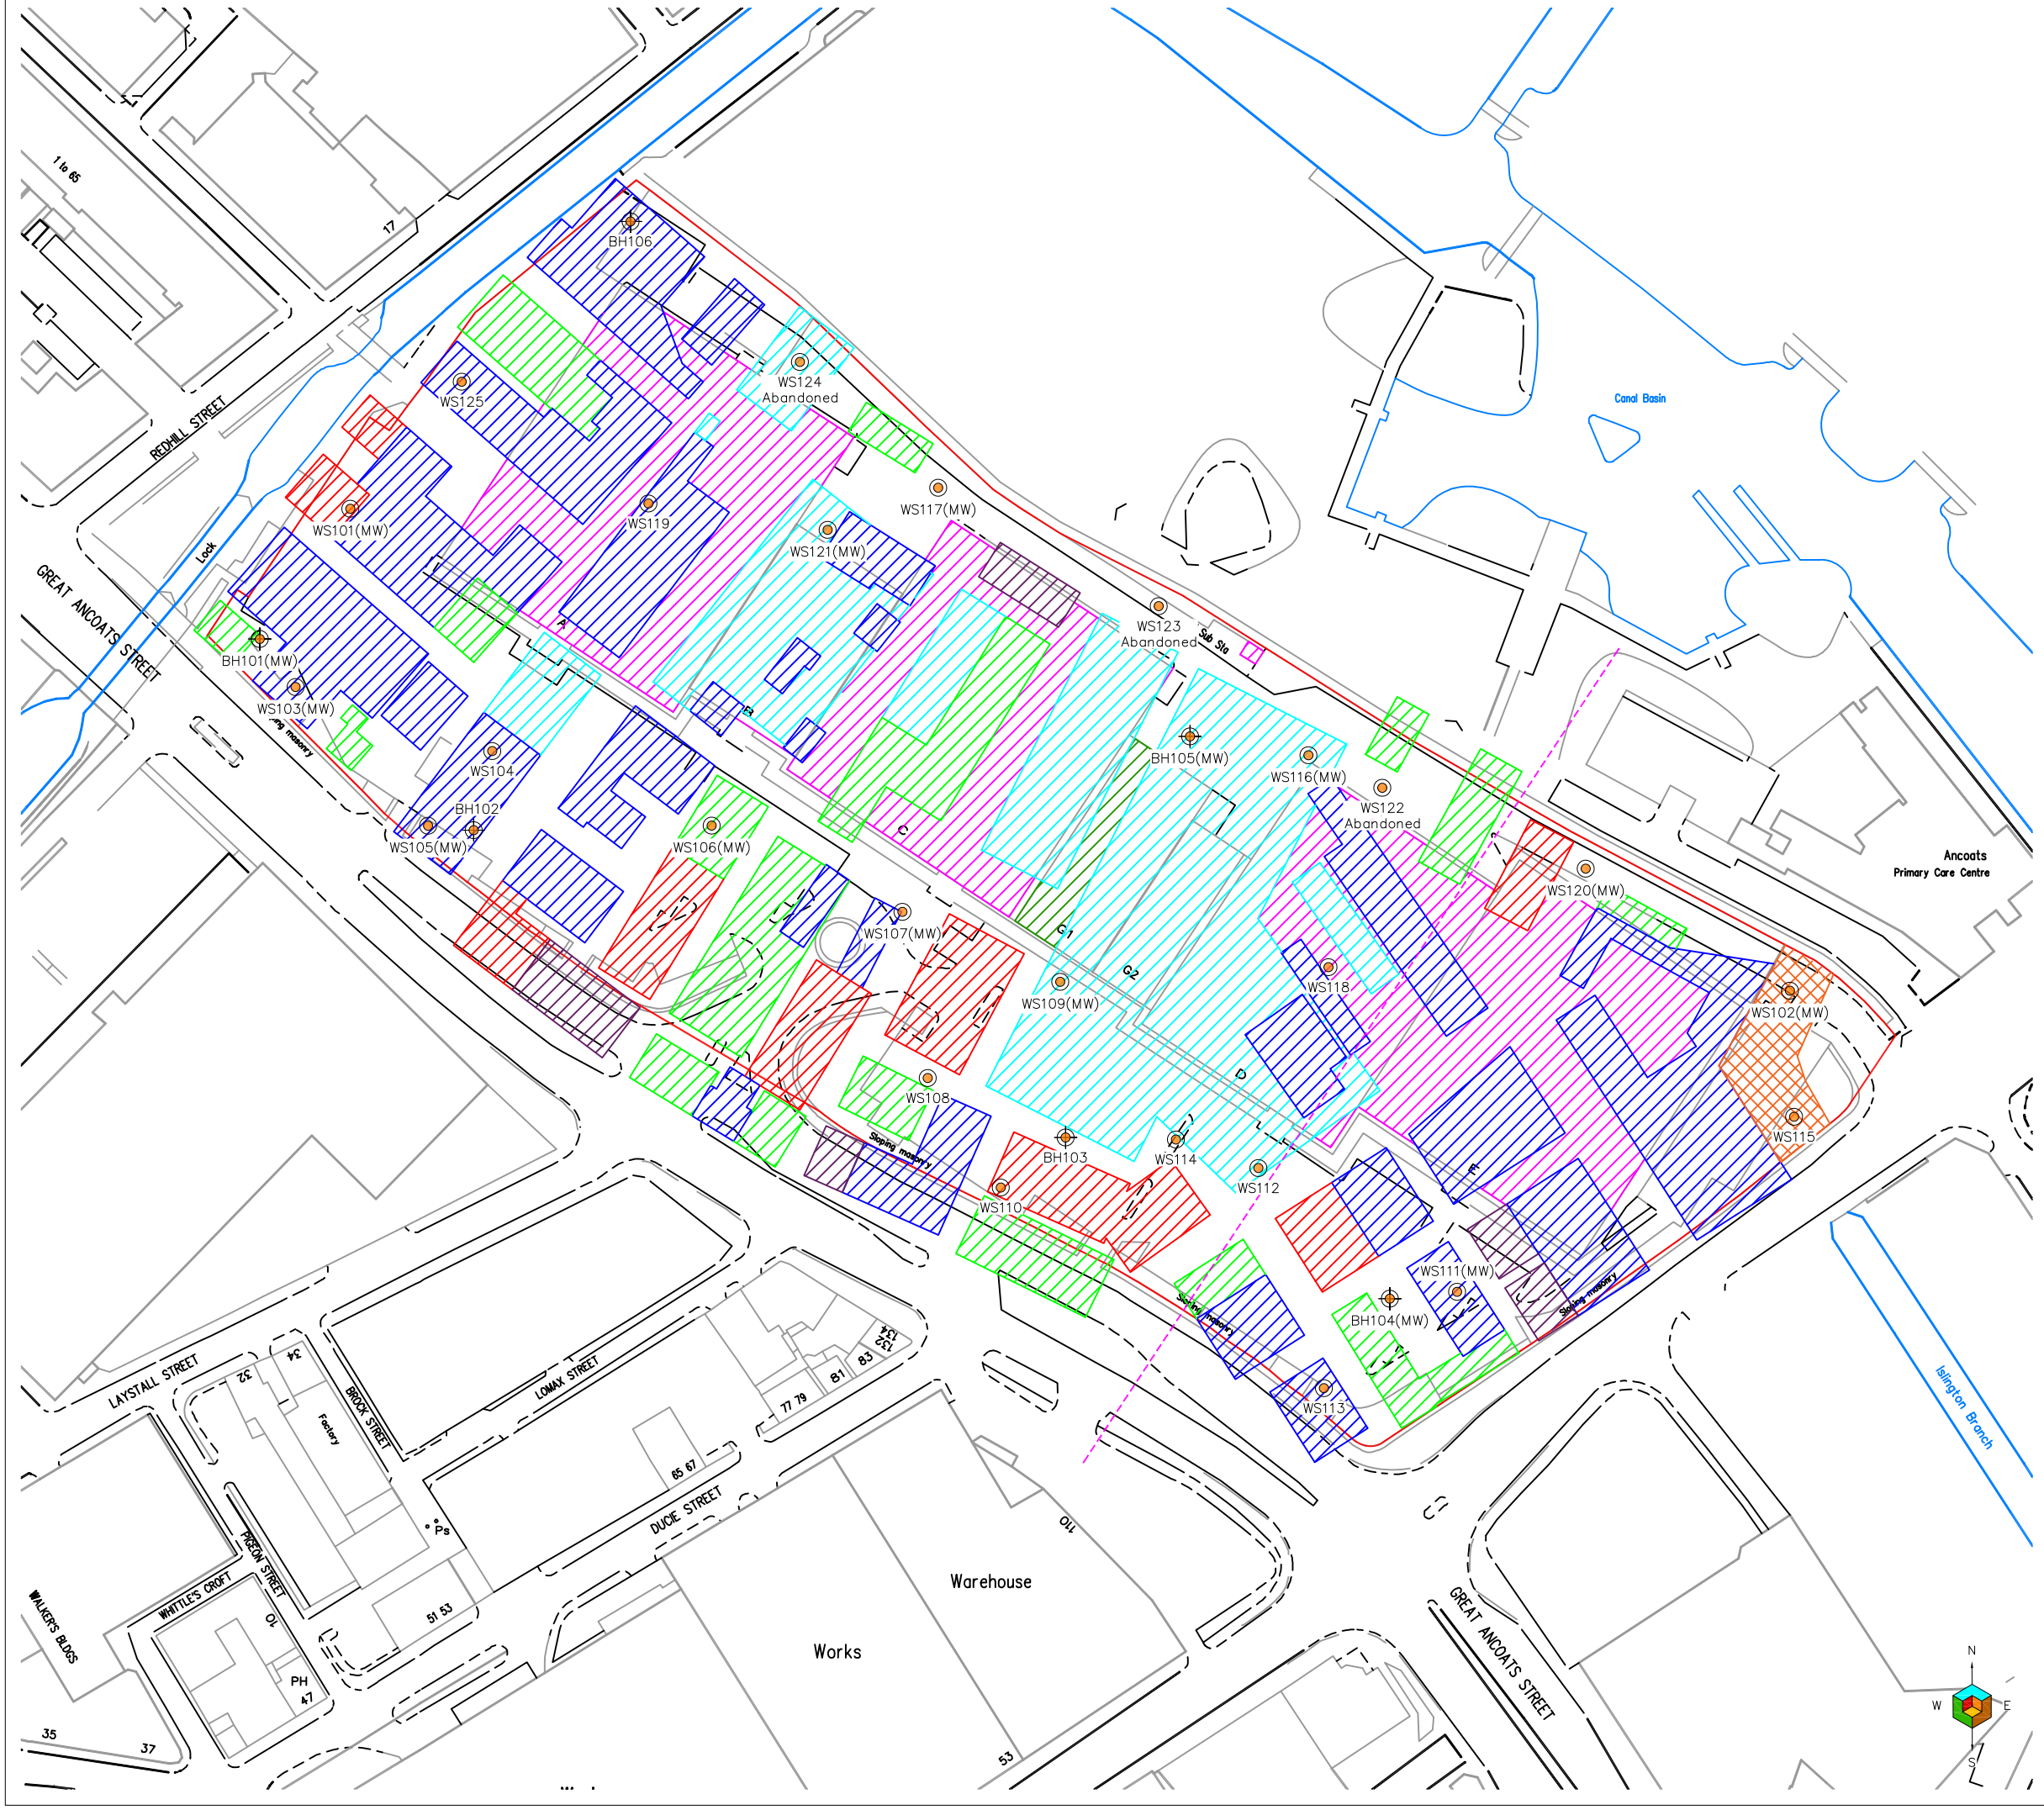
Drawing No: 003

The sampling locations are illustrated in Drawing 11-834-003 (Appendix III). The ground conditions encountered are indicated on the logs which are provided in Appendix VI.

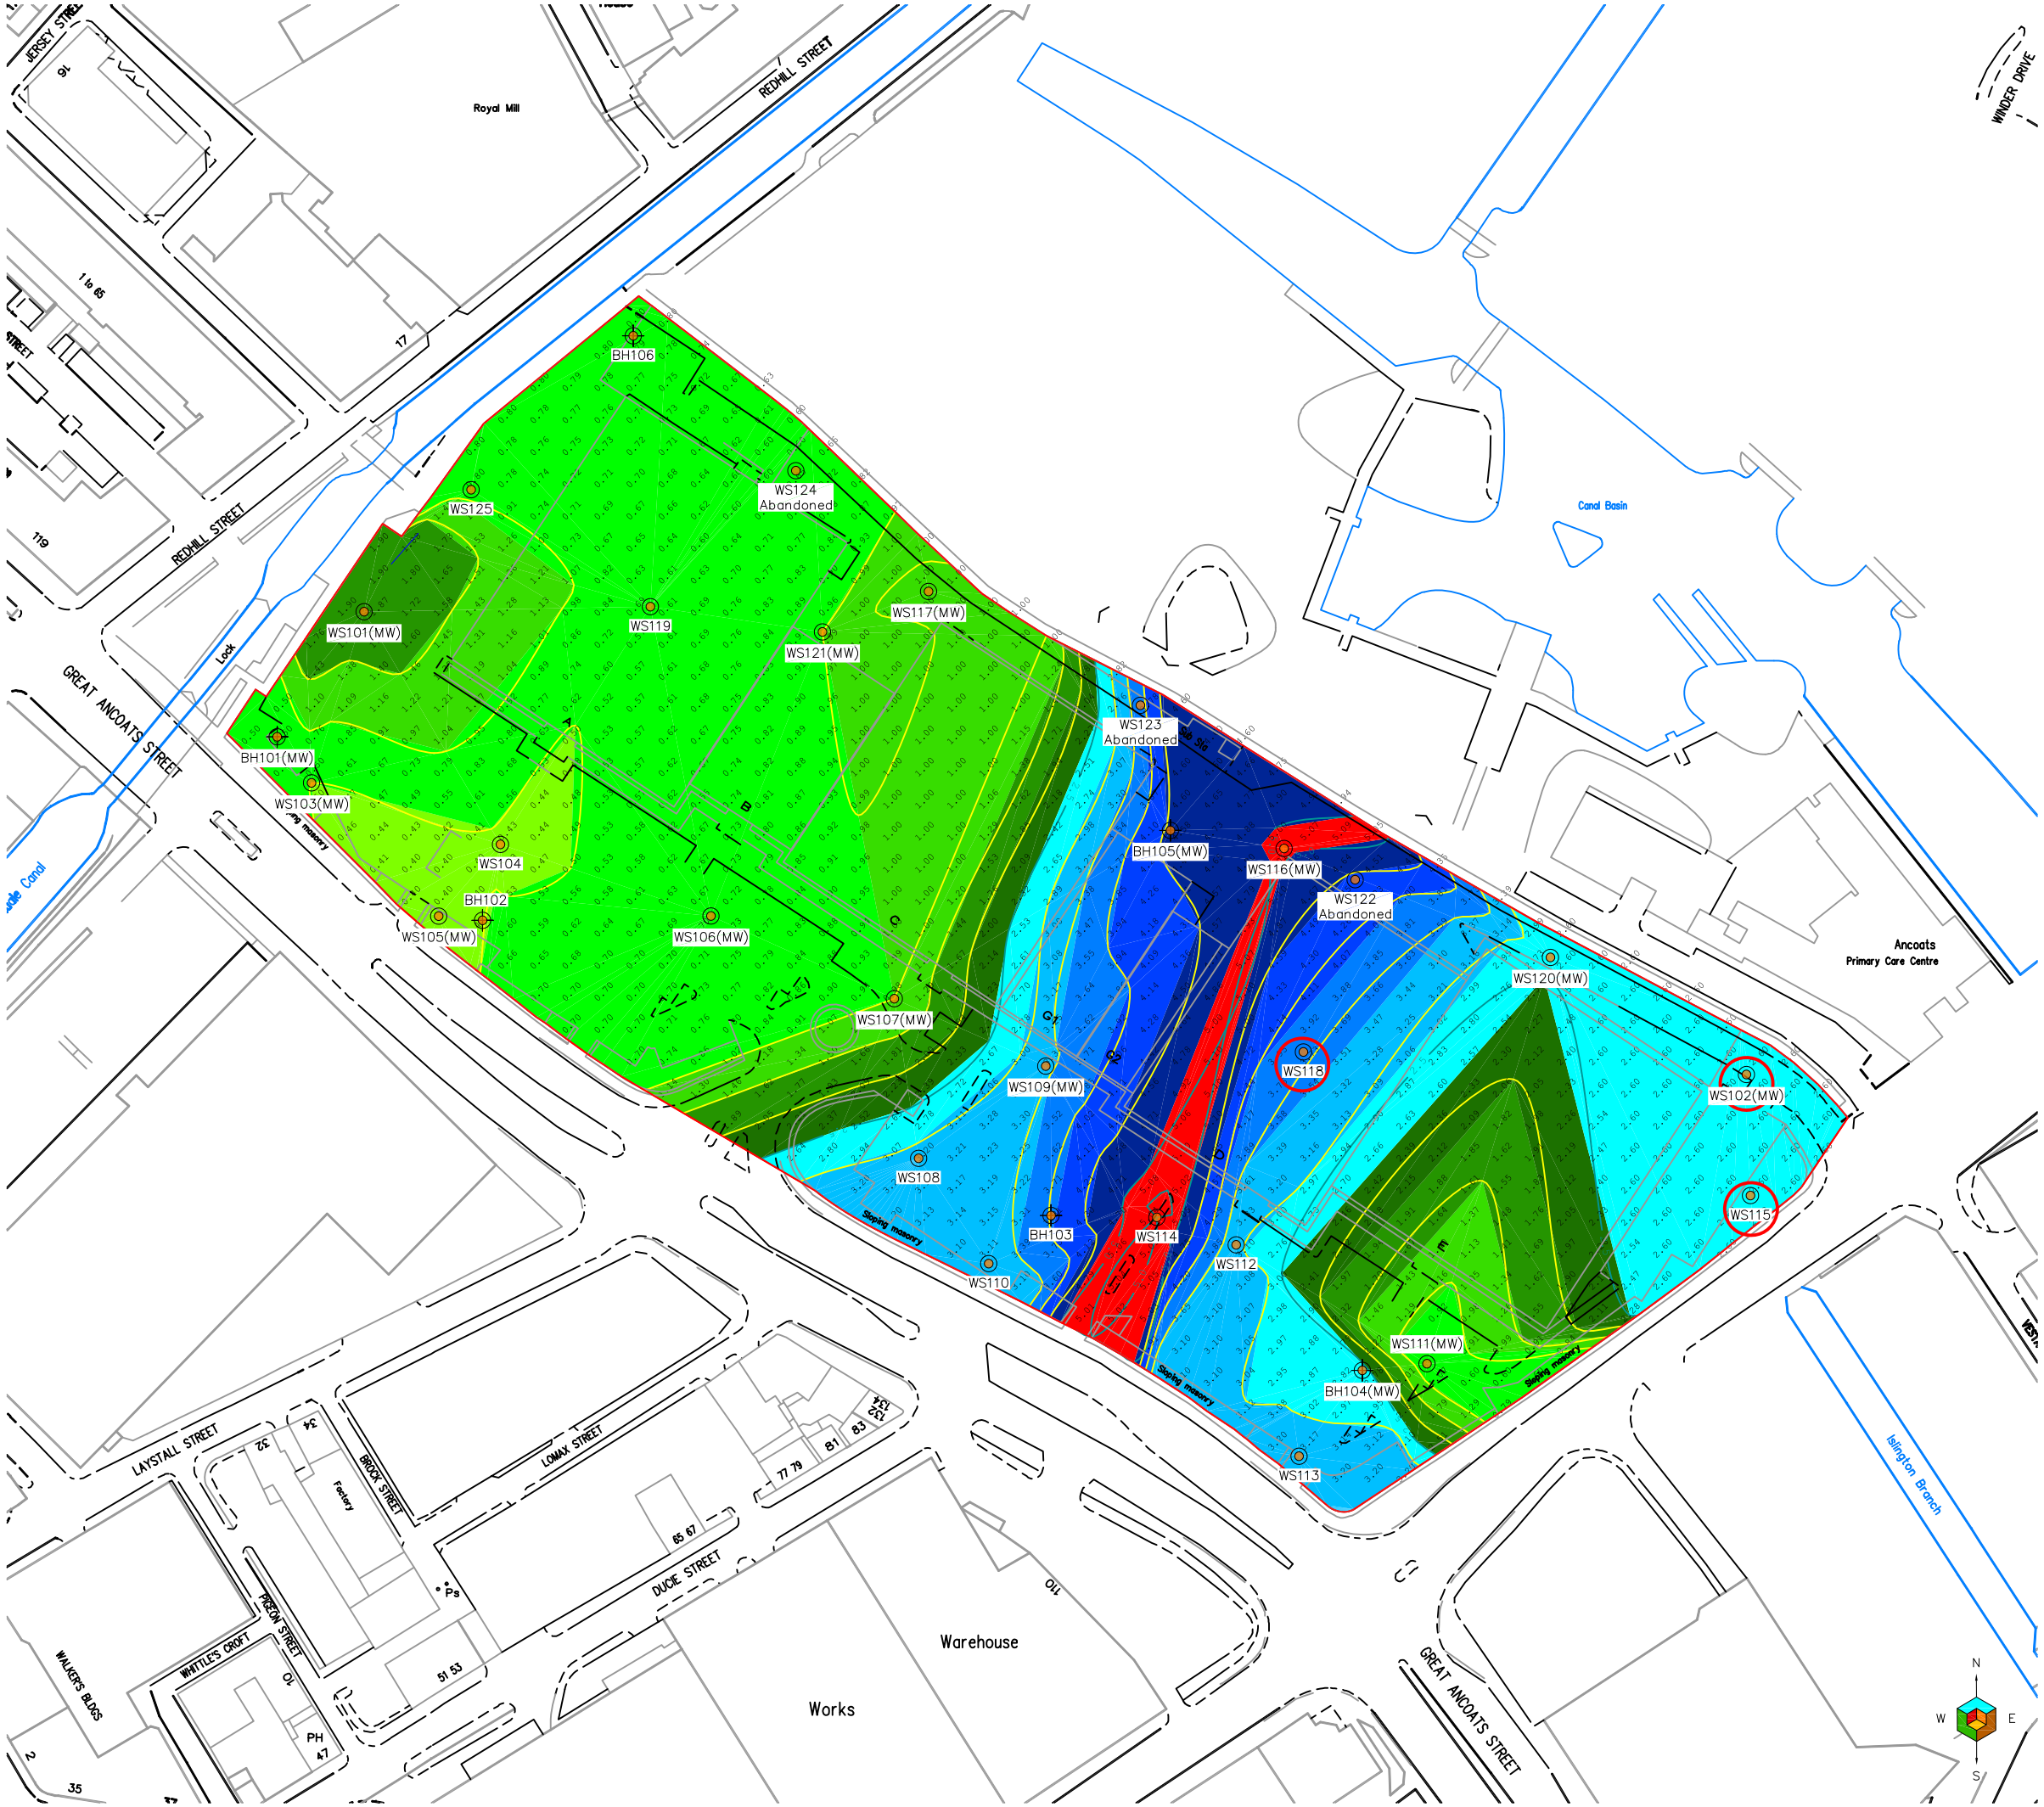
Drawing Title: Depth of Made Ground Plan

Made Ground has been recorded in all exploration locations as a variable gravelly sand and sandy gravel with various anthropogenic materials as summarised in Table 8.1. No visual or olfactory evidence of hydrocarbon impact was observed.

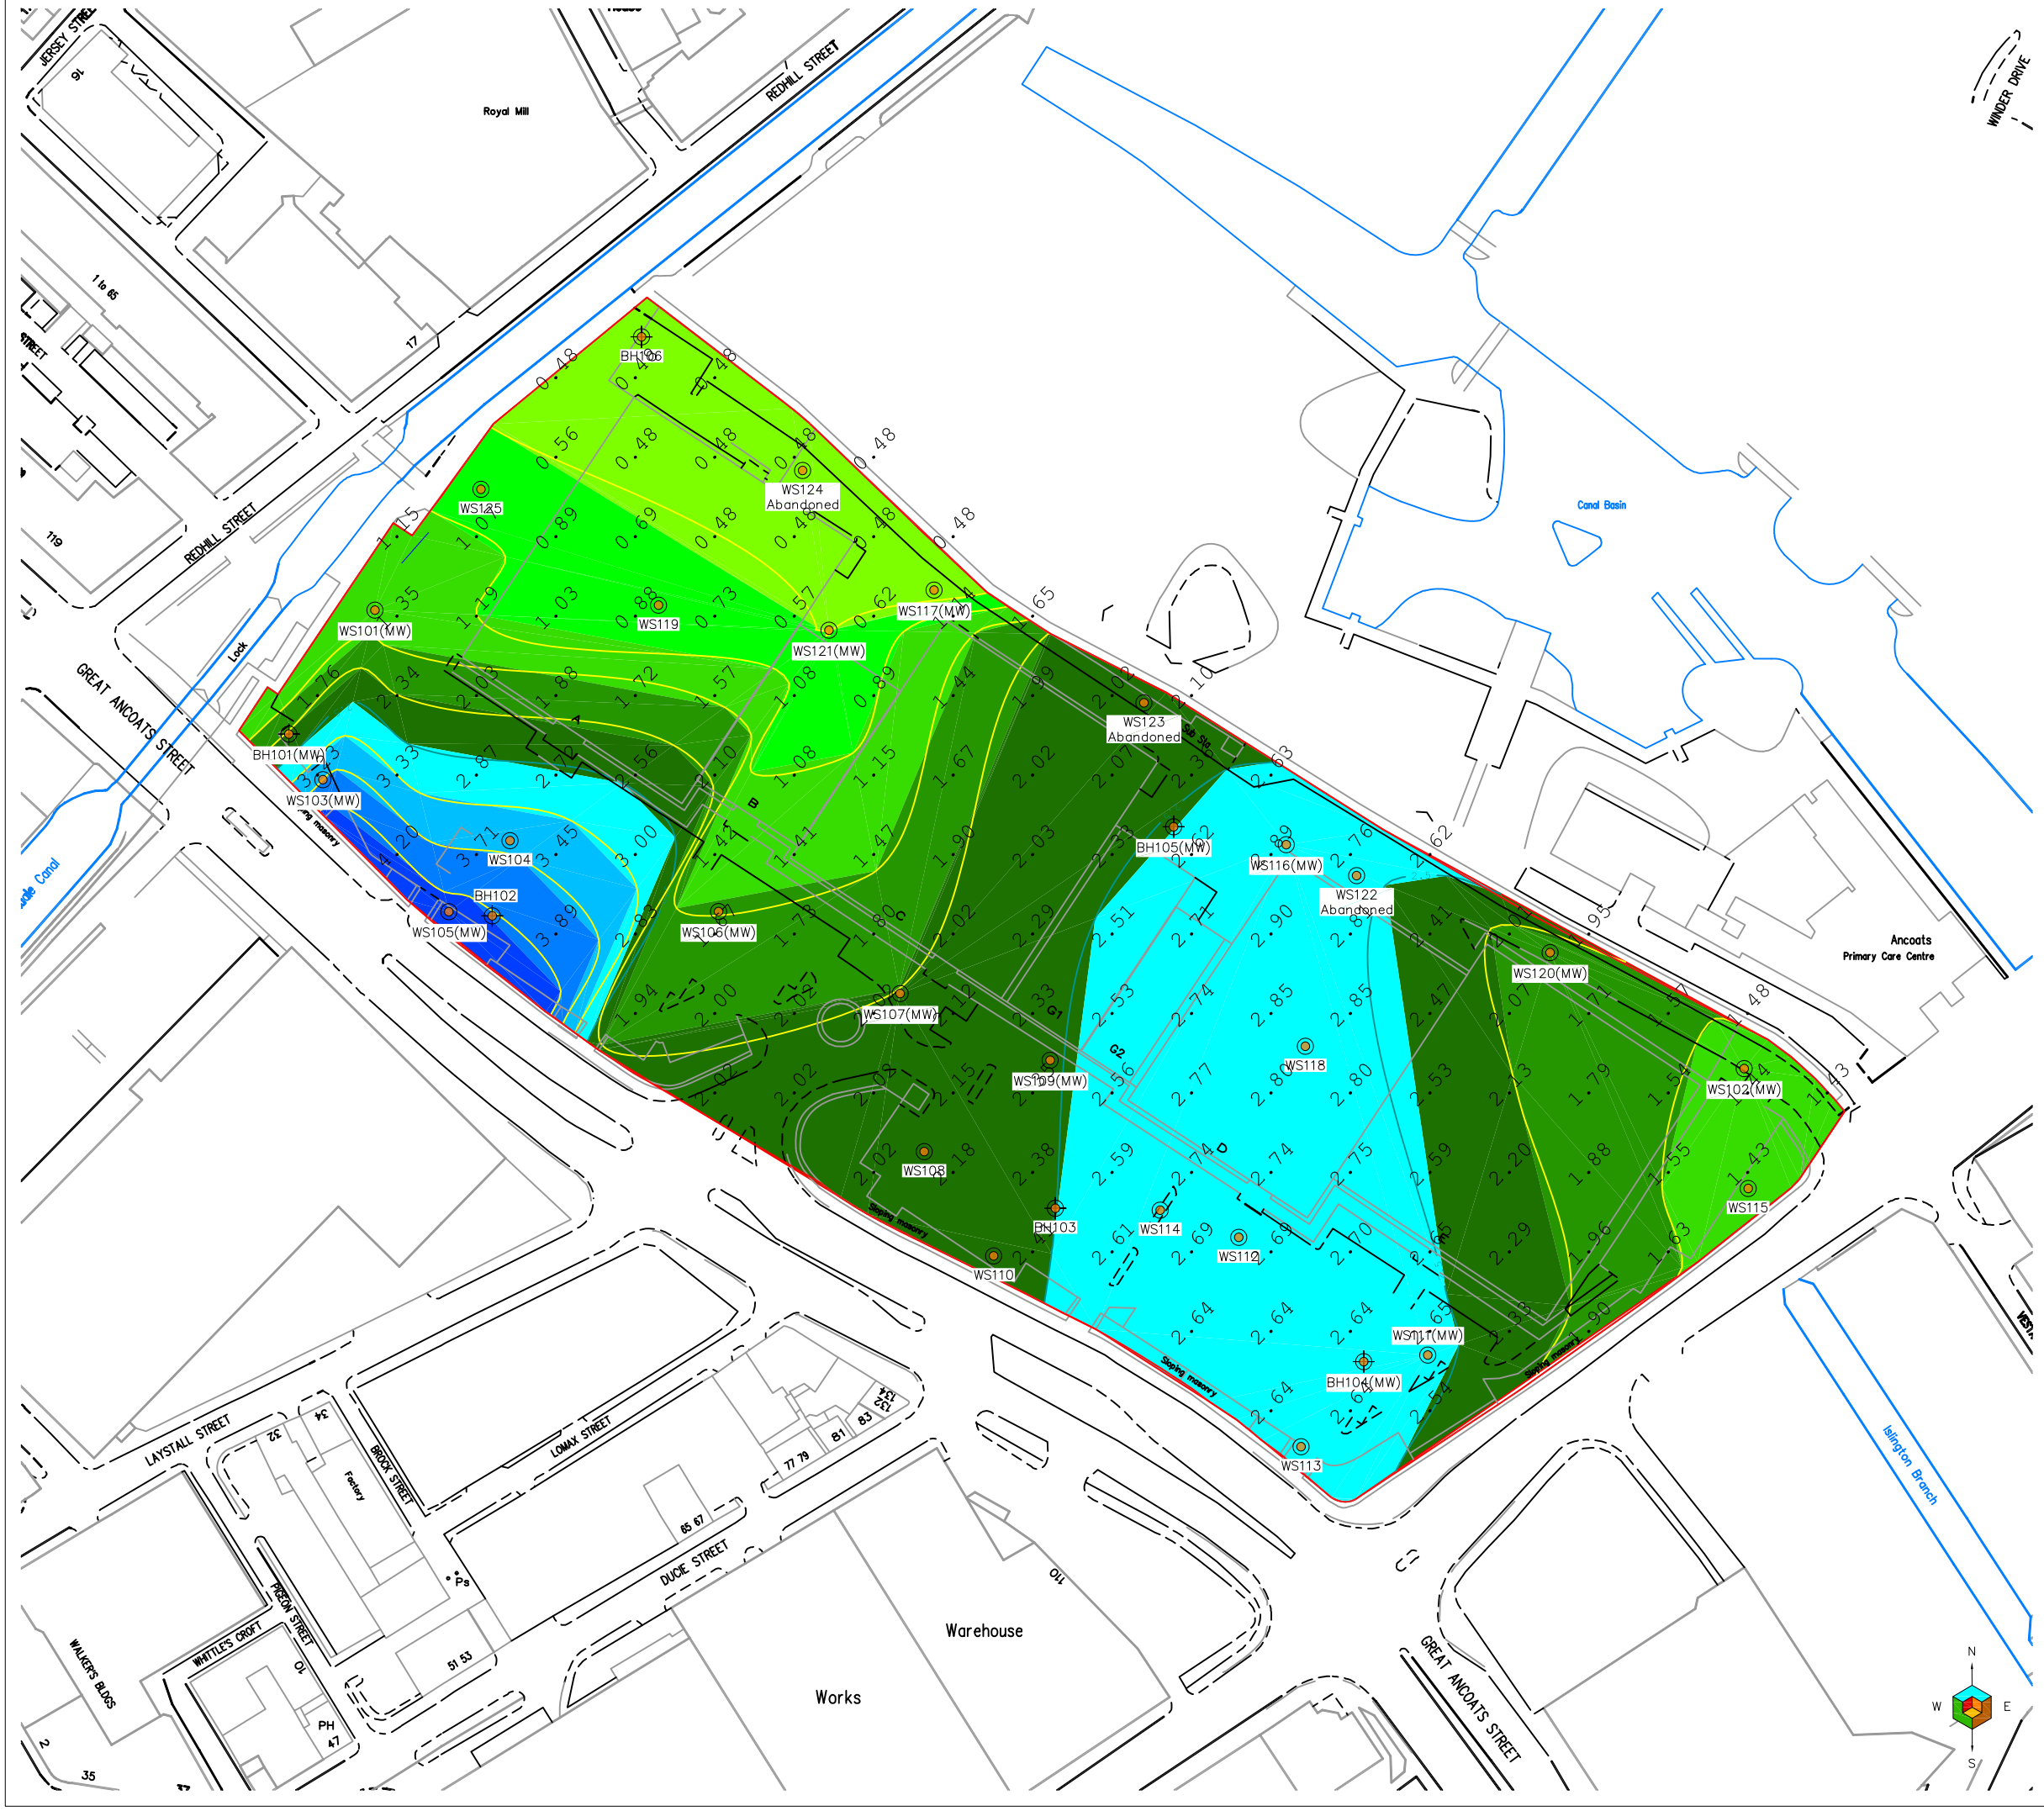
Client: GVA	Job No: 11-834	Date: 25-07-2017
	Drawing No: 006	Scale: NTS @ A3
Job Title: Central Retail Park, Manchester	Drawing Title: Depth to Shallow Groundwater Plan

Topographic surveying is to be completed to accurate define groundwater depths and flow and seasonal variation in groundwater depths is likely and should be considered going forward, particularly as infiltration through the low permeability Clay is likely to be limited.
