Phase I Geoenvironmental Site Assessment
Pitsford Road, Miles Platting

Reference:16-148-R1-1
Date: October 2022

Pitsford Road,
Miles Platting,
Manchester,
M40 8GS

PROJECT NUMBER	16-148		
VERSION	Version 1		
REMARKS	Draft for Comment		
DATE	October 2022		
PREPARED BY	M Dimes		
QUALIFICATIONS	BSc (Hons)		
CHECKED BY	R Walker		
QUALIFICATIONS	BSc(Hons), FGS, AIEMA, AMICE, MIEnvSc, CEnv		
AUTHORISED BY	A Edgar		
QUALIFICATIONS	BSc, MSc, PIEMA, MIEnvSc, CEnv

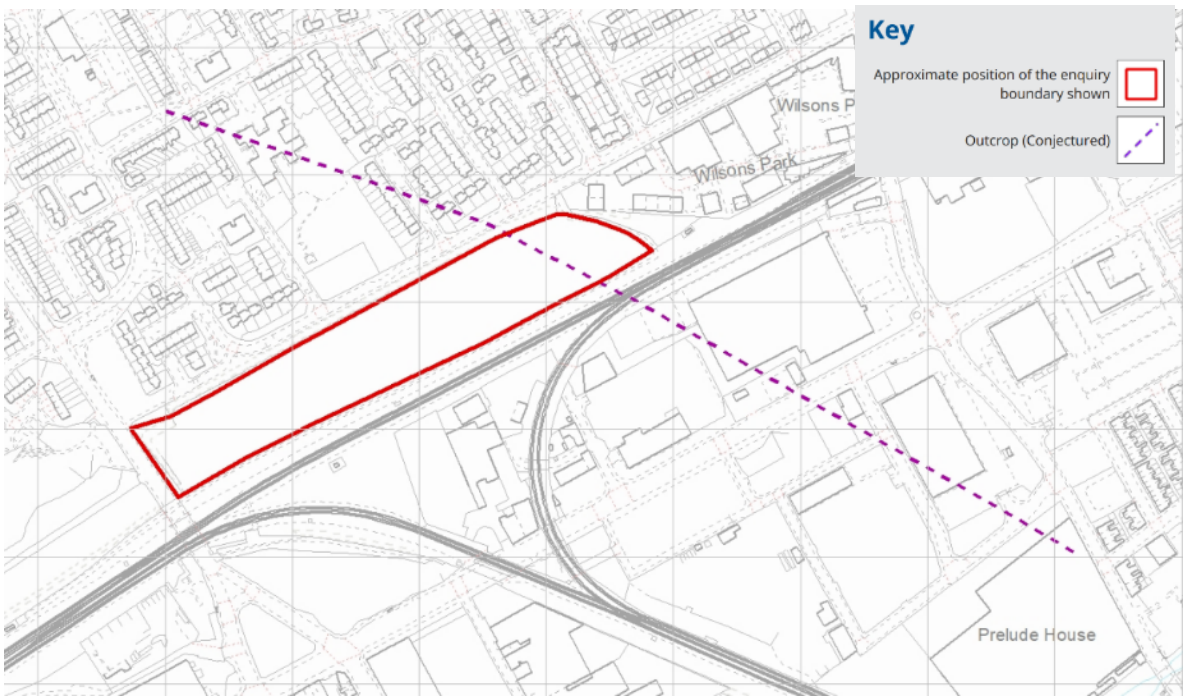
FIGURE 4.3 COAL AUTHORITY PLAN FOR THE SITE

The Coal Authority plan referenced: GS-9081814_Large Plot shows the conjectured coal seam beneath the site and this is presented in Figure 4.3.

Given the potential presence of a seam at the site confirmatory boreholes may be required to demonstrate that the coal is not of workable thickness.

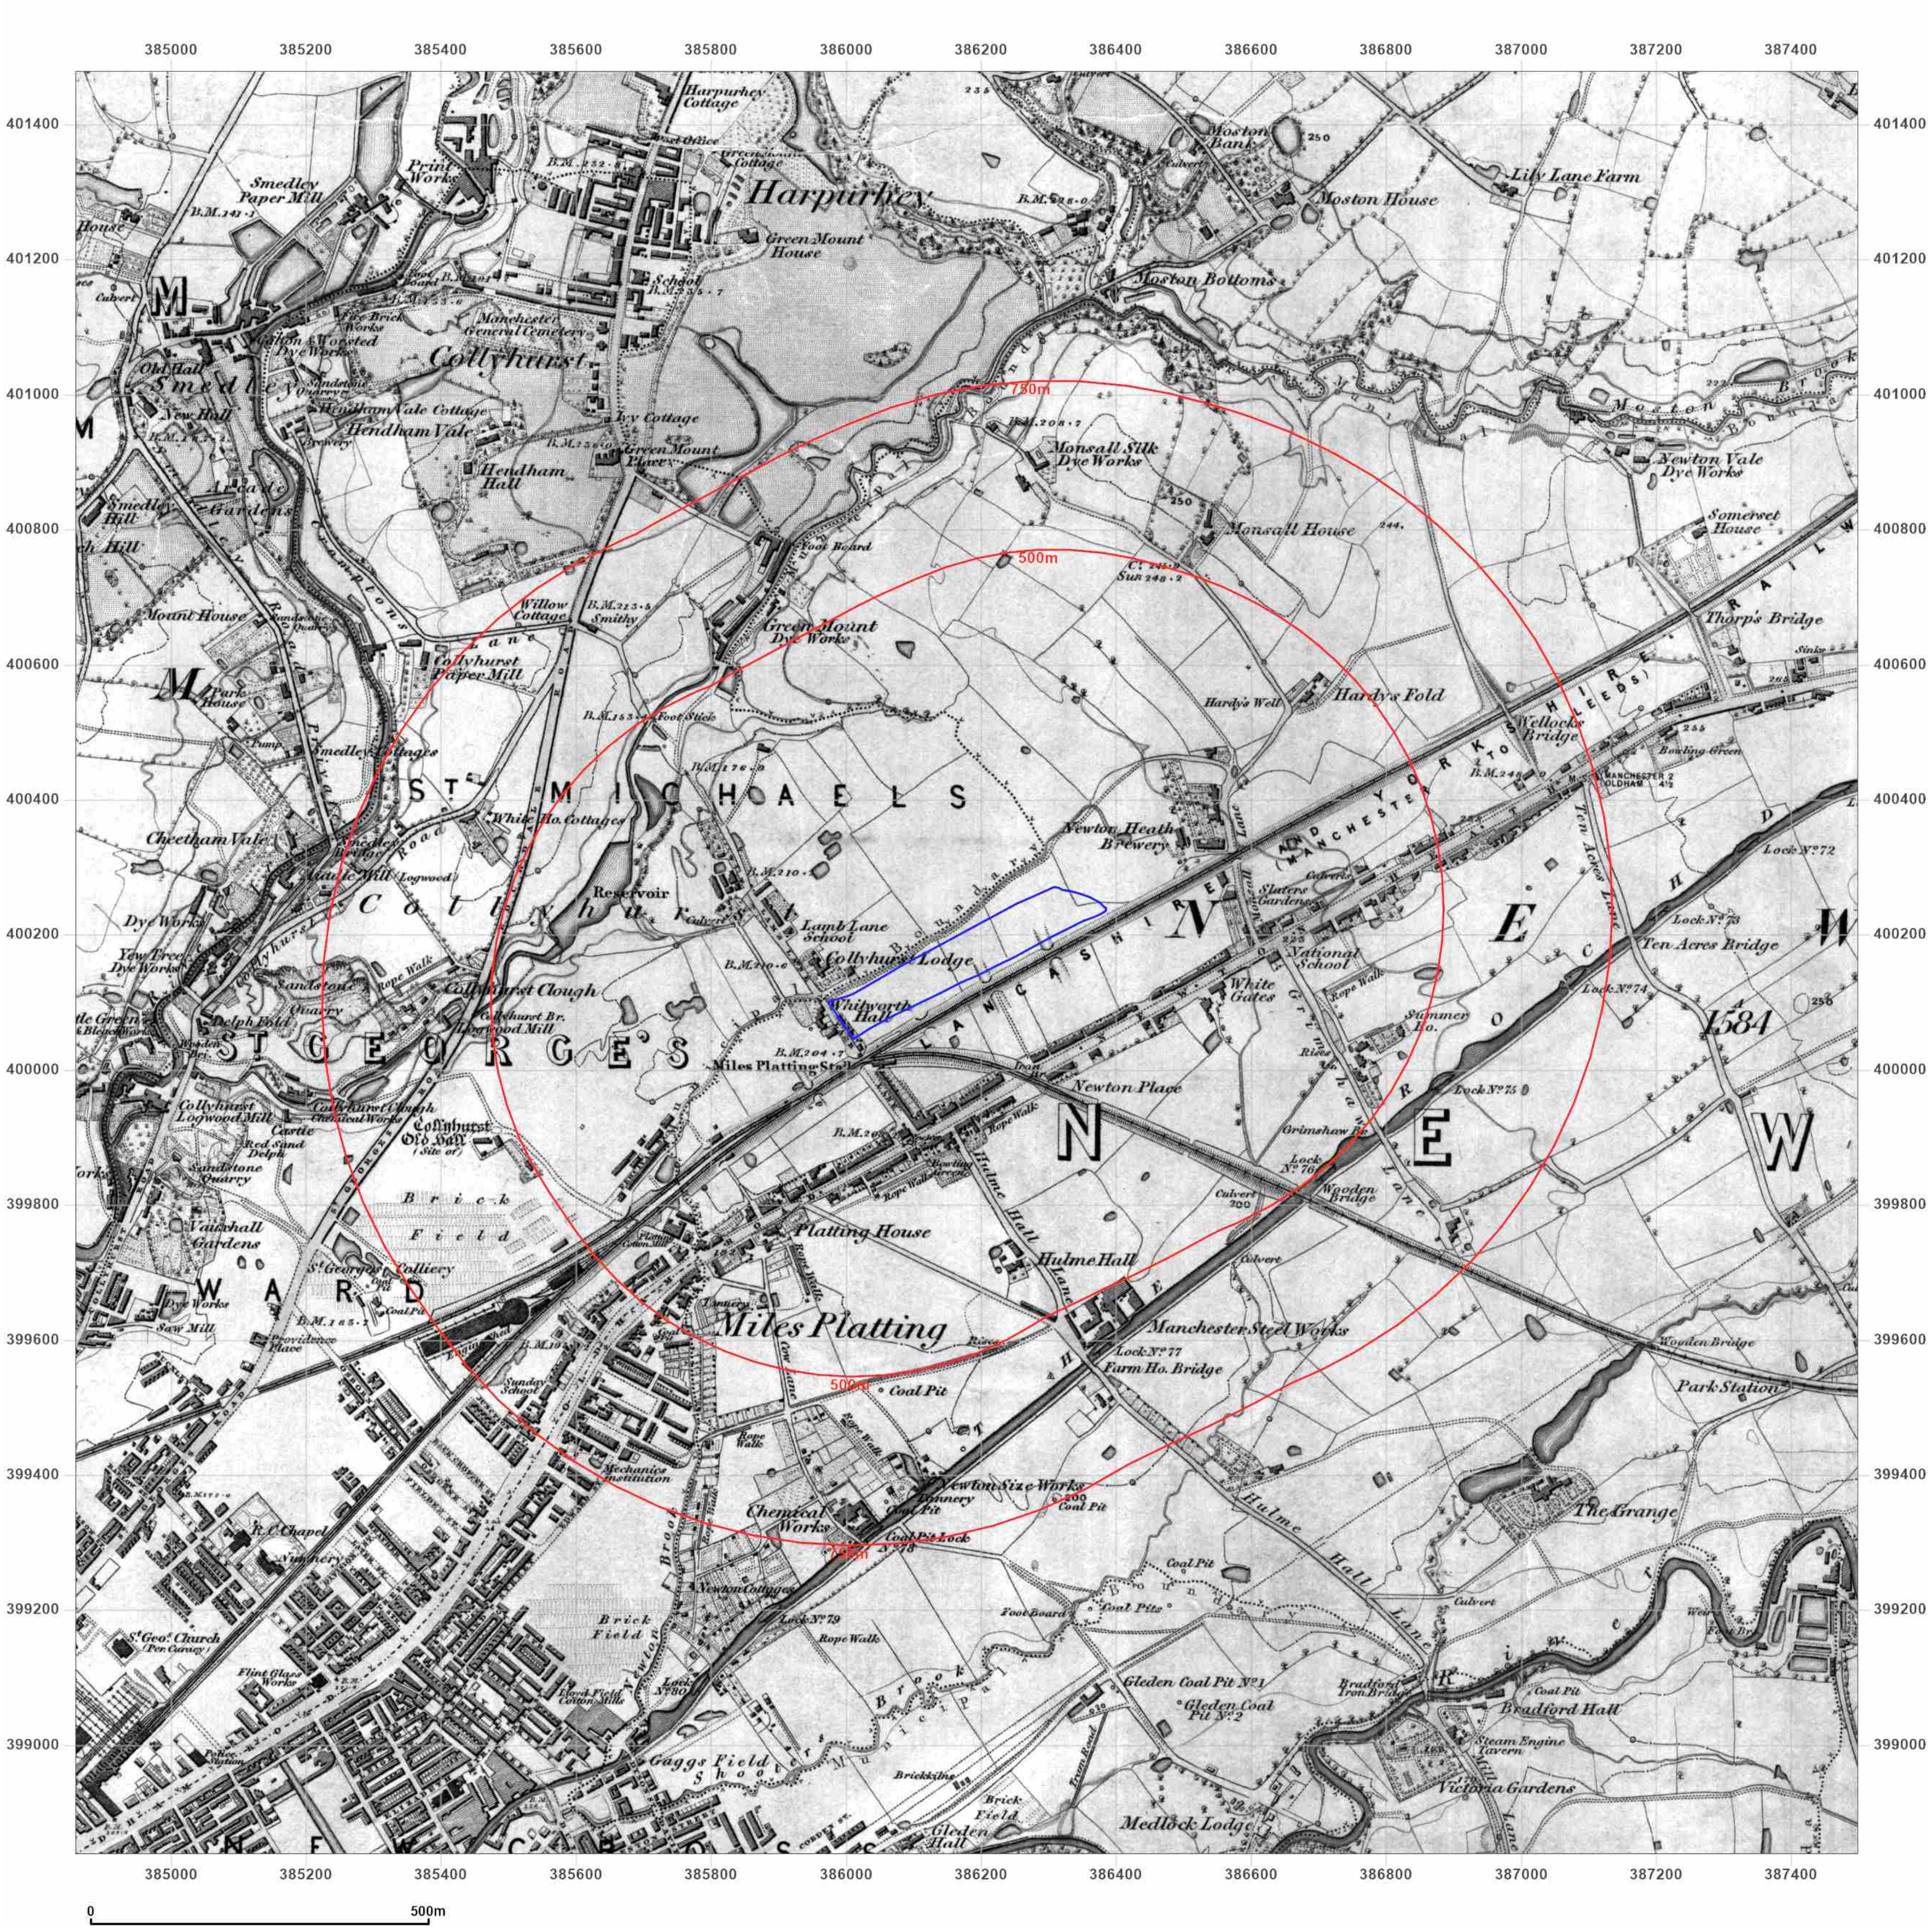
PLATE 5 – RETAINING WALL IN WEST OF THE SITE

Surface Cover (%)	**Buildings**	0%
	Hardstand	5%
	Soft Cover	95%
Structures	No above ground structures have been identified within the site boundary with the exception of the retaining wall at the western end of the site.	
Access	Both pedestrian and vehicular access can be gained in the northeast of the site via a narrow lane off Pitsford Road. Pedestrian access is also possible at a number of breaks in the fence along Pitsford Road.	
Slope	Determining the topography of the site is difficult due to the presence of dense vegetation. The site is elevated above Pitsford Road and a significant slope present on all sides. In some areas the slope is estimated to be ca. 2.50m higher than surrounding features.	
Retaining Structures	There is a ca. 3.00m brick wall forming the western boundary of the subject site that appears to act as a retaining wall for the site and Queens Road. The wall is showing some evidence of cracking suggesting possible movement.
