PROJECT: Manchester Art Gallery

TITLE: WP08 Ceiling Repair Detail

DRAWING REF: MAG-BKP-08-B1-DR-S-40-0810

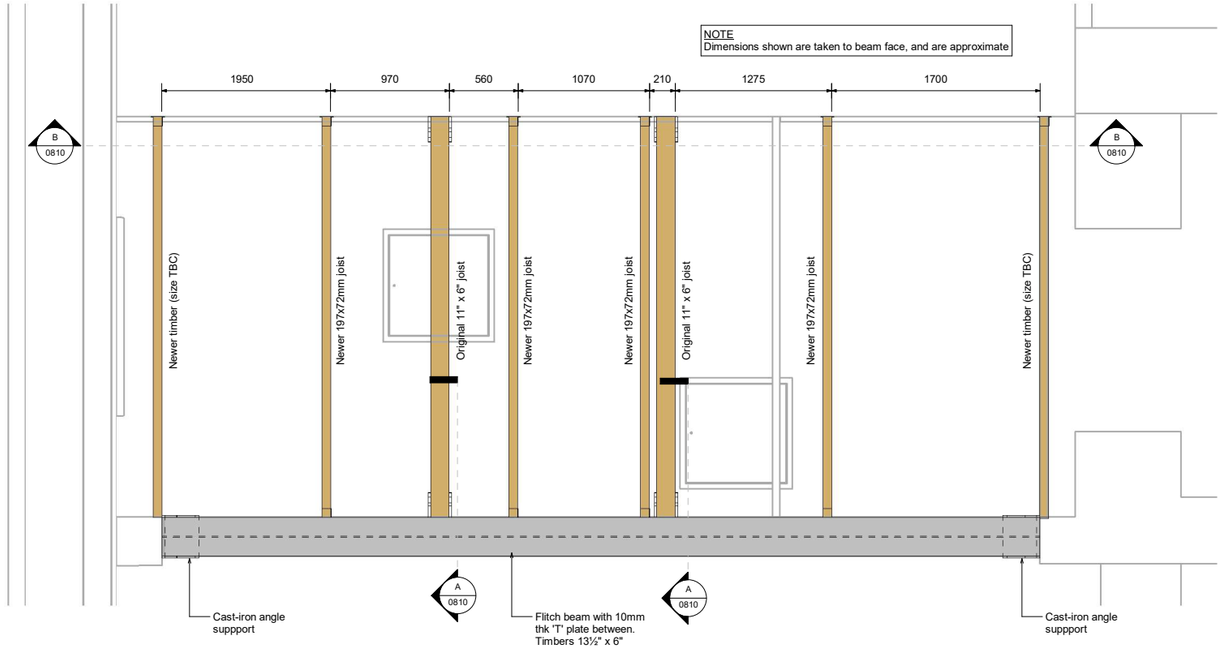
GROUND FLOOR G.A. 43.820m

NOTE
Any existing or proposed services must not be fixed to cracked old timber beams. Any fixings to be removed and reconnected to newer joists

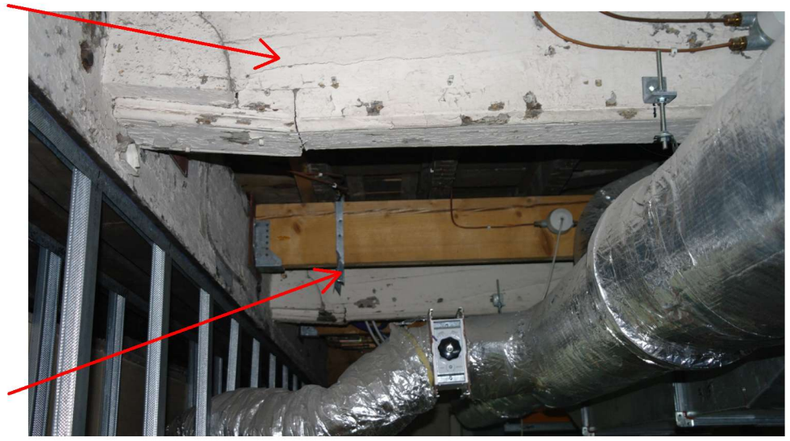
IMAGE SHOWING CRACKED ORIGINAL TIMBERS (2No.)
