PROJECT:
India House Whitworth Street Manchester

DESCRIPTION:
Turret

FILE IDENTIFIER:
IH-BTP-00-DR-A-4545_206

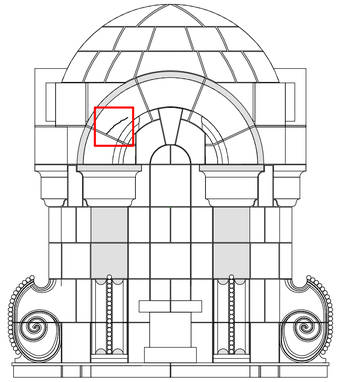
TYPICAL ELEVATION

Vegetation and moss growth between mortar joints to be removed

Allow for repointing entire Turrets, contractor to remove existing mortar with care and replace with a Lime based alternative TBC once testing results confirmed for an original match

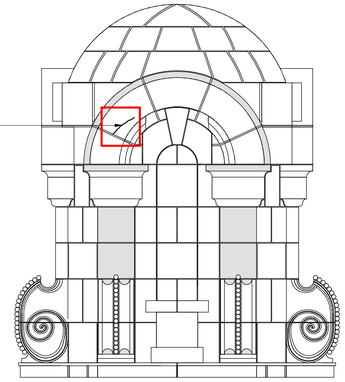
EXISTING TERRACOTTA TURRET TYPICAL DETAIL

Crack to Terracotta arch head detail

Allow for sympathetically cleaning facades by hand and without the use of abrasive/corrosive chemicals
