PROJECT:
India House Whitworth Street Manchester

DESCRIPTION:
Tympanum Pediment Chimney Detail Proposed

JOB NO:	STATUS CODE:	DRAWING NO:	REV
4545	S0	204	1

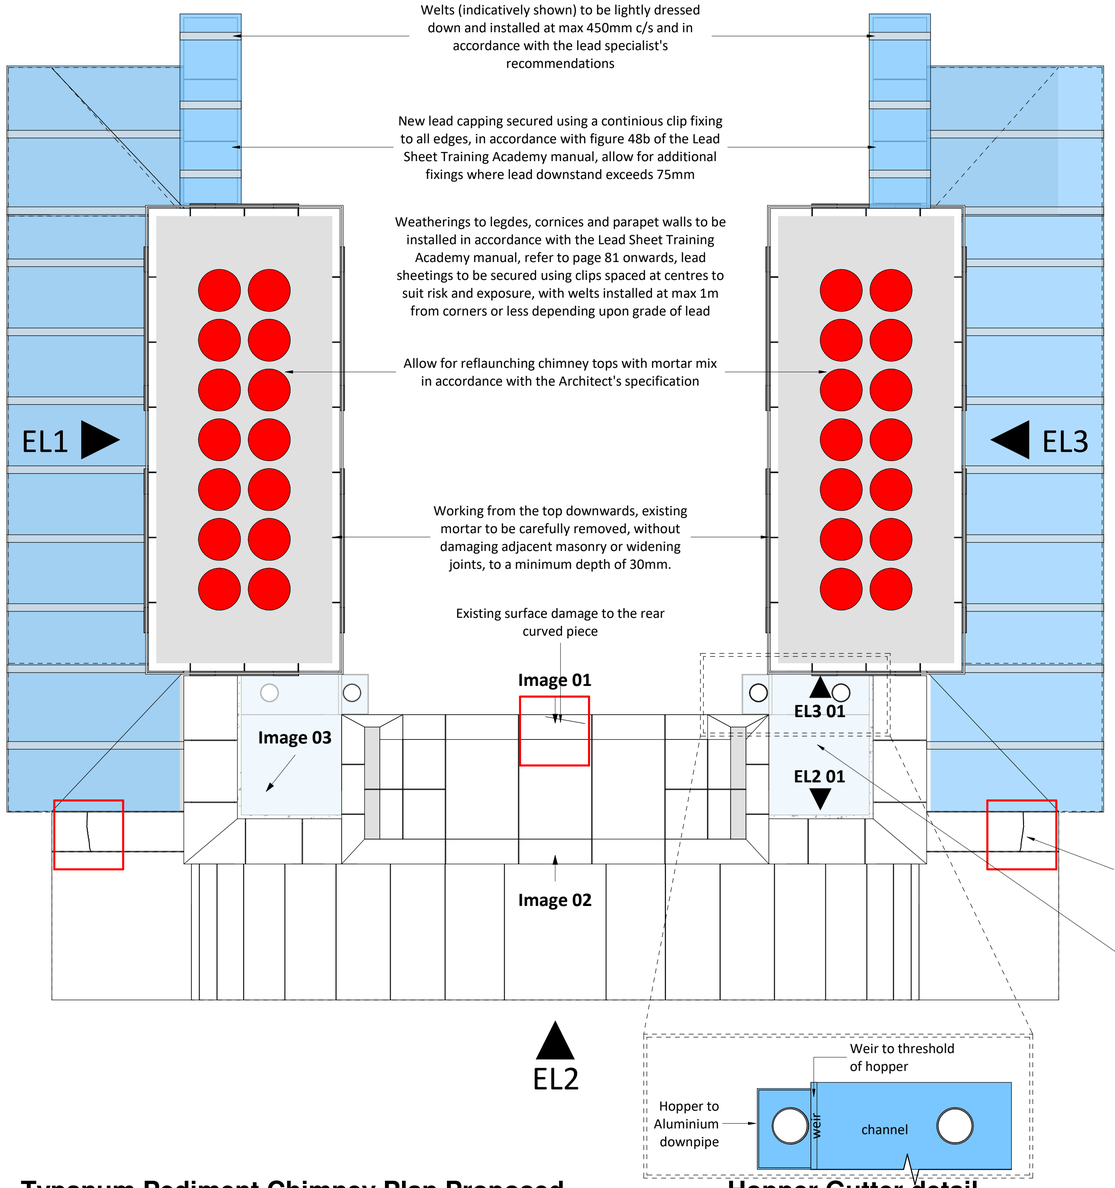
Typanum Pediment Chimney Plan Proposed
1 : 20

Allow for assessing Terracotta conditions and repointing to the underside of the arch

Allow for cleaning all plinths and ledges of detritus before repairing hairline cracks and surface damage

Working from the top downwards, existing mortar to be carefully removed, without damaging adjacent masonry or widening joints, to a minimum depth of 30mm.

Allow for replacing Terracotta pieces, refer to Terracotta Schedule
