MI-054 – Sunlight House

Atrium Roof Drainage outlets:

Additional information for CDN/24/0844 - Discharge of condition 4 (M&E) attached to listed building consent 136161/LO/2023

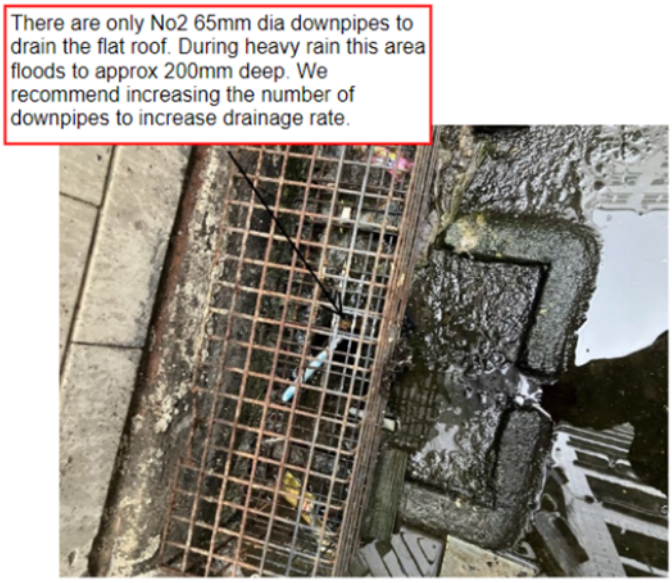
The drainage issues are caused by the 65mm drainage outlets, then going to the 100mm pipework.

Existing outlets that block due to size.

For the upgraded outlets to the atrium roof MYCO are proposing to use a cast iron drainage outlet, trapped below slab to allow future maintenance.

The new drainage outlets will be connected into the existing 100mm drainage system below the slab.
