CLIENT:
Guinness Partnership

PROJECT:
India House Whitworth Street Manchester

DESCRIPTION:
Tympanum Pediment Chimney Detail Existing

JOB NO:	STATUS CODE:	DRAWING NO:	REV
4545	S0	203

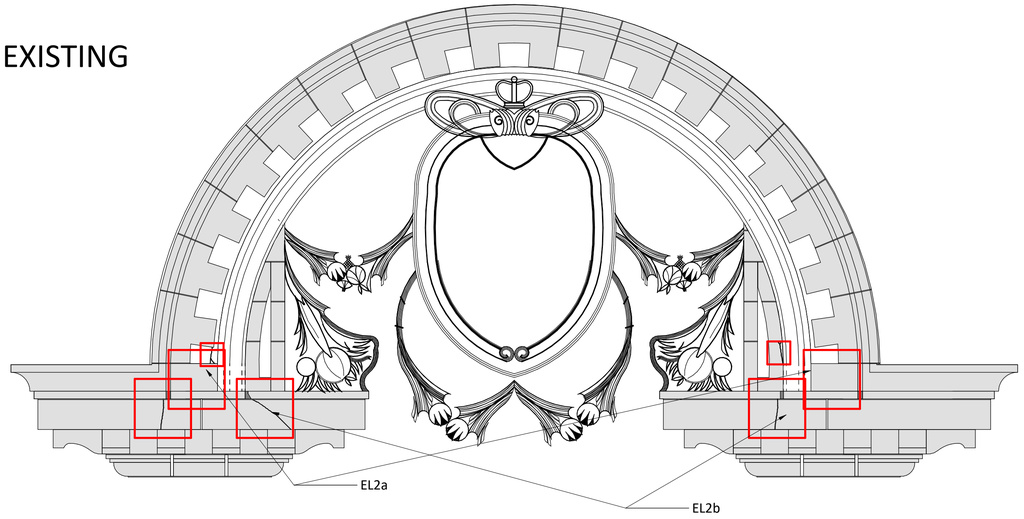
Front Elevation - Whitworth Street - Pediment (EL2)
1 : 50

Tympanum interior wall damage (EL2a)

Cracking (EL2a)

Cracking (EL2b)

Cracking to base plint to Tympanum (EL2a)

Parapet wall once weathered coping damage and cracking to Terracotta (EL2Pa)

Cracking to Tympanum (EL2a)

Allow for removing flashing substitute and replacing with Code 4 Lead or higher (EL2Pb)

Allow for repointing between Terracotta pieces

Allow for removing existing flashing, new flashing to extend minimum 600mm up (EL2Pc)

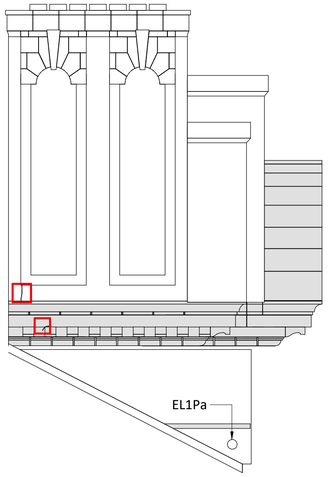
Side Elevation (EL1)
1 : 50

Cracking to plinth (EL1a)

Allow for replacing with wider diameter outlet with provision for rainwater overflow (EL1Pa)

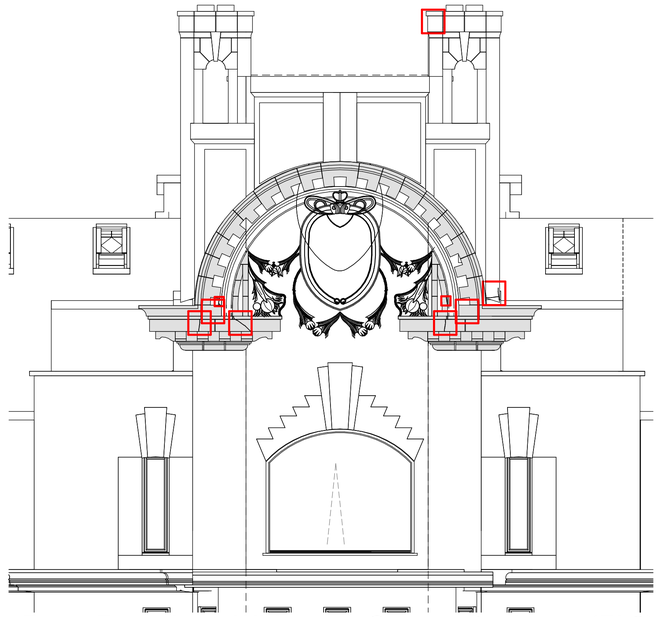
Previous infill repair

Cracking to base plinth to Tympanum (EL2a)

Allow for removing existing vegetation and making good with Lead capping

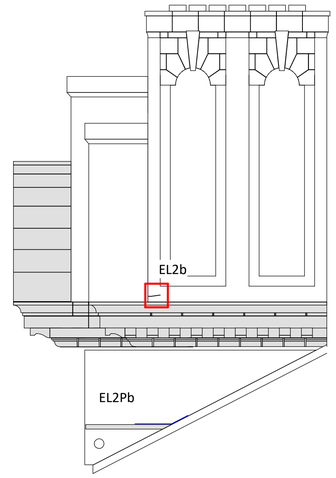
Side Elevation (EL3)
1 : 50

Cracking to base of Chimney (EL3b)

Cracking to plinth (EL3a)
