Sunlight House - MCR

17/Jun/2024 | 09:41

Sunlight House Anchors

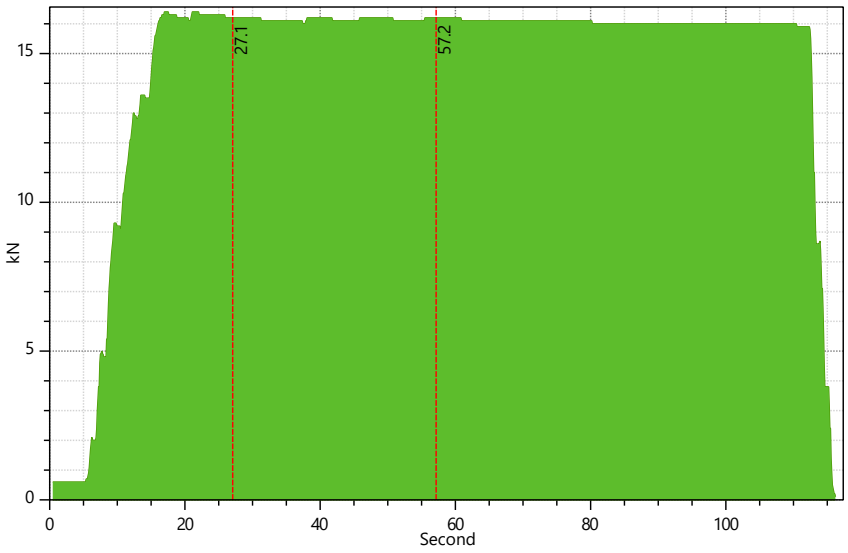
Mechanical 1 (Equipment: MAN6952 25kN, Calibration Expiry: 30/Jan/2025)

Time	Total Time	Target	Torque Achieved	Displacement	Reference	Result
30 secs	1m 56s	16kN	16.4 kN	0 mm	WOLES6EJ706IKU	Passed

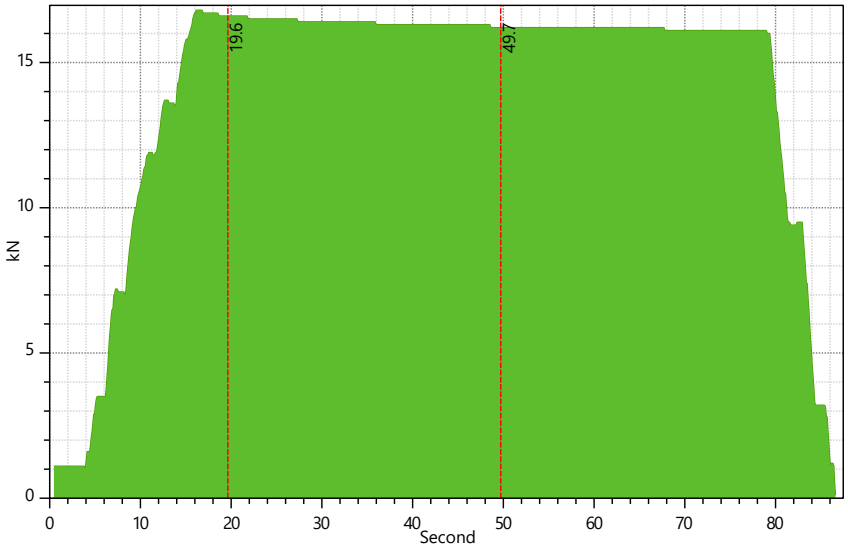
Mechanical 2 (Equipment: MAN6952 25kN, Calibration Expiry: 30/Jan/2025)

Time	Total Time	Target	Torque Achieved	Displacement	Reference	Result
30 secs	1m 26s	16kN	16.8 kN	0 mm	ELB7KTQMAXGARS	Passed

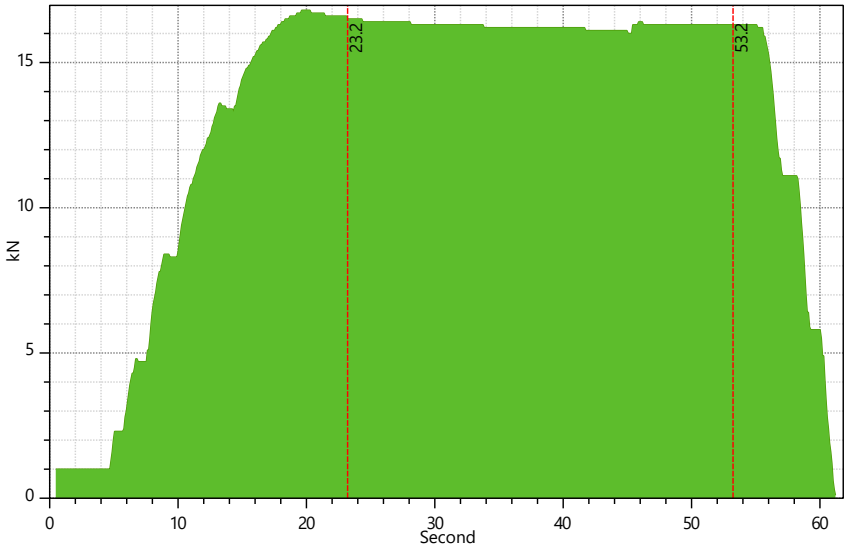
Mechanical 3 (Equipment: MAN6952 25kN, Calibration Expiry: 30/Jan/2025)

Time	Total Time	Target	Torque Achieved	Displacement	Reference	Result
30 secs	1m 1s	16kN	16.8 kN	0 mm	OXWZCDNVY97BFA	Passed

Lowest fixing of 3
