PROJECT:
India House Whitworth Street Manchester

DESCRIPTION:
Scaffold Eyelet Fixing Detail

FILE IDENTIFIER:
IH-BTP-00-DR-A-4545_209

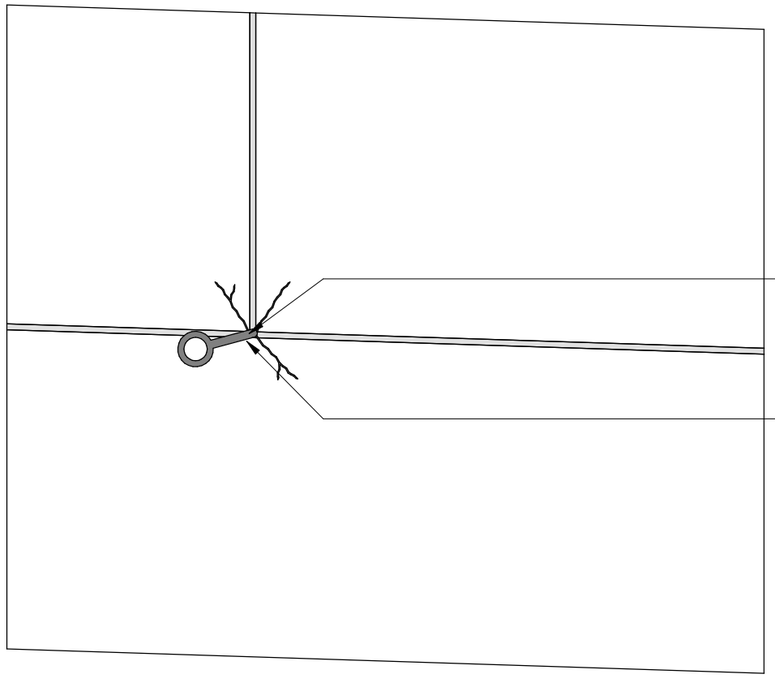
Image 01 - Typical Eyelet scaffold fixing

Scaffold eyelets screwed into mortar in between and through Terracotta pieces throughout the front and side elevations of India House.

Allow for removing scaffold screw eyelets and replacing with matching Stainless Steel bolts to plug the holes future reuse to prevent/limit damaging Terracotta or

allow for a new matching 25mm Terracotta tile piece, mortar fixed into place over existing scaffold fixing point holes

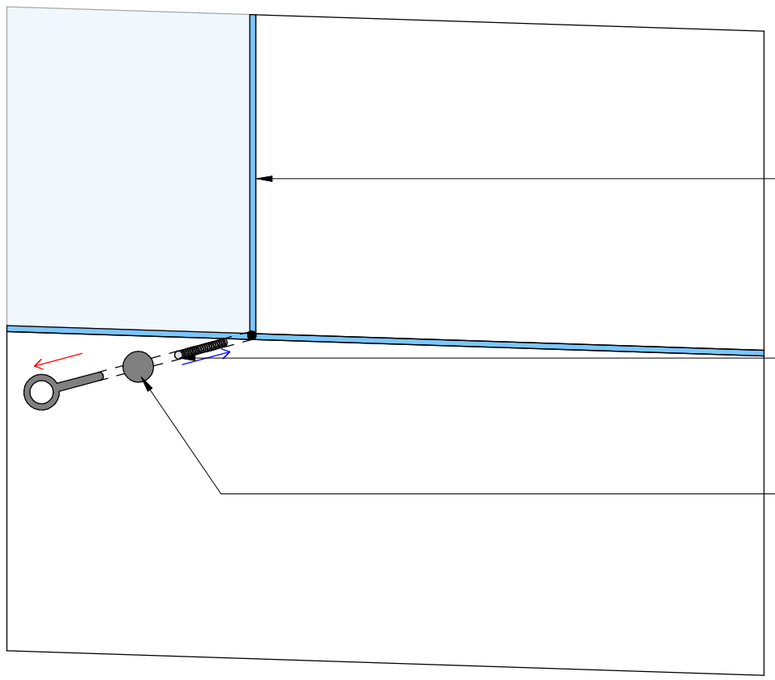
Image 02 - Previous Eyelet scaffold fixing through Terracotta

Some eyelets screwed into the Terracotta have caused cracking and further damage to the brickwork

Allow for repointing to areas and repairing Terracotta pieces towards the end of works
