PHOTOGRAPHS-EXTERIOR

PHOTOGRAPHS-INTERIOR

CABLE ROUTES INSIDE THE BUILDING- REFER TO REFERENCE NUMBERS ON DRAWING L2-02 FOR LOCATIONS OF PHOTOGRAPHS

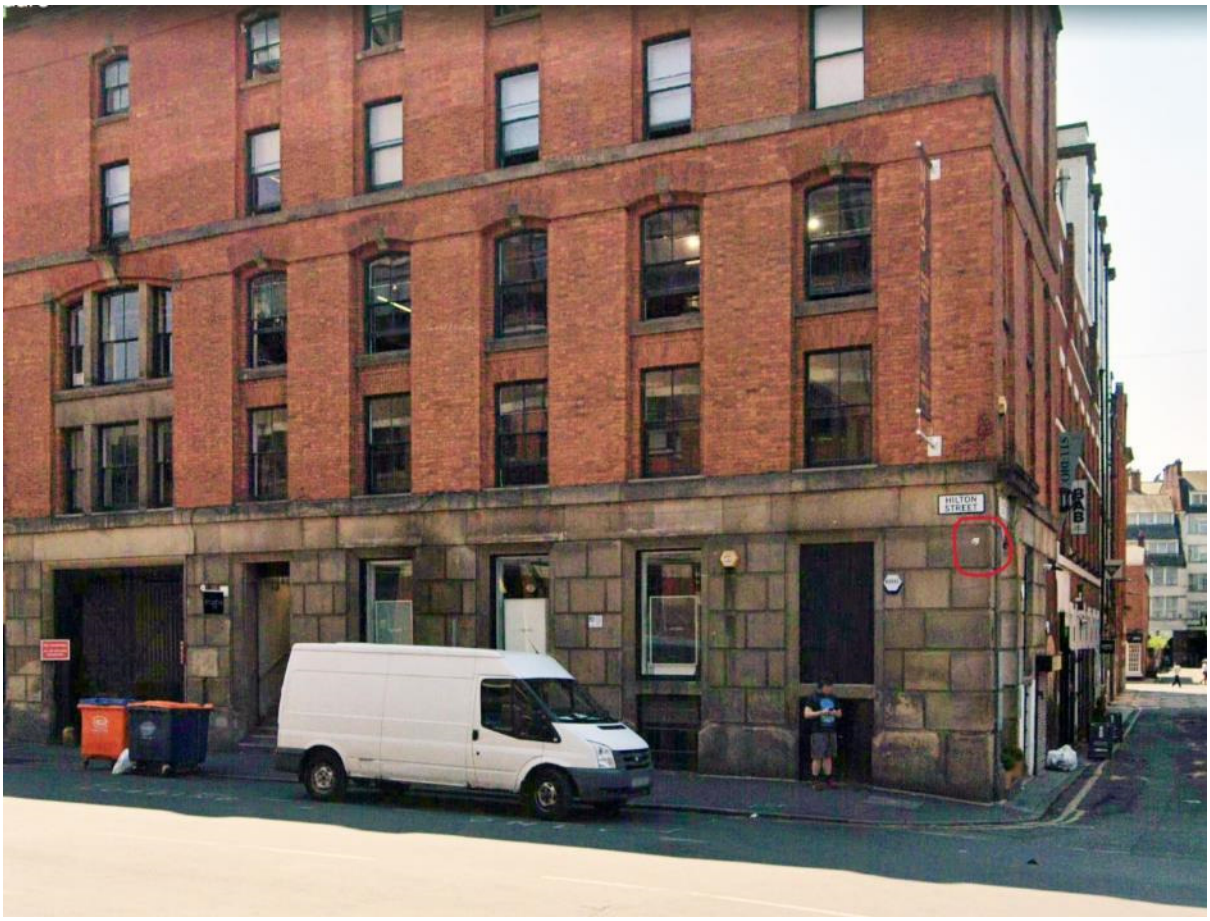
HILTON STREET

CCTV CAMERAS RINGED IN RED

Note: the existing cameras shown are proposed to be replaced with black colour and relocated to new positions under the current LBC Application.

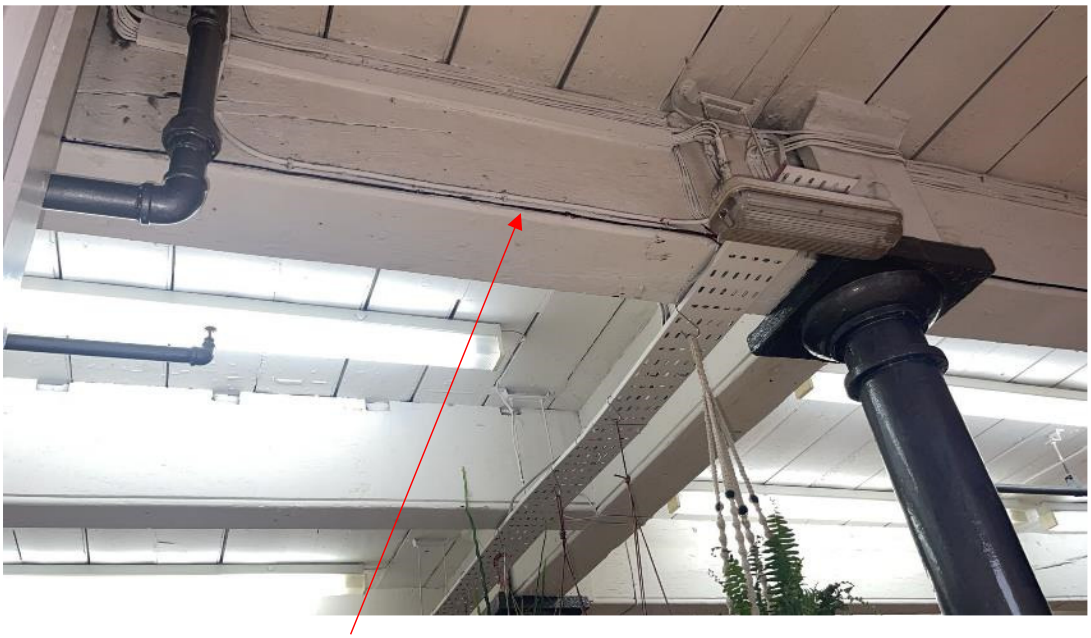
PHOTO IN LOCATION **REF 2.**

ALL EXISTING WIRING RUNS ON TOP OF INTERNAL ORIGINAL DECORATIVE CORNICE. THE NEW CABLE FOLLOWS THE SAME ROUTE AS OTHER CABLES.

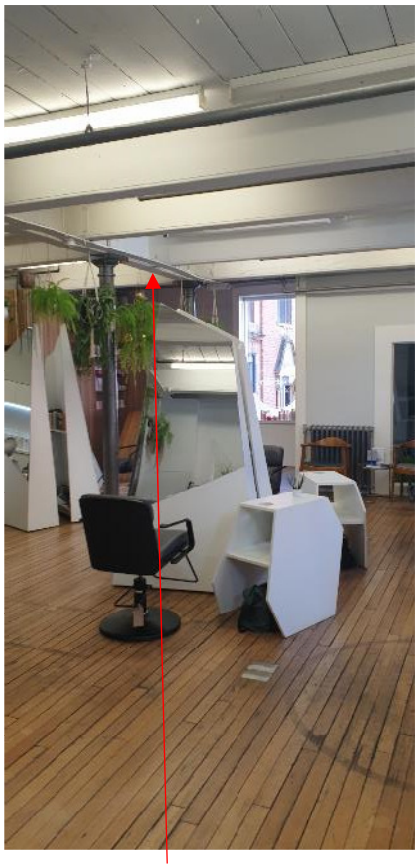
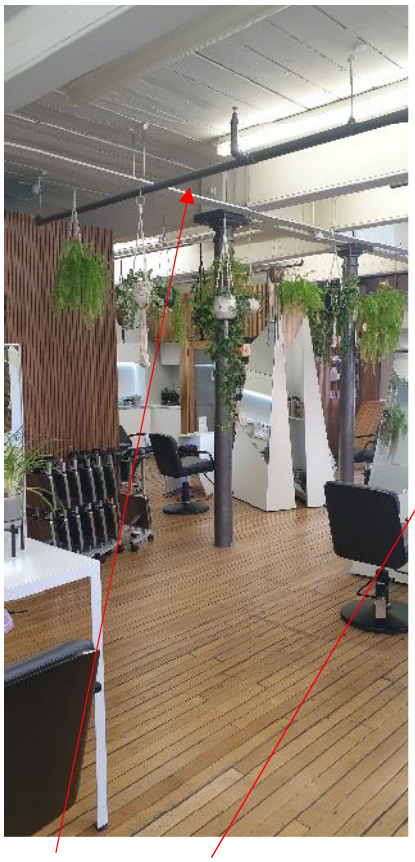
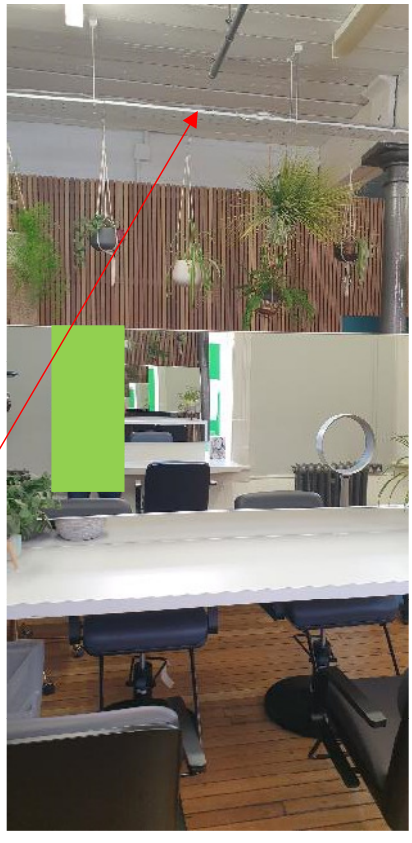
PHOTOS IN LOCATION **REF 4.**

NON-ORIGINAL CABLE CONTAINMENT TRAY RUNNING FULL LENGTH OF SALON.

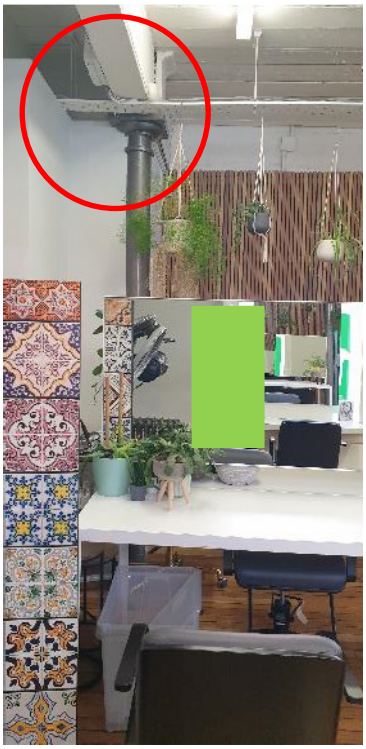
PHOTOS IN LOCATION **REF 5.**

CABLE TERMINATIONS AT CCTV /ALARM CONTROL BOX SHOWN IN RED CIRCLE

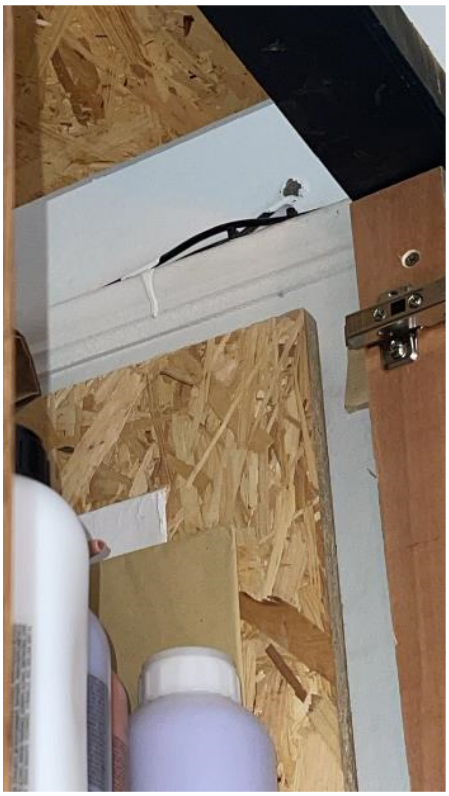
PHOTOS IN LOCATION **REF 6.**

CABLE FROM EXTERIOR THROUGH ORIGINAL MASONRY AND RUN ALONG TOP OF EXISTING ORIGINAL CORNICE AROUND REAR OF CUPBOARD.
