John Rylands Library and Beyer Building, Manchester

John Rylands Library - Stone Repairs
Spinningfields Elevation

Project	No
MAN.JRL.02	2220
Scale (A1)	Status / Revision
1:100	M / 2

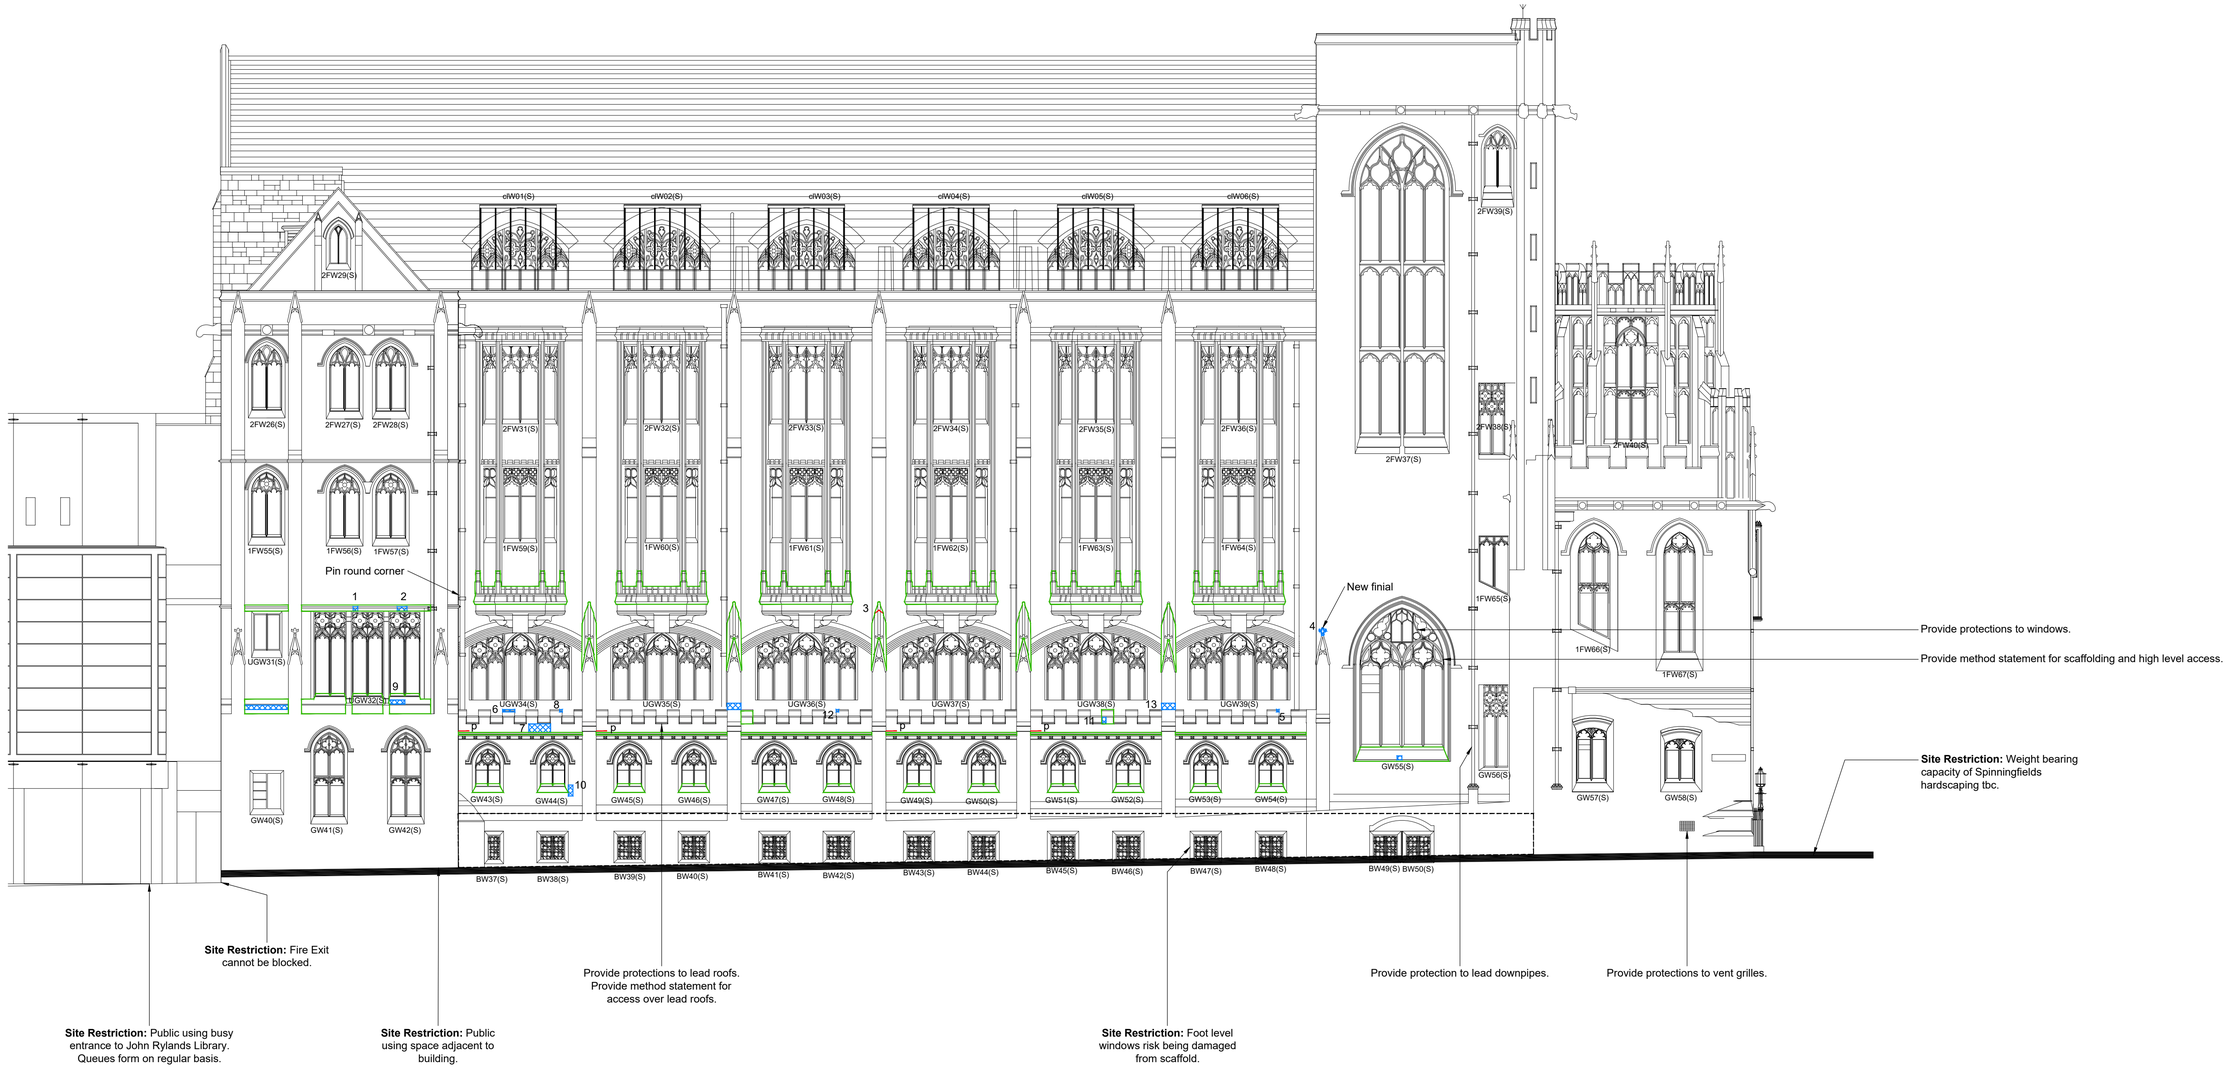
Area to be surveyed

Areas for proposed indent stone repairs. Cut out decayed / damaged stone and fit new stone indent repair

Cracks to stone to be pinned or repaired with grout/ mortar repair ('P' indicates a pin is required)

Area within hatch to be re-pointed, precise areas to be confirmed with architect.

Outline specification for mortar mix for repointing:
3.5:1
NHL2: moist pink silica sand: nosterfield sand

Carefully rake out mortar. If mechanical methods required they are to be undertaken by a skilled operative
