South Elevation as Existing Current Condition - Sheet 2

Project Title	NEW WAREHOUSE
Client	SCIENCE & INDUSTRY MUSEUM
Location	MANCHESTER
Drawing Title	New Warehouse South Elevation As Existing Current Condition - Sheet 2
Date	23/11/22
Checked	AS
Scale	1:50
Orig Paper Size	A1
Status	**PLANNING**

9488 - BUT - NW - XX - DR - A - (02)207 - P1

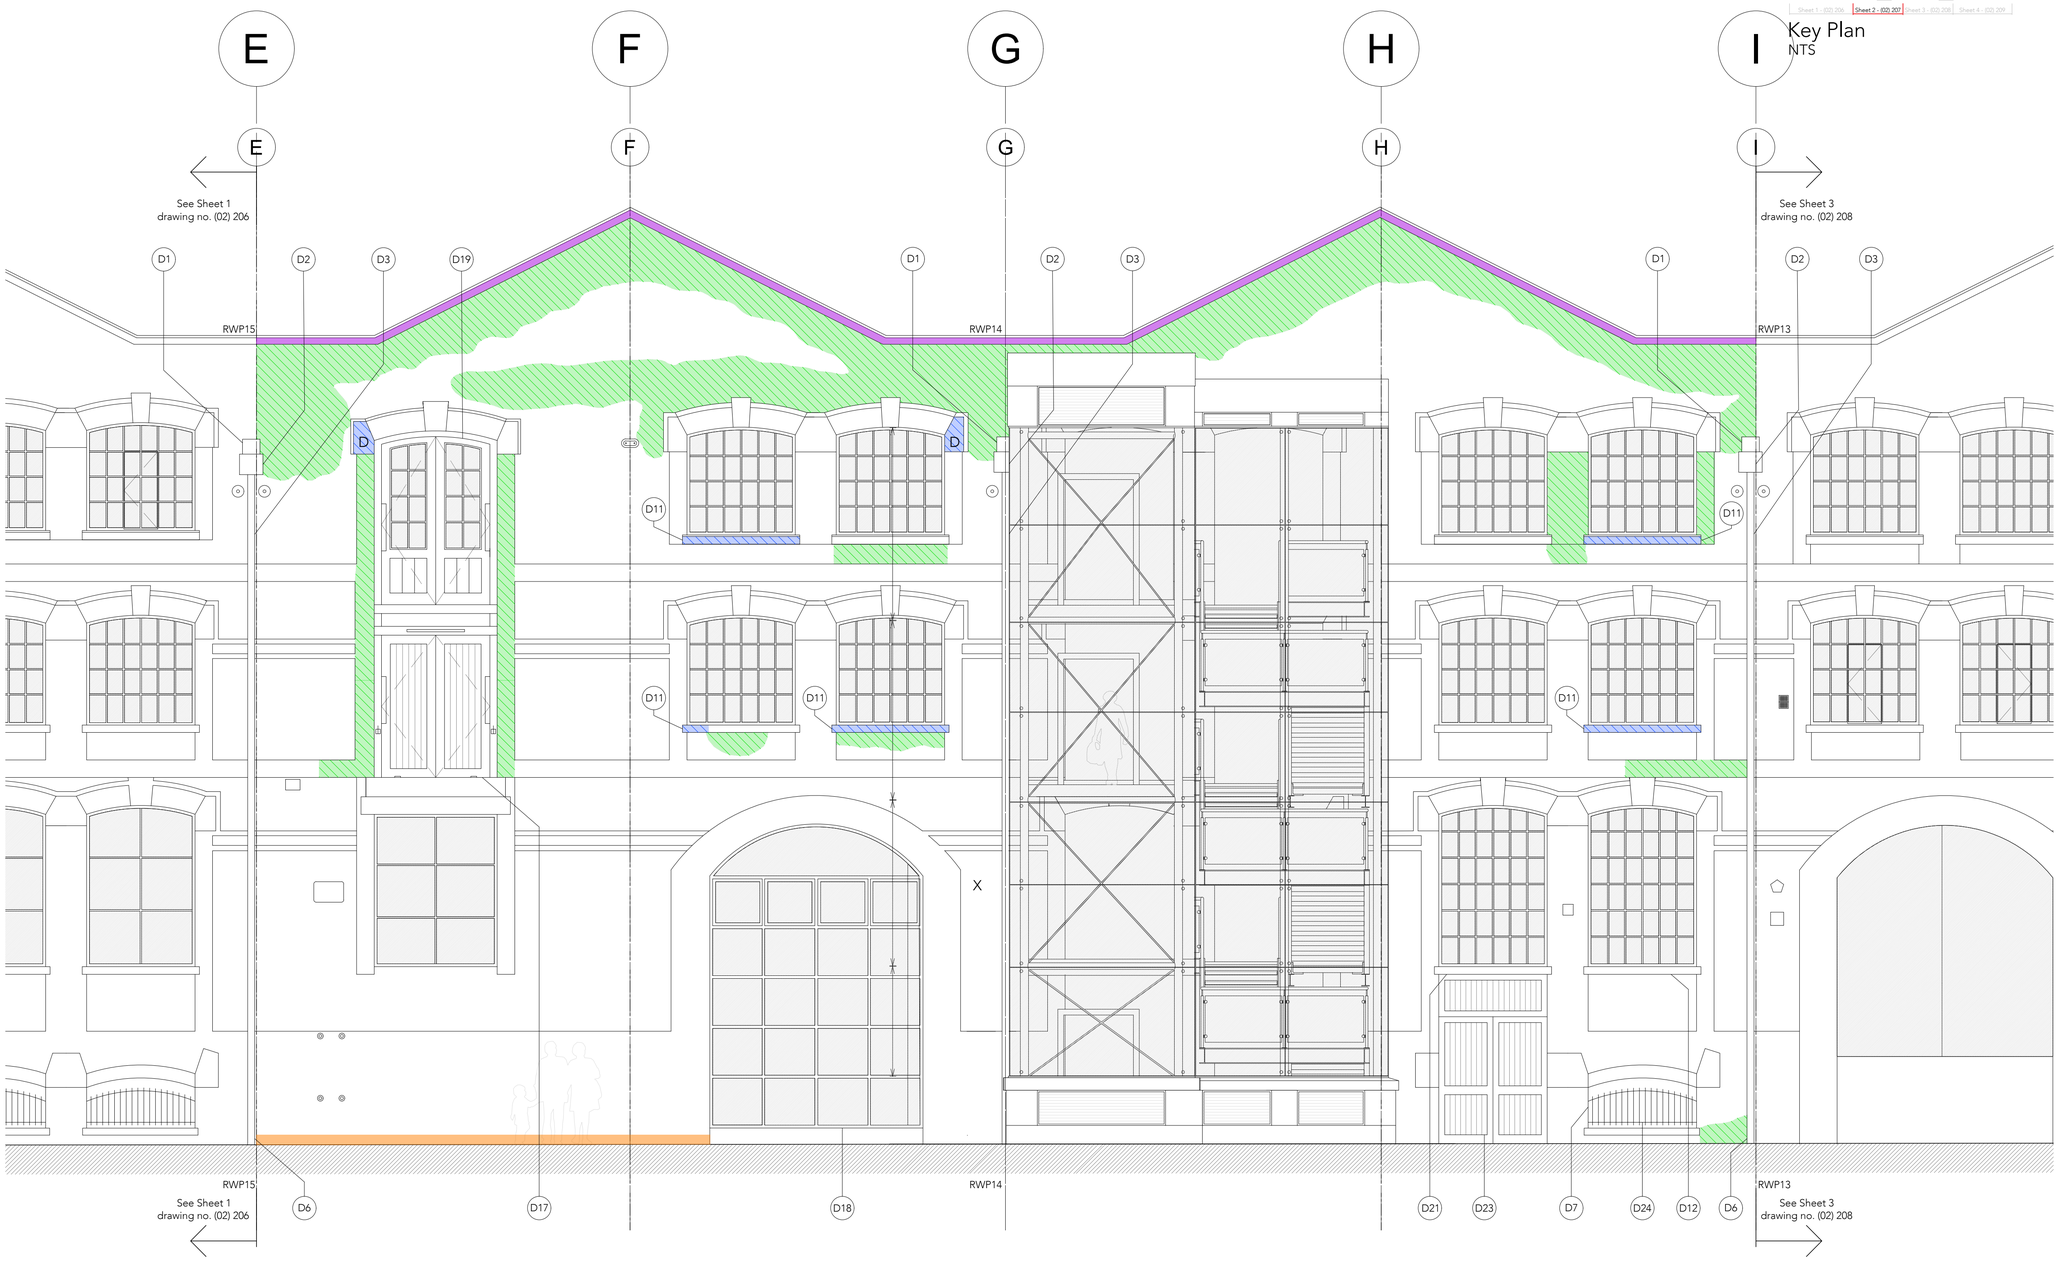
Open Mortar Joints	D1	Lead Chute	D8	Iron Railings with Glazed Metal Framed Window	D15	Timber Framed Window Finishes Deteriorating	D22	Paint Splatter
	Defective Masonry / Stonework	D2	Hopper	D9	Spalled Brick	D16	Stepped Vertical Cracking Due to Rust Jacking	D23	Flaking / Blistered Decorations
	Open Mortar Joints Across Copings	D3	UPVC Downpipe	D10	Defective Bricks	D17	Remnants of Ferrous Bracketing to Cill	D24	Defective / Corroded Railings
	Cementitious Render	D4	CCTV System	D11	Loss of Detail Across Cill	D18	Timber Framed Window	D25	Modern Metal Framed with Glass Louvres
	Defective Steel Decorations	D5	Flood Light	D12	Fracture Through Cill	D19	Blistered & Flaking Decorations and Localised Decay & Distortion	D26	Previous Repairs of Poor Quality
D	Delamination	D6	Rodding Point	D13	Poor Quality Masonry	D20	Vegetation	D27	Glazed Metal Framed Window in Poor Condition
X	Ferrous / Steel Embedded Fixing Elements	D7	Iron Railings with Timber Louvres Beyond	D14	Decay Across Window Frames	D21	Spalling to Soffit of Lintel	D28	Stepped Vertical Crack
