Phase 1 GeoEnvironmental Desk Study

The Albion Inn

Burnage

Report No. A5595/23/FDS **OCTOBER 2023**

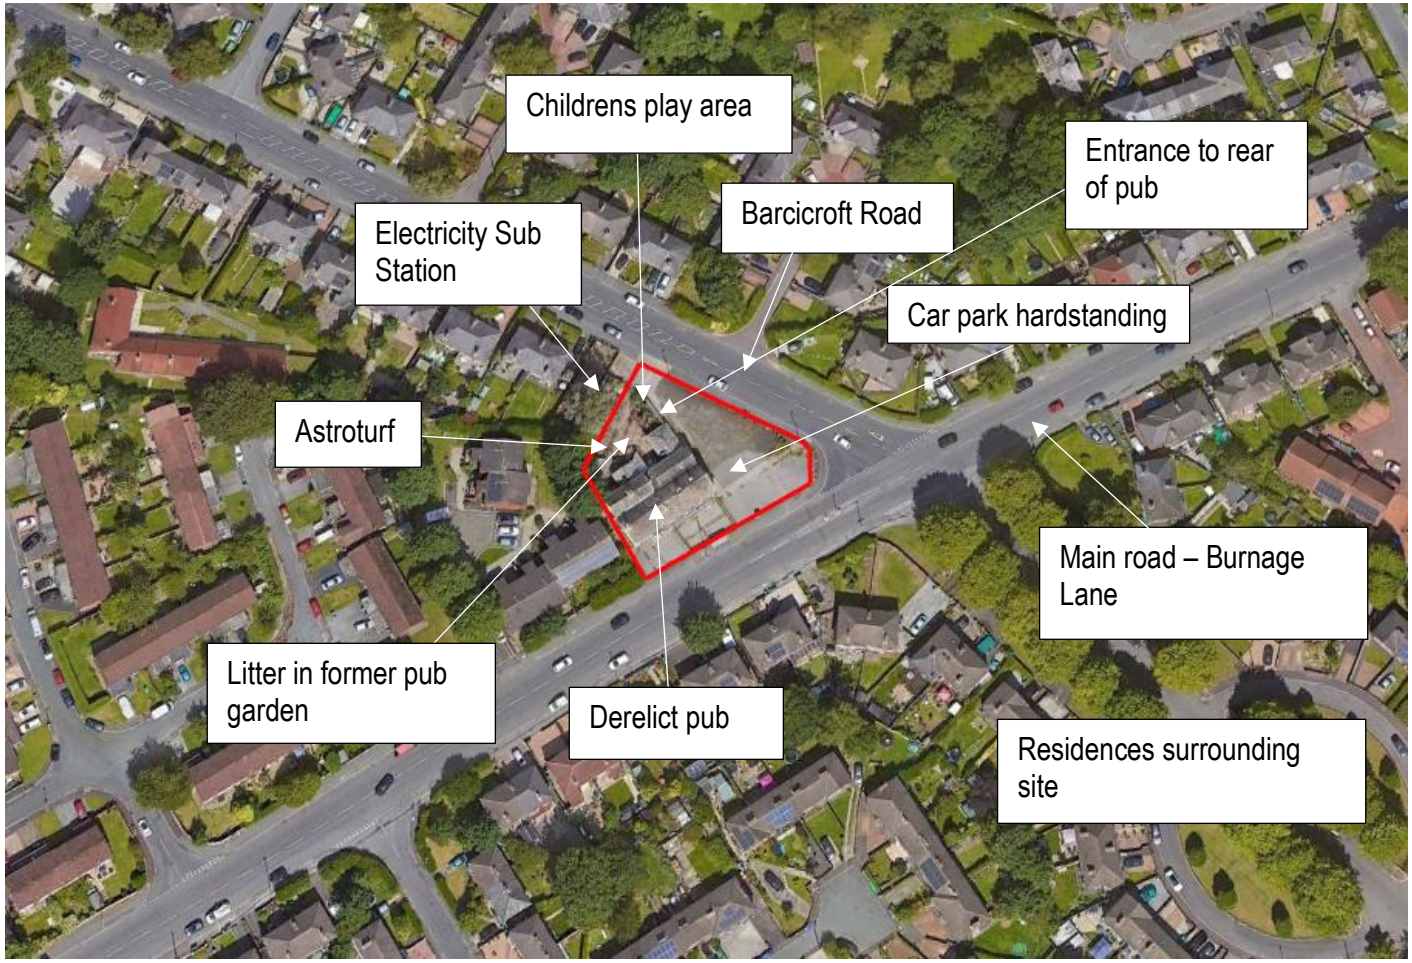
Figure 9 Site Features plan

5.4 There is a derelict pub in the southern section of the site with an associated pub garden to the rear. There is some vegetation to the rear of the pub and a single mature tree. Also, to the rear of the pub there is a large amount of litter including a children's play area, astroturf, broken wooden and metal fencing, waste bins, a donation bin, and a trolley. There is a car park hardstanding to the north and east of the site. Also, to the south of the site there is a small wooden fenced area.

5.5 There are no overhead cables on site. There are three various drainage manhole covers on the site, two of which are located to the rear of the pub and the other near the southern boundary of the site.
