SOUTH ELEVATION MASONRY REPAIR WORKS

Project: **SIM SITE WIDE CAPITAL WORKS**

Drg Title: NEW WAREHOUSE
MASONRY REPAIR ELEVATIONS
SHEET 1

Drawing No.: **SIM-BHE-NW-XX-SK-S-1151**

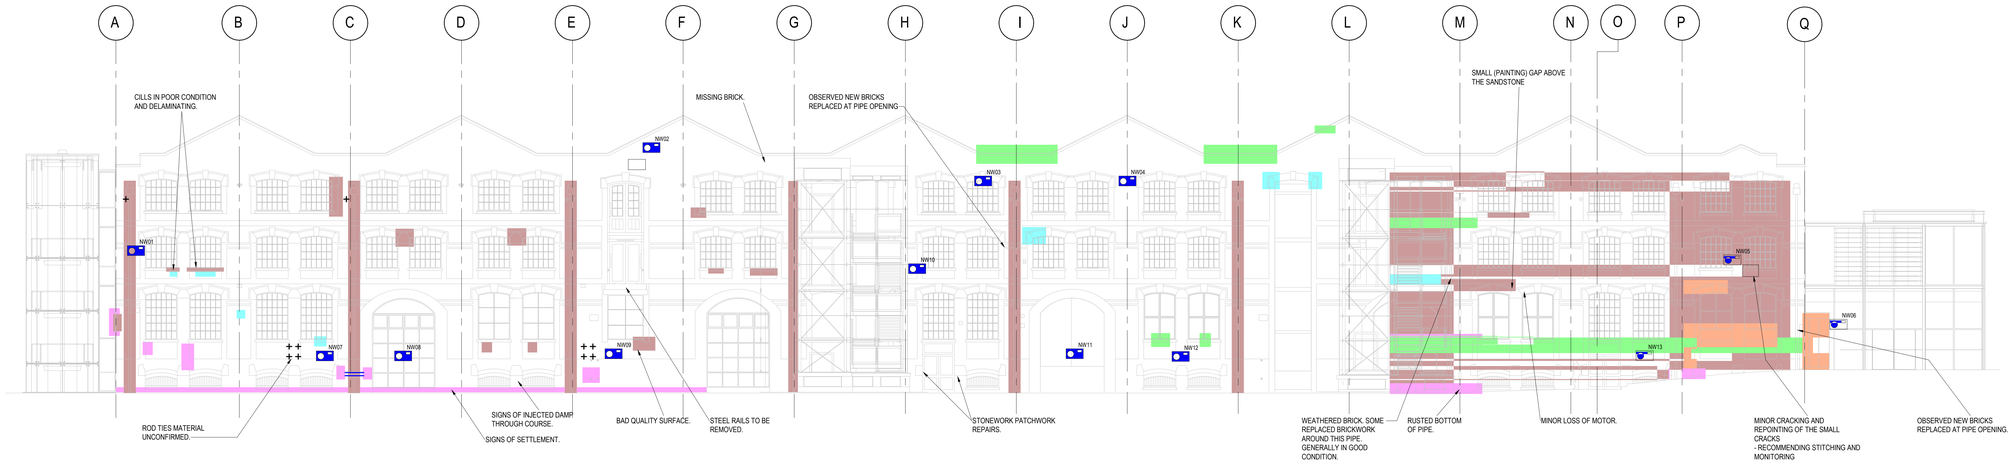
IN GENERAL:
- WINDOWS AND SILLS REPLACED AND IN GOOD CONDITION BUT SHOW SIGNS OF WEATHERING.
- OVERALL BRICKS IN GOOD CONDITION.
- OVERALL STRAIGHT AND SQUARE BRICK LINE FORMATION.
- PATCHWORK BRICKWORK REPLACEMENT / REPEARS SEEN ALONG FACADE.
- BRICK FACADE BROKEN FOR DOWNPIPE INSTALLATION (DATE UNKNOWN). AREAS OF MISSING BRICK WHERE DRAIN PIPES HAVE BEEN POST EMBEDDED INTO FACADE. EDGE OF BRICKWORK CUT OUTS ARE ROUGH AND CRACKED. SOME REQUIRE REPOINTING OR REPLACING.
- AREAS OF BRICK REPOINTING SEE PRIMARILY ALONG THE BOTTOM TWO WINDOW FLOORS.
- STEEL TIES IDENTIFIED NEAR THE TOP OF DOWN PIPES (MATERIAL TBC)
- BOTTOM

PHOTO REF.	PHOTO	DESCPRIPTION	COMMENTS
NW01		DRAINPIPE EMBEDDED INTO BRICK.	
NW02		LINTEL INFILL.	
NW03		NEW BRICK SEEN AT TOP LAYERS OF LINTELS.	
NW04		STONE DELAMINATION.

PHOTO REF.	PHOTO	DESCPRIPTION	COMMENTS
NW05		BROKEN / MISSING PART OF WINDOW SILL.	
NW06		SLIGHTLY DAMP AND SALT EFFLORESCENCE AND MOSS STAINING SANDSTONE.	
NW07		DOUBLE STEEL WORK HORIZONTAL CURVE DETAIL AROUND DRAINPIPE.	
NW08		PATCHWORK BRICK REPAIRS AND AREAS OF REPOINTING.

PHOTO REF.	PHOTO	DESCPRIPTION	COMMENTS
NW09		ROD TIES MATERIAL UNCONFIRMED - CRACKING IDENTIFIED THROUGH TO GROUND AND DIPPED AT GROUND LEVEL.	
NW10		BRICK AND MOTOR IN GOOD CONDITION SHOWING SIGNS OF REPOINTING.	
NW11		NEW BRICKWORK INKEEPING WITH BLUE BRICK FACADE.	
NW12		SMALL FIXINGS STICK OUT.

PHOTO REF.	PHOTO	DESCPRIPTION	COMMENTS
NW13		MISSING BRICK AND CRACKING IN WALL AND RAILING.
