2&3 Angel Square

Ground Engineering Summary Report

050930-BH-XX-XX-RP-GE-0001

11 May 2023

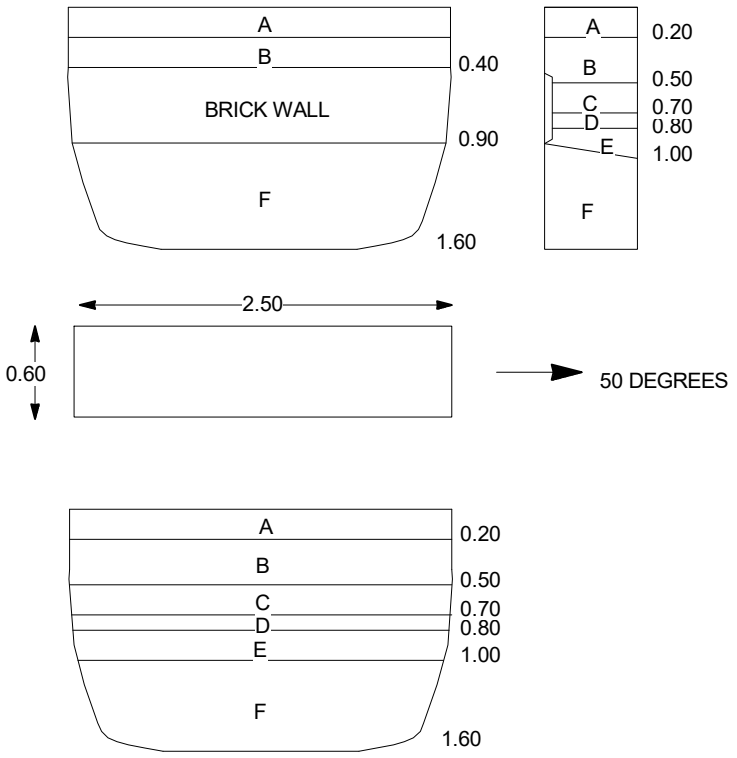
Contract:		Client:		Trial Pit:
2 & 3 Angel Square		**MEPC Ltd**		**TP102**
Contract Ref:	Start: **22.07.21**	Ground Level:	National Grid Co-ordinate:	Sheet:
765325	End: **22.07.21**	**47.10**	**E:384410.5 N:399004.2**	**2** of **2**

c	MADE GROUND: Bricks, presumed to be a brick foundation.

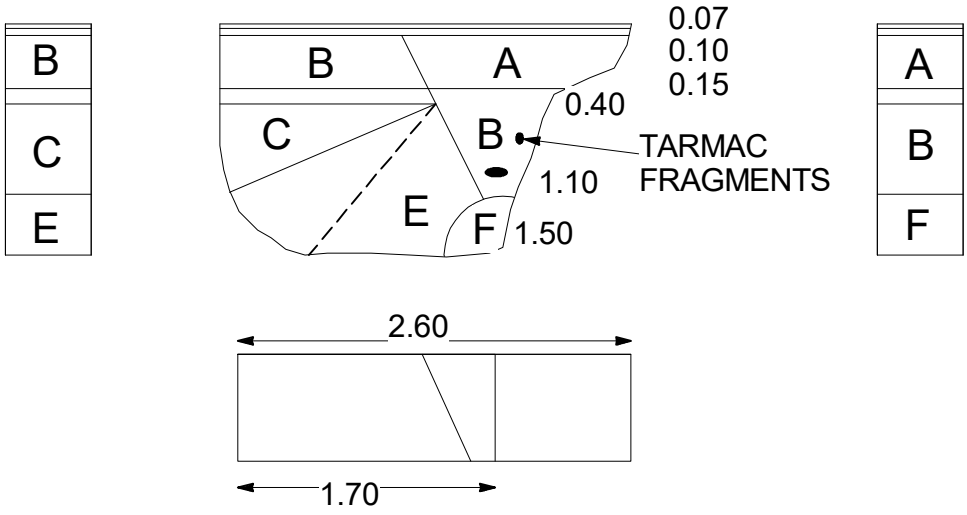
Contract:		Client:		Trial Pit:
2 & 3 Angel Square		**MEPC Ltd**		**TP110**
Contract Ref:	Start: **20.07.21**	Ground Level:	National Grid Co-ordinate:	Sheet:
765325	End: **20.07.21**	**44.40**	**E:384342.1 N:398981.4**	**2** of **2**

A number of obstructions were recorded within the Made Ground during the SSL 2021 GI which are likely to be associated with relic substructure from historic buildings located on site, most notably a 3.2 m deep chamber in TP110a. This chamber and any other insitu obstructions will require removal prior to installation of the new foundations.

It should also be noted that during the SSL 2021 GI a ~3.2 m below ground chamber was encountered in TP110a. This is recorded on any previous surveys, therefore it is recommended that further investigation is undertaken to understand if the existing chamber / infrastructure is still in use and requires diverting, or if it is part of an abandoned system to be grubbed up/ grouted up.
