NORTH ELEVATION MASONRY REPAIR WORKS

Project: **SIM SITE WIDE CAPITAL WORKS**

Drg Title: NEW WAREHOUSE
MASONRY REPAIR ELEVATIONS
SHEET 2

Drawing No. **SIM-BHE-NW-XX-DR-SK-S-1152**

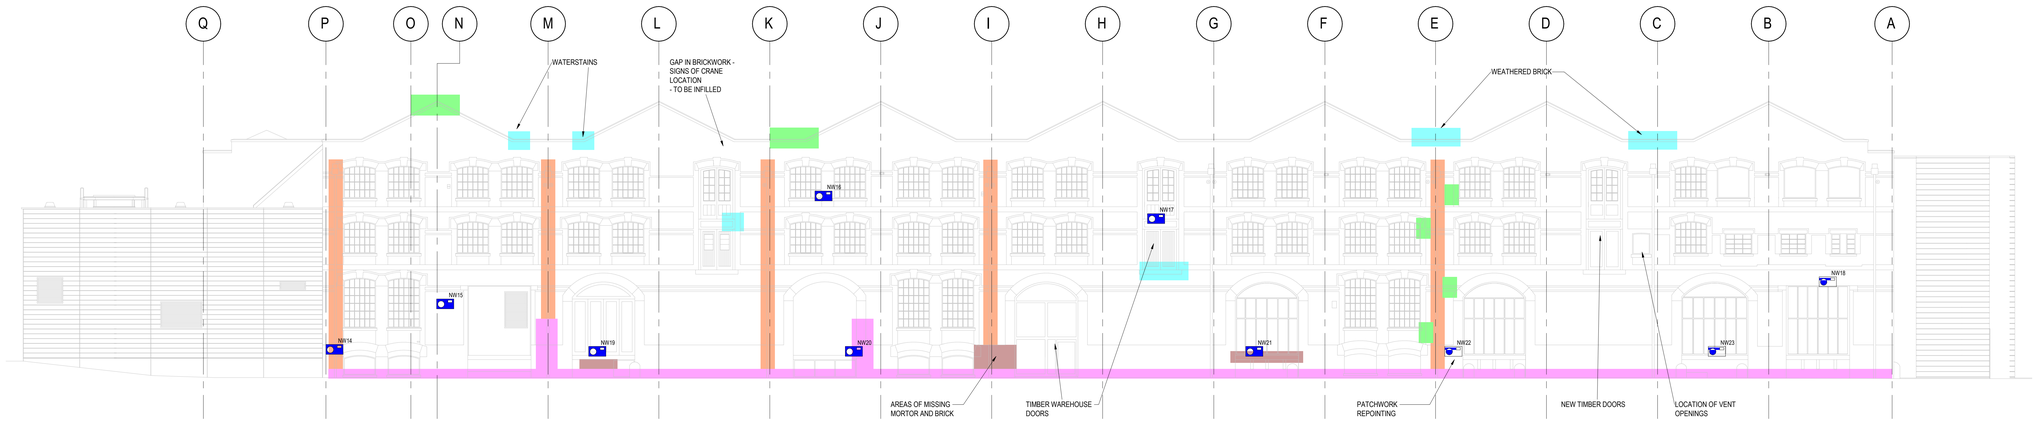
IN GENERAL:
- WINDOWS AND SILLS REPLACED AND IN GOOD CONDITION BUT SHOW SIGNS OF WEATHERING.
- OVERALL BRICKS IN GOOD CONDITION.
- OVERALL STRAIGHT AND SQUARE BRICK LINE FORMATION.
- PATCHWORK BRICKWORK REPLACEMENT / REPEARS SEEN ALONG FACADE.
- BRICK FACADE BROKEN FOR DOWNPIPE INSTALLATION (DATE UNKNOWN). AREAS OF MISSING BRICK WHERE DRAIN PIPES HAVE BEEN POST EMBEDDED INTO FACADE. EDGE OF BRICKWORK CUT OUTS ARE ROUGH AND CRACKED, SOME REQUIRE REPOINTING OR REPLACING.
- AREAS OF BRICK REPOINTING SEE PRIMARILY ALONG THE BOTTOM TWO WINDOW FLOORS.
- STEEL TIES IDENTIFIED NEAR THE TOP OF DOWN PIPES (MATERIAL TBC)
- BOTTOM

PHOTO REF.	PHOTO	DESCPRIPTION	COMMENTS
NW14		DRAINPIPE EMBEDDED INTO BRICK.	
NW15		POOR QUALITY BRICKS SEEN ACROSS ELEVATION.	
NW16		WINDOWS IN POOR CONDITION.	
NW17		STEEL CRANE RETAINED .	
NW18		POOR CONDITION OF CAST IRON UNDERSIDE REQUIRING BLAST OFF AND REPAINTING.	
NW19		DELAMINATION OF STONE WORK AND AREAS OF MISSING BRICK.	
NW20		CRACK BRICKS OBSERVED ALONG THE BASE OF BUILDING. BRICKS REQUIRING REPOINTING.	
NW21		STEEL AND TIMBER SILLS IN POOR CONDITION.	
NW22		EVIDENCE OF SALT BRICK INDICATING DRAINAGE LEAK.	
NW23		BOLLARDS AND STEEL STUBS ALONG LINE.
