South Elevation as Existing Current Condition - Sheet 4

SCIENCE+ INDUSTRY MUSEUM

Project Title	NEW WAREHOUSE
Client	SCIENCE & INDUSTRY MUSEUM
Location	MANCHESTER
Drawing Title	New Warehouse South Elevation As Existing Current Condition - Sheet 4
Date	23/11/22
Checked	AS
Scale	1:50
Orig Paper Size	A1
Status	**PLANNING**

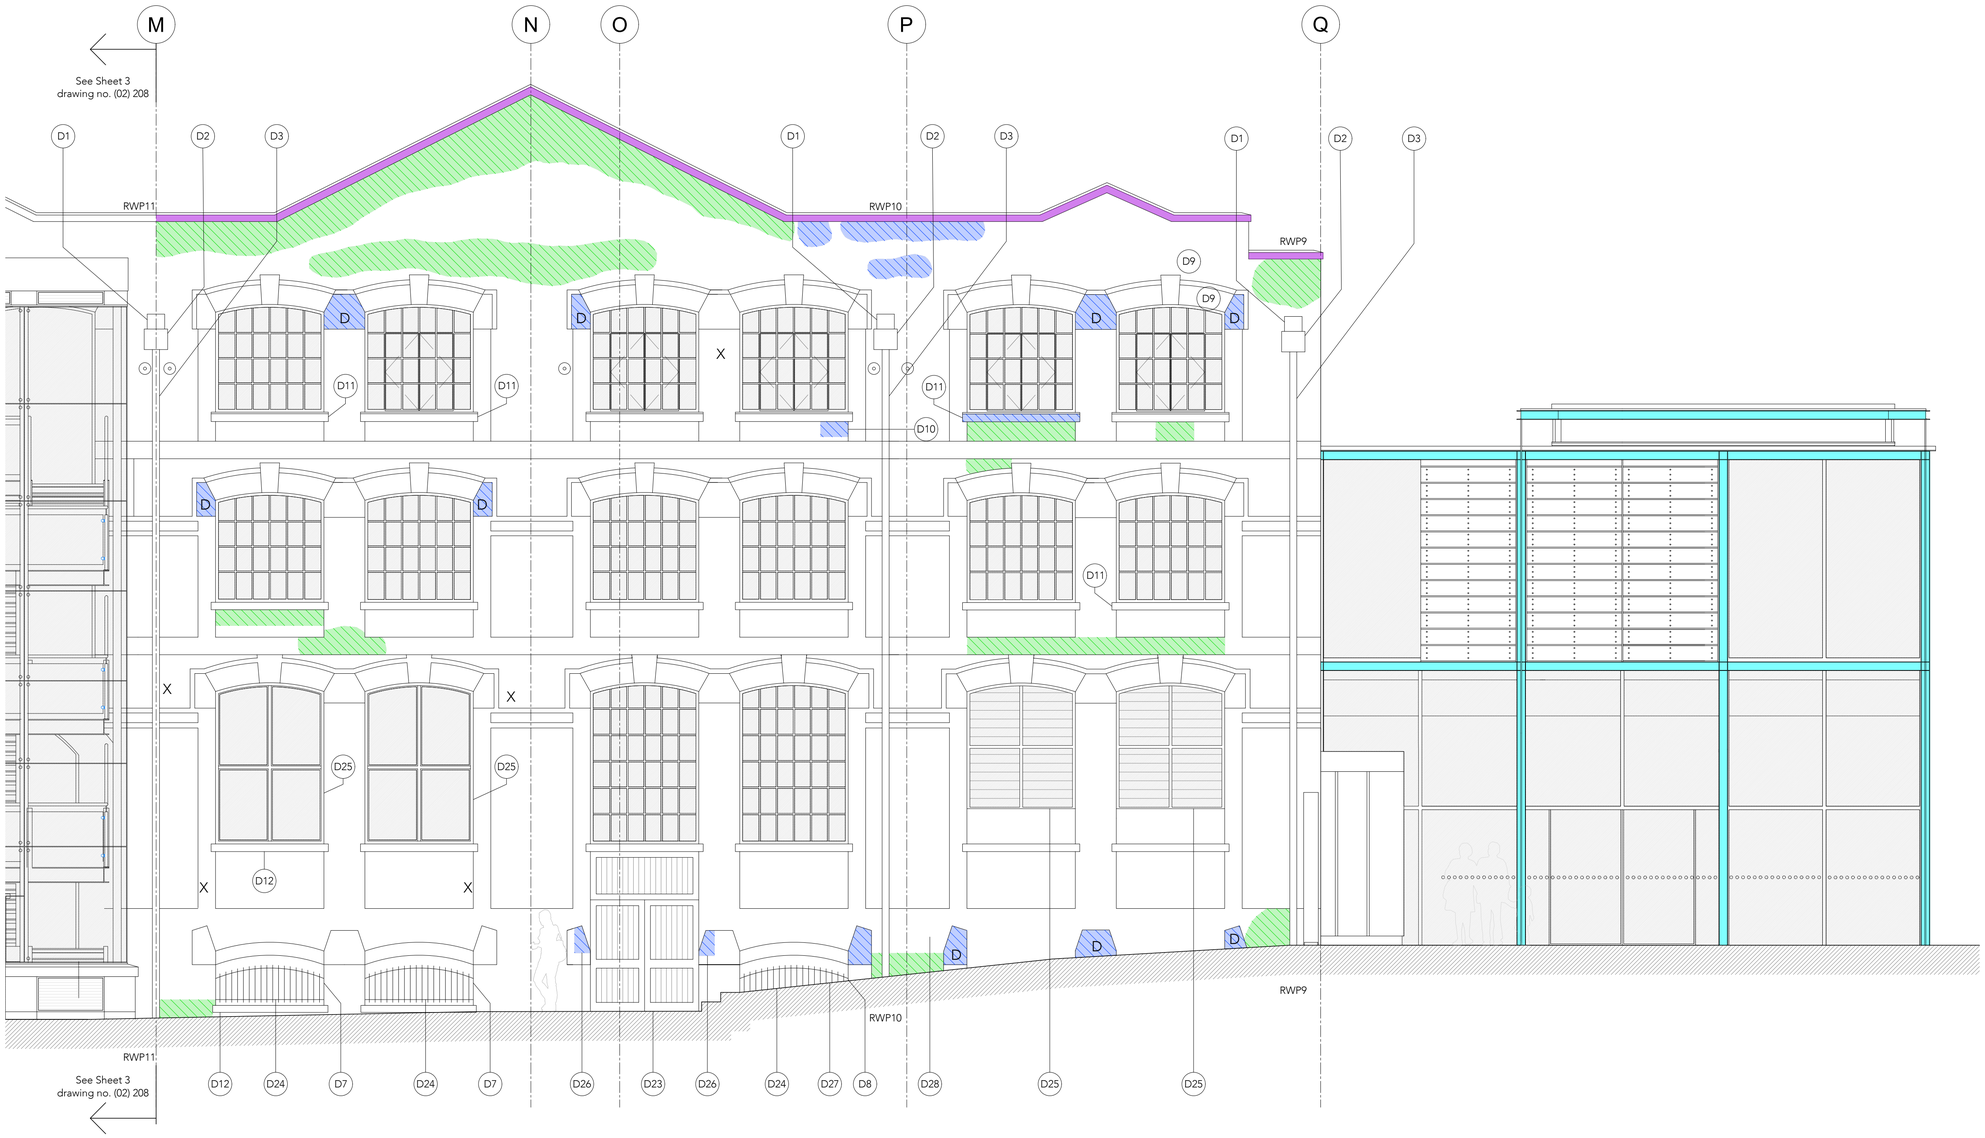
Open Mortar Joints	D1	Lead Chute	D8	Iron Railings with Glazed Metal Framed Window	D15	Timber Framed Window Finishes Deteriorating	D22	Paint Splatter
	Defective Masonry / Stonework	D2	Hopper	D9	Spalled Brick	D16	Stepped Vertical Cracking Due to Rust Jacking	D23	Flaking / Blistered Decorations
	Open Mortar Joints Across Copings	D3	UPVC Downpipe	D10	Defective Bricks	D17	Remnants of Ferrous Bracketing to Cill	D24	Defective / Corroded Railings
	Cementitious Render	D4	CCTV System	D11	Loss of Detail Across Cill	D18	Timber Framed Window	D25	Modern Metal Framed with Glass Louvres
	Defective Steel Decorations	D5	Flood Light	D12	Fracture Through Cill	D19	Blistered & Flaking Decorations and Localised Decay & Distortion	D26	Previous Repairs of Poor Quality
D	Delamination	D6	Rodding Point	D13	Poor Quality Masonry	D20	Vegetation	D27	Glazed Metal Framed Window in Poor Condition
X	Ferrous / Steel Embedded Fixing Elements	D7	Iron Railings with Timber Louvres Beyond	D14	Decay Across Window Frames	D21	Spalling to Soffit of Lintel	D28	Stepped Vertical Crack
