PHASE 2 SITE INVESTIGATION

Proposed Mayfield Park, Manchester

Mayfield Partnership Ltd

December 2020

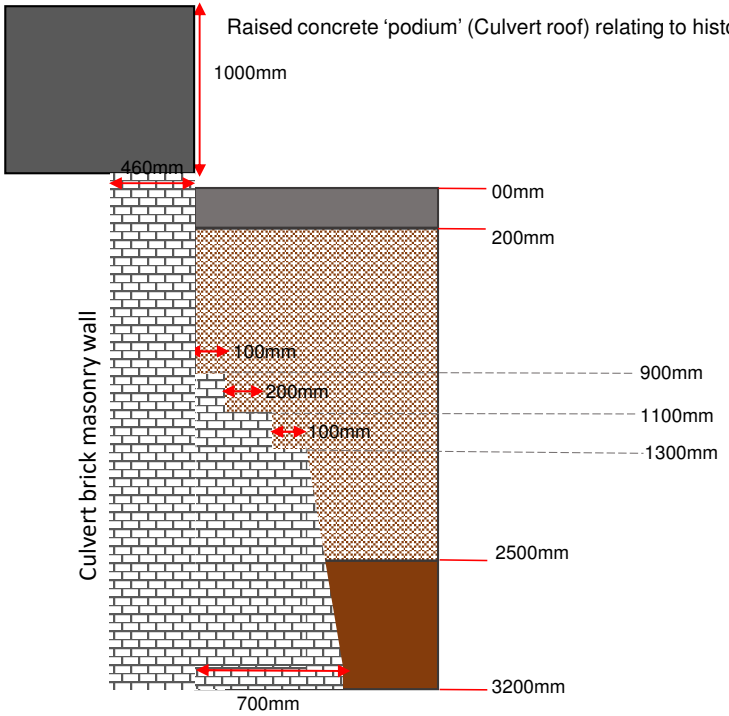
Trial Pit ref: PH304

Stepped brick masonry

Raised Concrete 'podium', Culvert entrance. Formed part of historical building

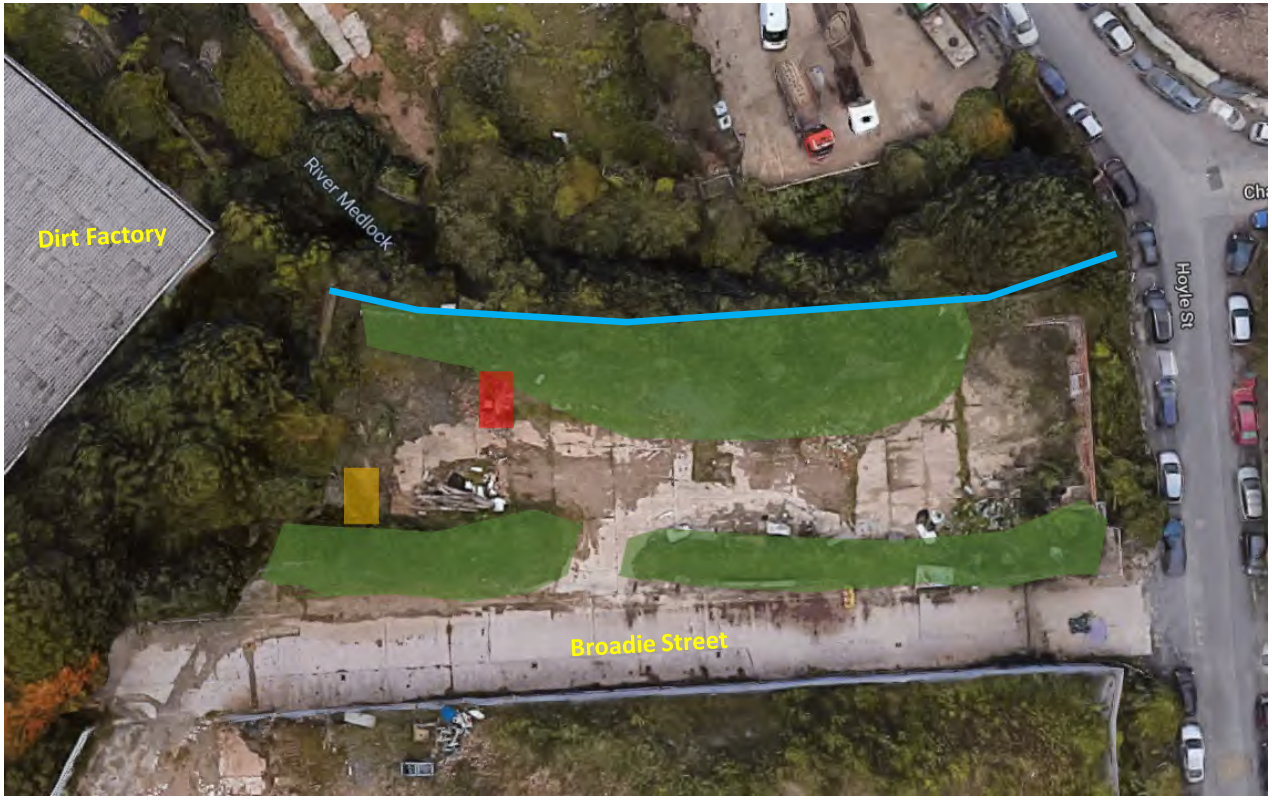
Mayfield Park : Britannia Brewery, Broadie Street

Previous sink hole (may also relate to basement feature?)

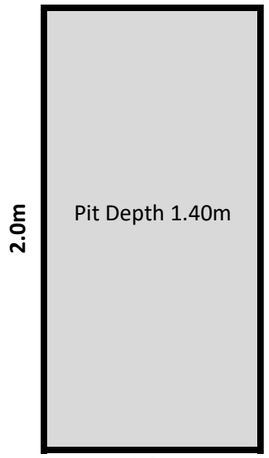
Photograph of Test Pit

SA1	Test 1	Test 2	Test 3
Start	0.55	0.52	0.56
5 sec	0.63	0.59	0.57
10 sec	0.71	0.66	0.61
15 sec	0.8	0.74	0.66
20 sec	0.88	0.83	0.69
30 sec	0.95	0.91	0.72
1 min	1.08	1.03	0.81
2 min	1.15	1.11	0.86
3 min	1.18	1.17	0.93
4 min	1.2		0.98
5 min	END	1.22	1.04
10 min			1.16
15 min			1.22
30 min			END

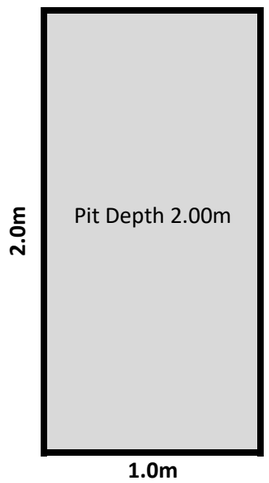
Photograph of Test Pit

SA2	Test 1	Test 2	Test 3
Start	0.9	0.95	0.9
5 sec	1	1.02	0.95
10 sec	1.08	1.09	0.99
15 sec	1.16	1.13	1.04
20 sec	1.25	1.2	1.098
30 sec	1.3	1.26	1.11
1 min	1.65	1.6	1.15
2 min	1.79	1.71	1.2
3 min	1.9	1.8	1.37
4 min		1.88	1.52
5 min	1.94	END	1.6
10 min			1.7
15 min			1.79
20 min			1.85
30 min			1.9

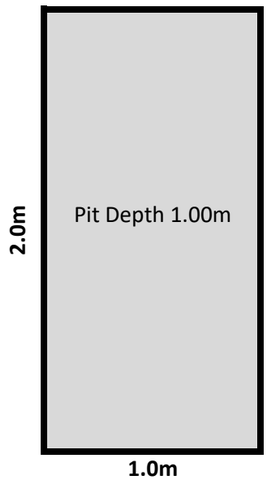
Photograph of Test Pit

SA3	Test 1	Test 2	Test 3
Start	0.1	0.12	0.1
5 sec	0.12	0.14	0.11
10 sec	0.13	0.15	0.12
15 sec	0.14	0.15	0.13
20 sec	0.15	0.16	0.14
30 sec	0.16	0.17	0.15
1 min	0.19	0.18	0.19
2 min	0.26	0.24	0.25
3 min	0.31	0.28	0.29
4 min	0.33	0.32	0.31
5 min	0.35	0.34	0.33
10 min	0.42	0.4	0.39
15 min	0.44	0.43	0.42
20 min	0.48	0.46	0.46
30 min	0.57	0.54	0.55
40 min	0.62	0.58	0.57
50 min	0.71	0.66	0.63
60 min	0.76	0.72	0.7
90 min	0.89	0.87	0.85

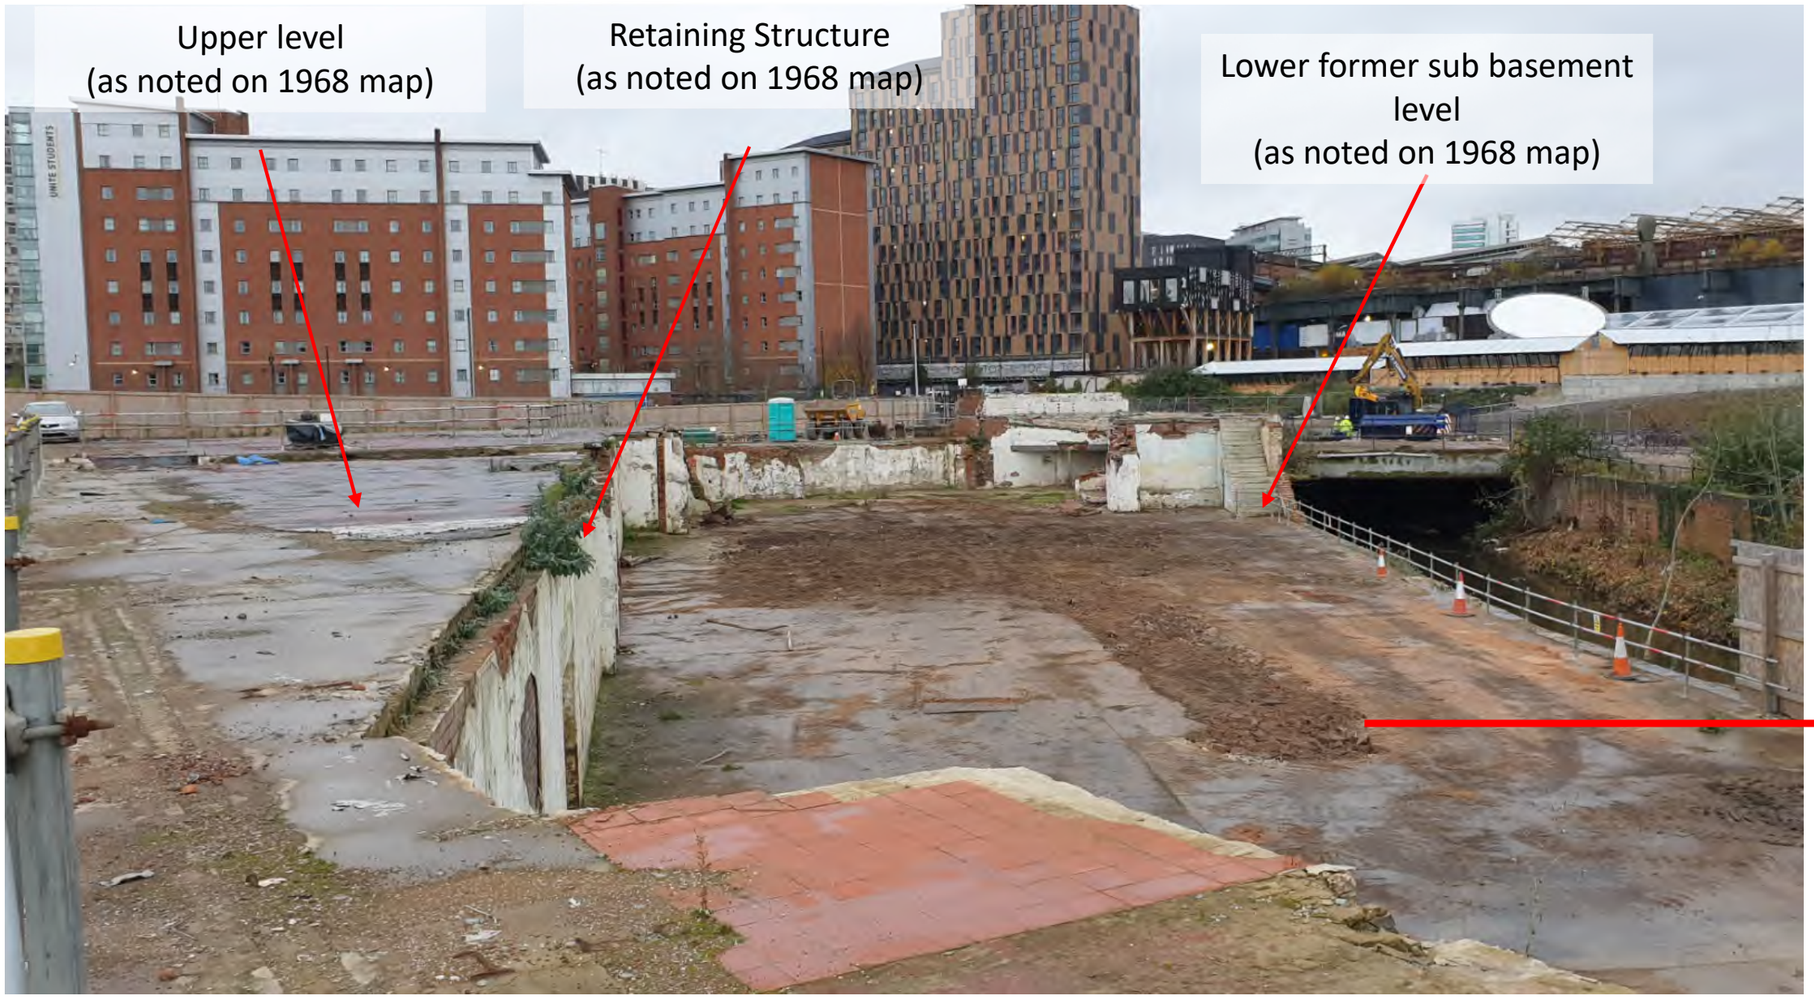
JOB NO	4153	SKETCH NO	TN101	DRAWN BY :AS 03 02 2021
PROJECT TITLE	Mayfield Park, Manchester	SKETCH TITLE	Current aerial view of site showing approx. developments and tannery operations

Looking west across the former Tannery site in October 2020 showing extent of upper and lower levels & recently completed archeological trenches
