EAST AND WEST ELEVATION MASONRY REPAIR WORKS

Project: **SIM SITE WIDE CAPITAL WORKS**

Drg Title: NEW WAREHOUSE
MASONRY REPAIR ELATIONS
SHEET 3

Drawing No.: **SIM-BHE-NW-XX-DR-SK-S-1153**

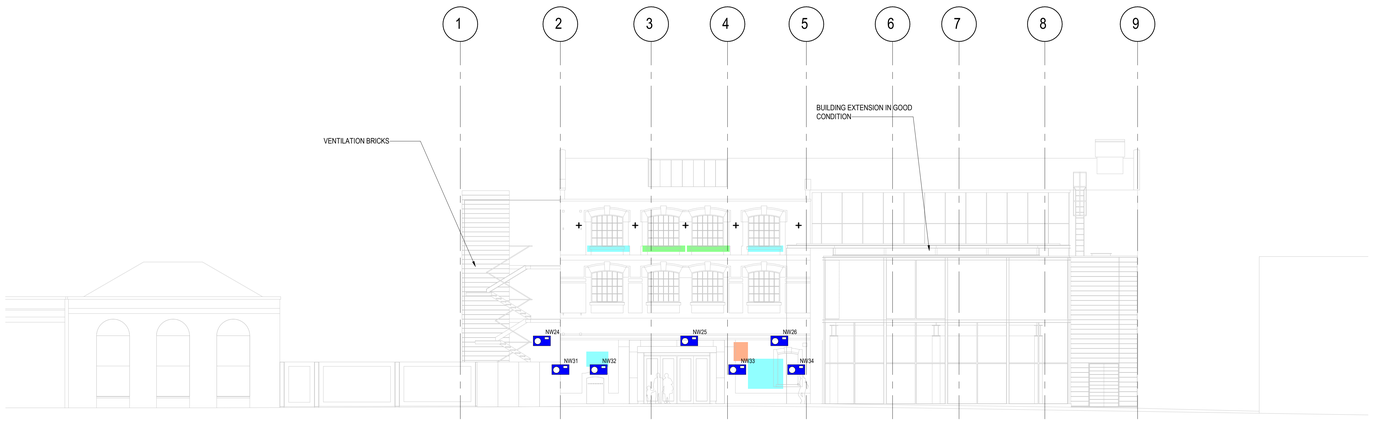
EAST ELEVATION

IN GENERAL:
- WINDOWS AND SILLS REPLACED AND IN GOOD CONDITION BUT SHOW SIGNS OF WEATHERING.
- OVERALL BRICKS IN GOOD CONDITION.
- OVERALL STRAIGHT AND SQUARE BRICK LINE FORMATION.
- PATCHWORK BRICKWORK REPLACEMENT / REPEARS SEEN ALONG FACADE.
- BRICK FACADE BROKEN FOR DOWNPIPE INSTALLATION (DATE UNKNOWN). AREAS OF MISSING BRICK WHERE DRAIN PIPES HAVE BEEN POST EMBEDDED INTO FACADE. EDGE OF BRICKWORK CUT OUTS ARE ROUGH AND CRACKED. SOME REQUIRE REPOINTING OR REPLACING.
- AREAS OF BRICK REPOINTING SEE PRIMARILY ALONG THE BOTTOM TWO WINDOW FLOORS.
- STEEL TIES IDENTIFIED NEAR THE TOP OF DOWN PIPES (MATERIAL TBC)
- BOTTOM
