PHASE 2 SITE INVESTIGATION

Proposed Mayfield Park, Manchester

Mayfield Partnership Ltd

December 2020

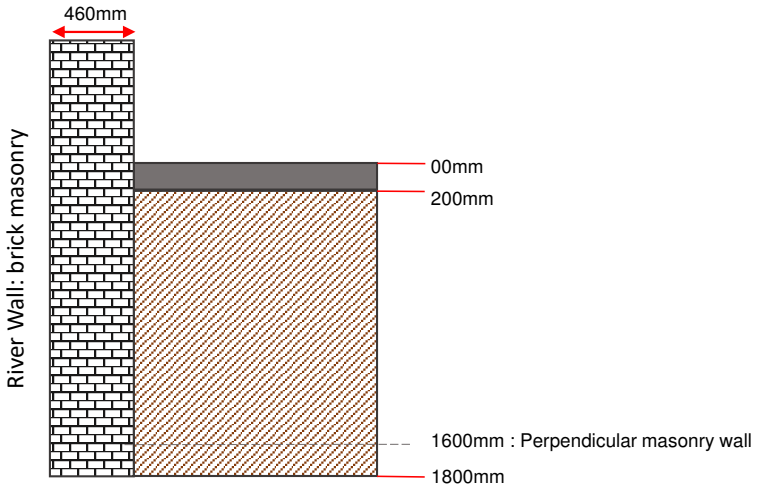
- Topsoil/made ground
- MADE GROUND - Slightly clayey sandy fine coarse sub angular to angular GRAVEL of brick and asbestos tile

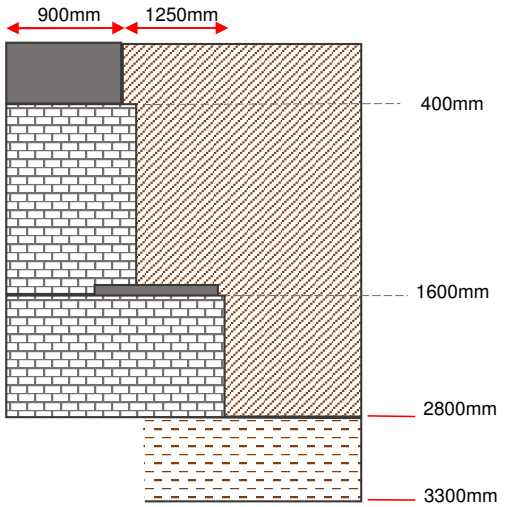
- MADE GROUND – COPING STONE
- MADE GROUND – Greyish brown clayey angular fine to coarse brick, concrete GRAVEL with high cobble content of brick and rare ash
- Weathered sandstone recovered as sandstone gravel
