North Elevation as Existing Current Condition - Sheet 4

Project Title	NEW WAREHOUSE
Client	SCIENCE & INDUSTRY MUSEUM
Location	MANCHESTER
Drawing Title	New Warehouse North Elevation As Existing Current Condition - Sheet 4
Date	23/11/22
Checked	AS
Scale	1:50
Orig Paper Size	A1
Status	**PLANNING**

Project:	Origin:	Zone:	Level:	Type:	Disc:	Number:	Rev:
9488 -	BUT -	NW	XX -	DR -	A -	(02)204 -	P1

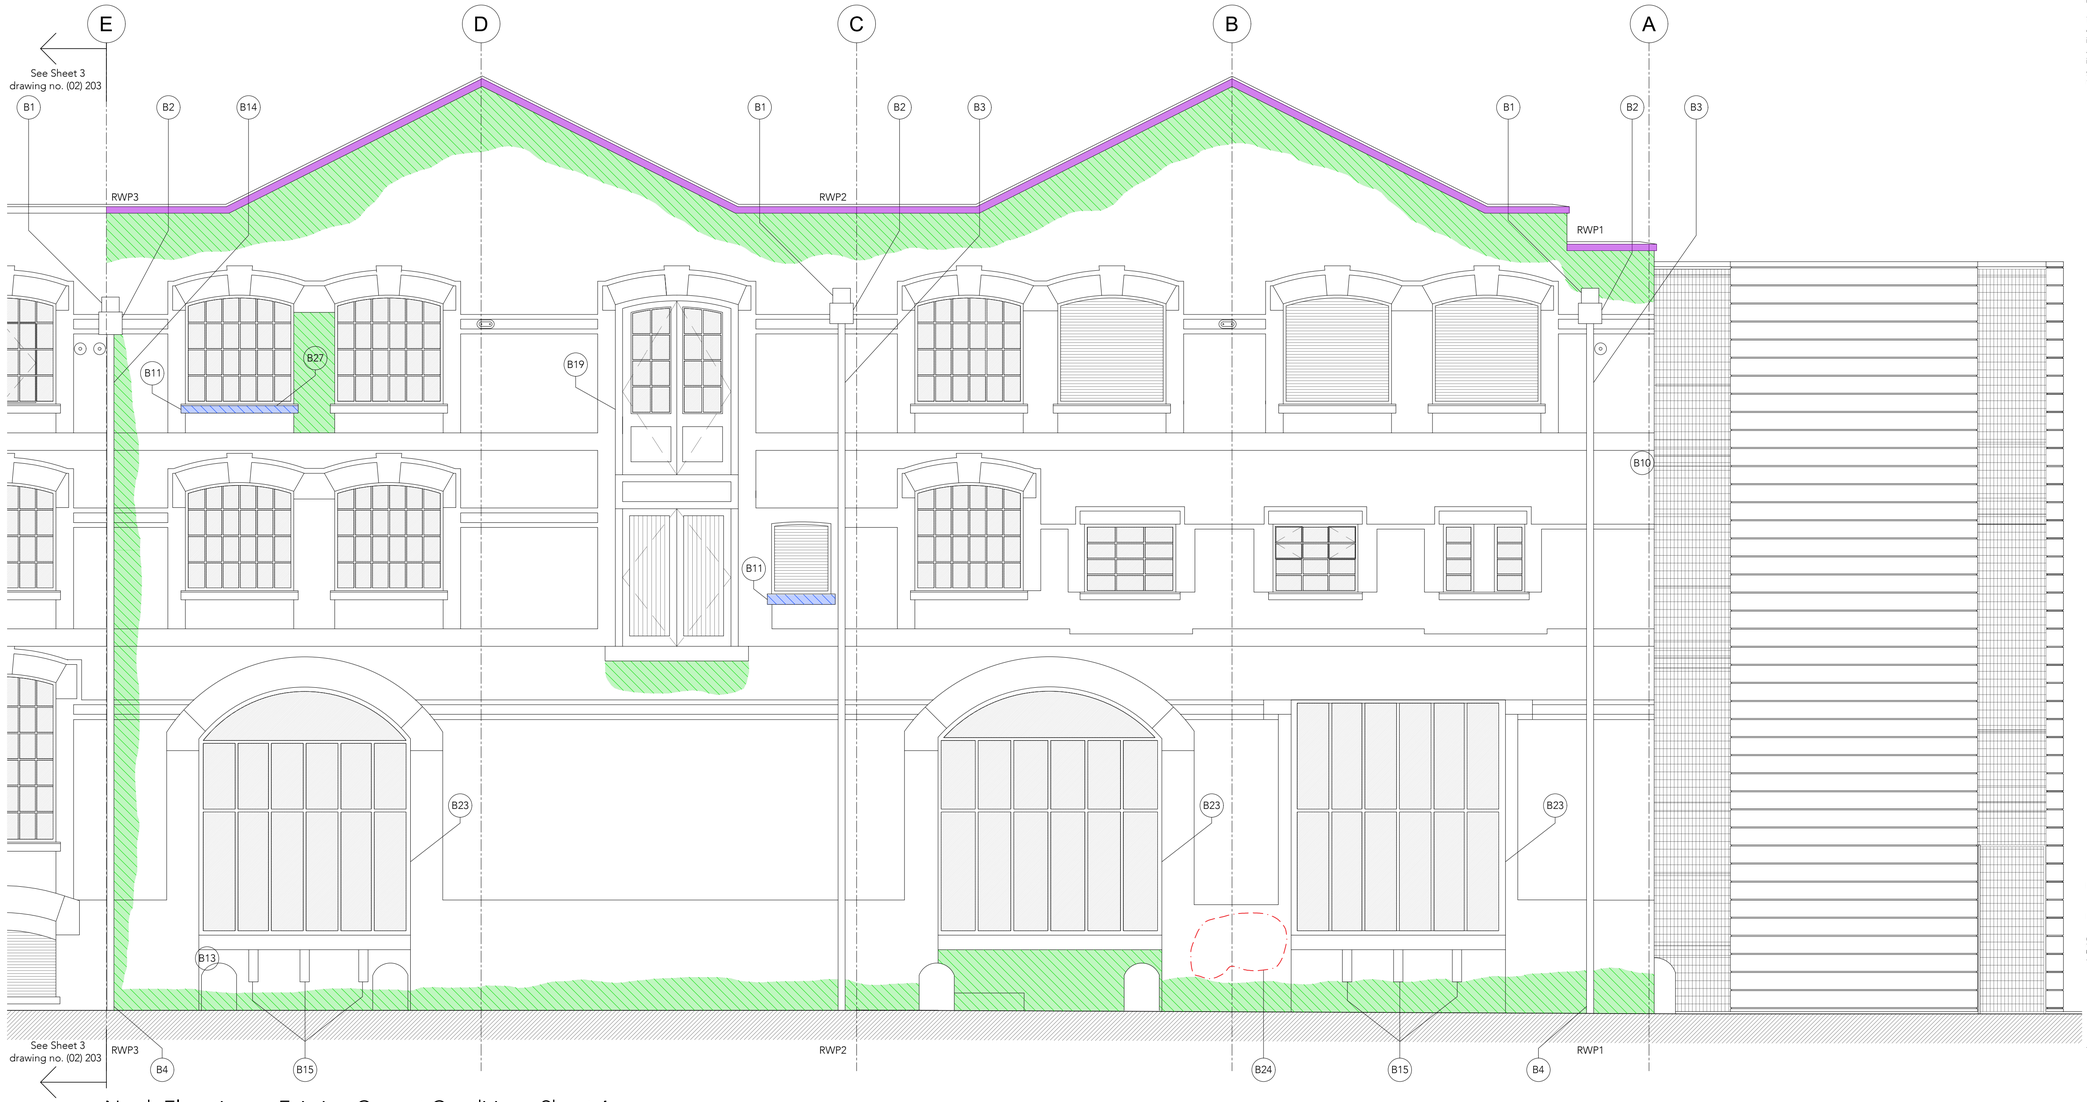
Open Mortar Joints	B1	Lead Chute	B8	Evidence of Injected DPC	B15	Corroded Ferrous Brackets	B22	Vertical Boarding
	Defective Masonry / Stonework	B2	Hopper	B9	Missing Brick	B16	Decayed & Rotten Bumper Cill	B23	Defective Decorations
	Open Mortar Joints Across Copings	B3	UPVC Downpipe	B10	Defective Bricks	B17	Opening	B24	Graffiti
	Cementitious Render	B4	Rodding Point	B11	Loss of Detail Across Cill	B18	Defective Decorations to Ferrous Plate / Angle	B25	Aluminium Louvres
	Defective Steel Decorations	B5	Spalled & Delamination Across Cill	B12	Fracture Through Cill	B19	Defective Decorations Across Doorsets	B26	Heavily Soiled & Saturated Fabric
D	Delamination	B6	Split / Defective Timber Louvre	B13	Hole	B20	Vegetation	B27	Moss on Cills
X	Ferrous / Steel Embedded Fixing Elements	B7	Iron Railings with Timber Louvres Beyond With Softwood Frame & Mesh to Front	B14	Cast Aluminium Downpipe	B21	Spalling to Soffit of Lintel	B28	Stepped Vertical Crack
