Client: Engie

Drawing No: 011

Job Title: Manox

Drawing Title: Tar Channel and DNAPL Manox Site

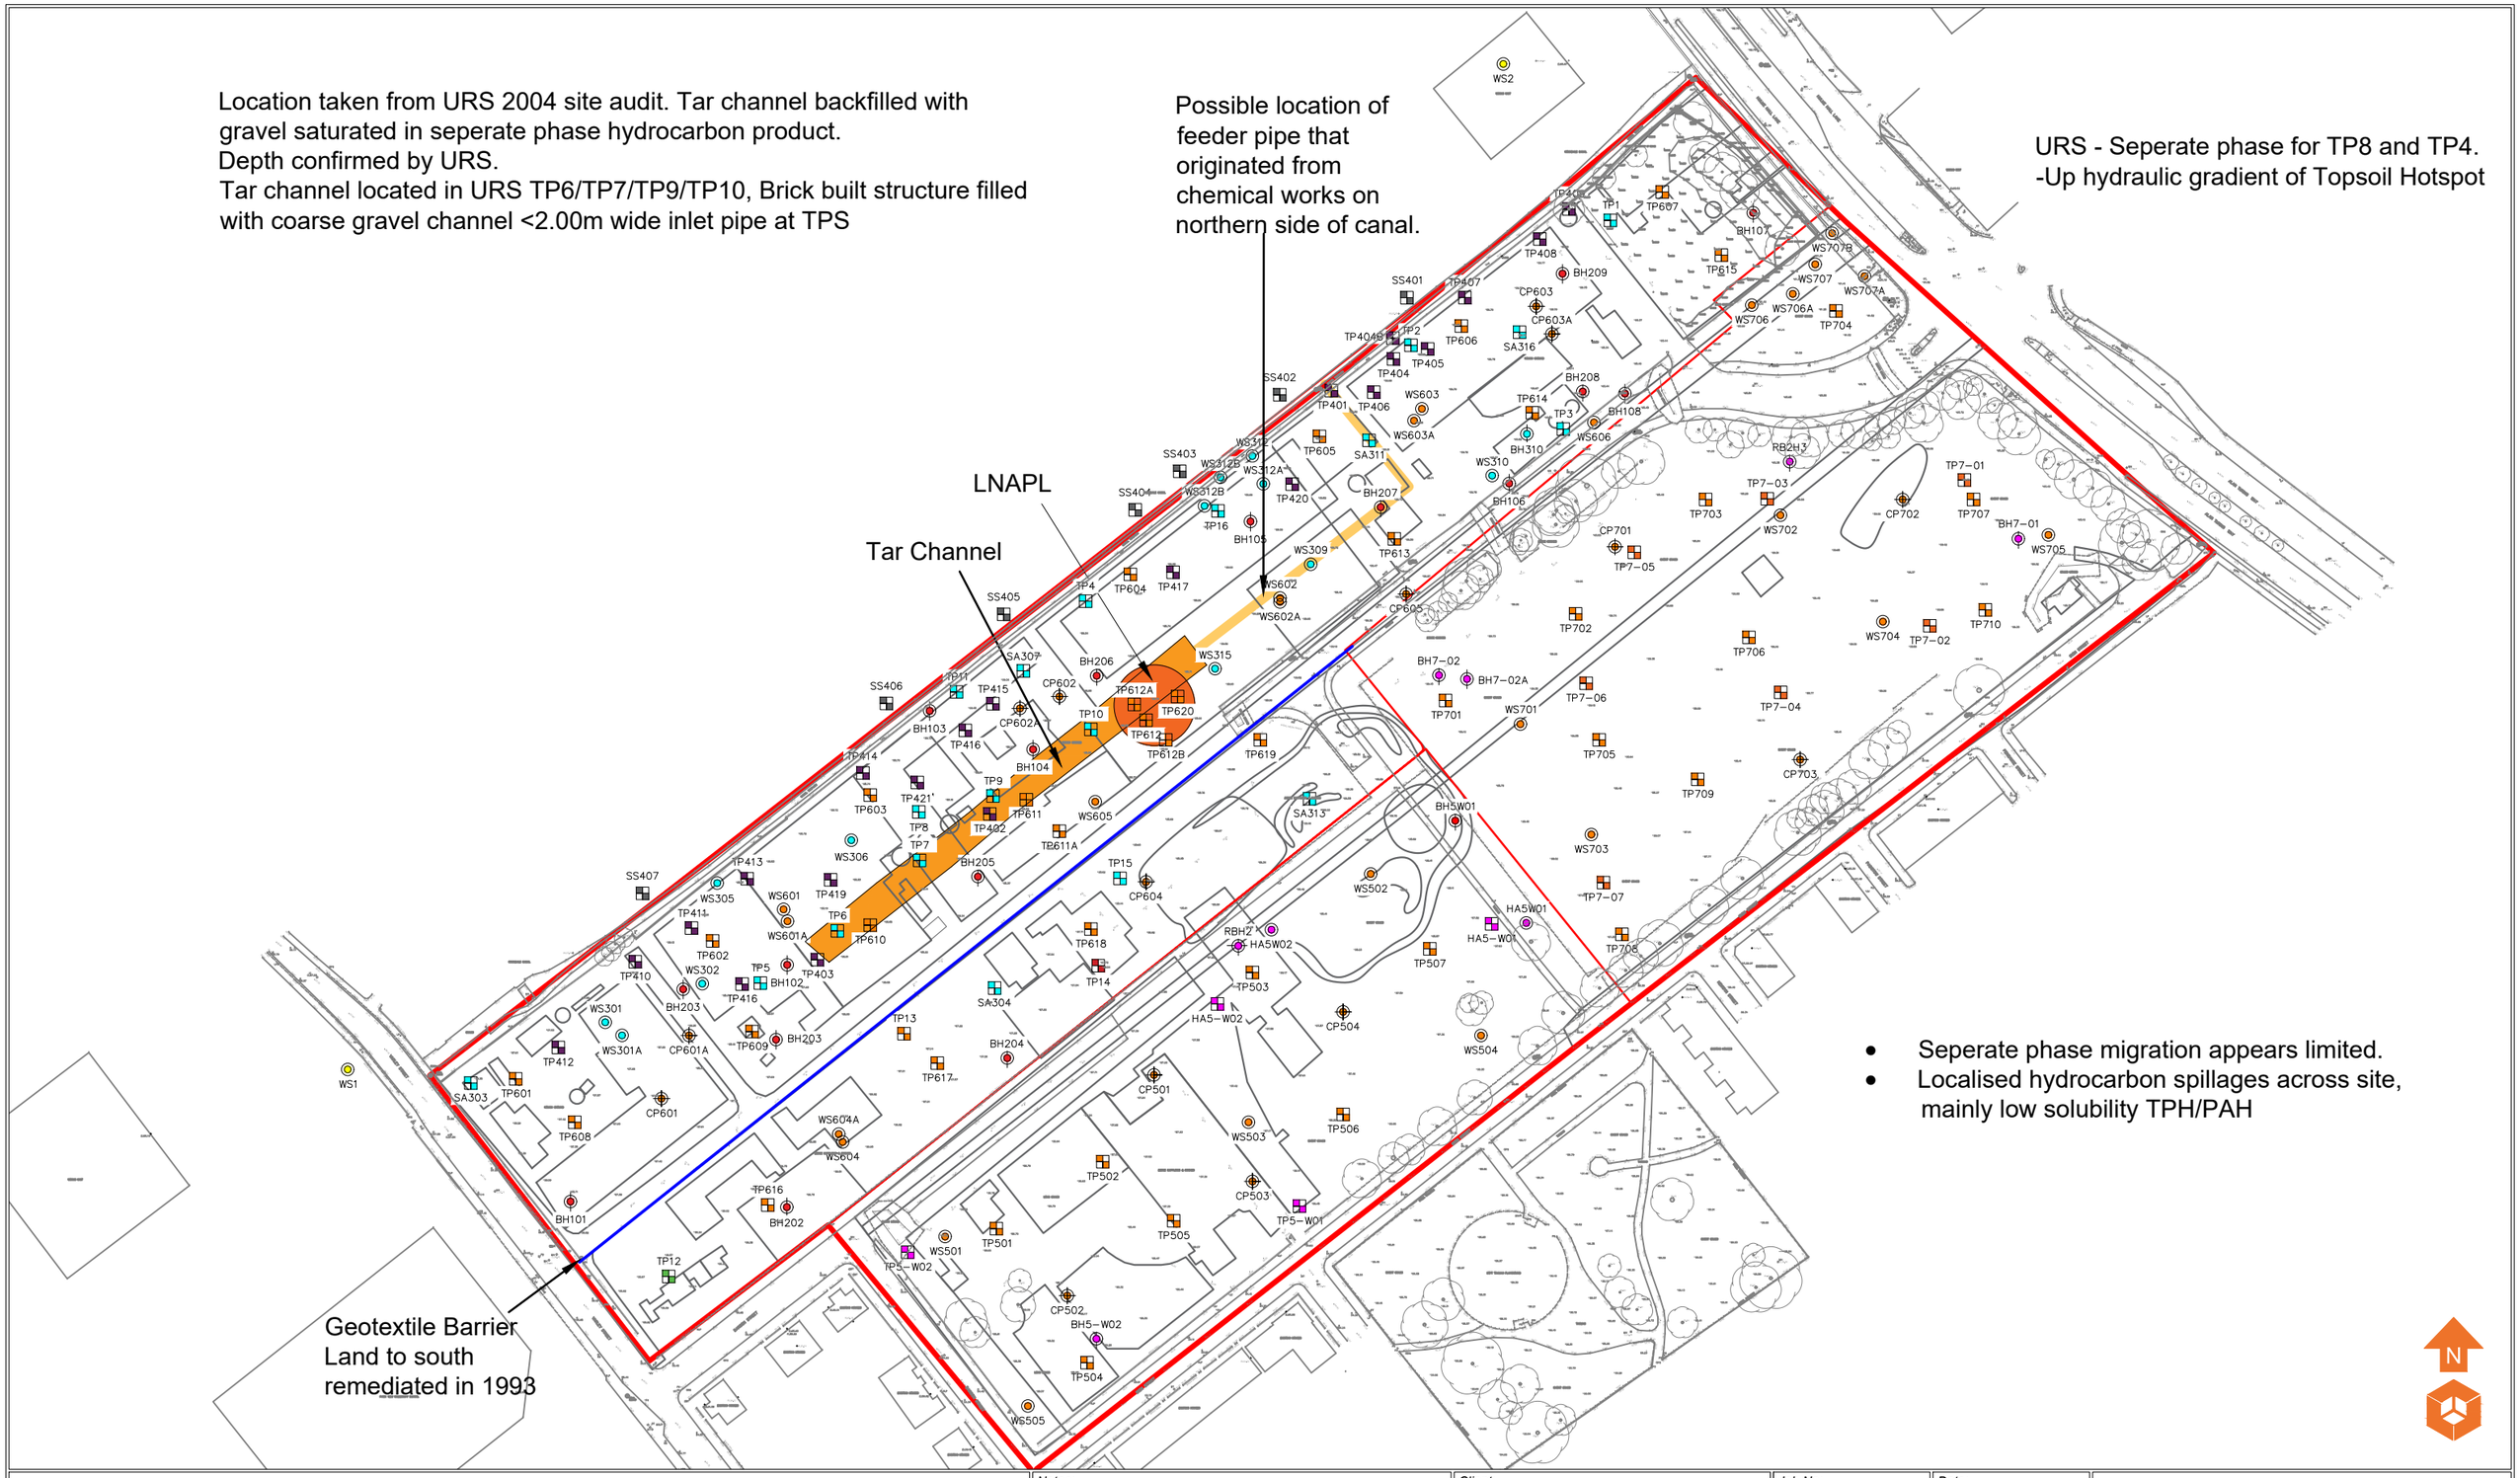
Location taken from URS 2004 site audit. Tar channel backfilled with gravel saturated in seperate phase hydrocarbon product.
Depth confirmed by URS.
Tar channel located in URS TP6/TP7/TP9/TP10, Brick built structure filled with coarse gravel channel <2.00m wide inlet pipe at TPS

Possible location of feeder pipe that originated from chemical works on northern side of canal.

URS - Seperate phase for TP8 and TP4.
-Up hydraulic gradient of Topsoil Hotspot

Geotextile Barrier
Land to south remediated in 1993

- Seperate phase migration appears limited.
- Localised hydrocarbon spillages across site, mainly low solubility TPH/PAH
