Technical Note

Blackley, Manchester

Dilapidation Survey

Our reference: BWJ/260251/TN01 – Rev00

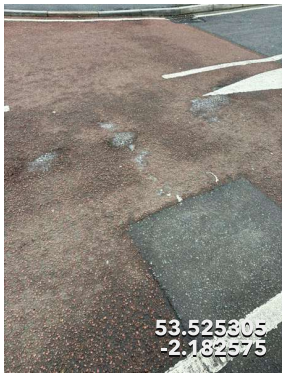
Photo 55

Hinchley Rd
Resurfacing patches and potholes present along speed table.

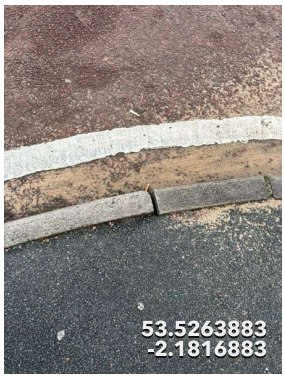
Photo 84

Hinchley Rd
Lining worn and resurface patches long speed table. Ironworks sunken below carriageway.

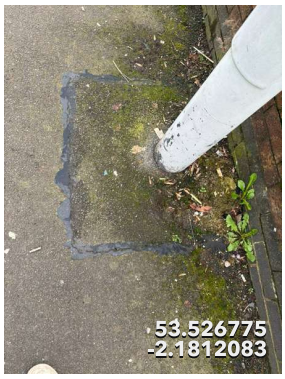
Cracking forming at edges or ironworks.

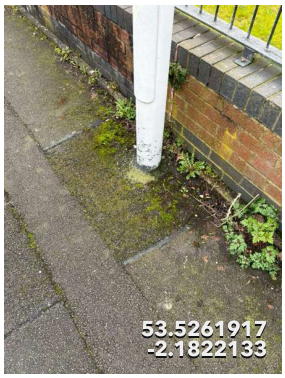
Photo 114

Hinchley Rd
Footway crazing at back of kerb.

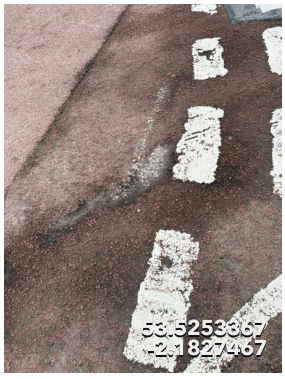
Crazing on carriageway around gully

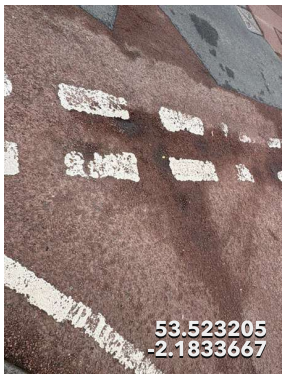
Photo 162

Ainsbrook Avenue
Resurfacing patches and potholes along surface of speed table. Cracks formed at construction joint of carriageway and resurfacing patch.

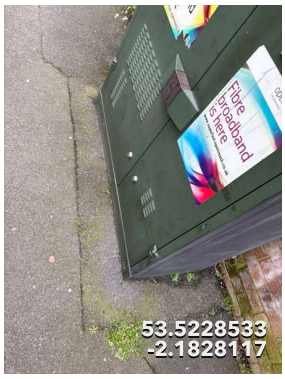
Photo 180

Ainsbrook Avenue
Trench scars along footway.

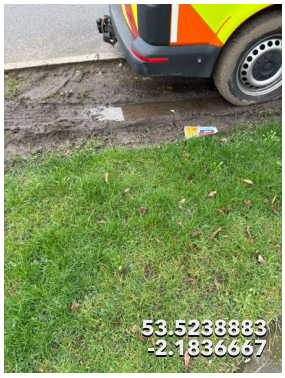
Photo 197

Ainsbrook Avenue
Verge destroyed by vehicles overrunning kerbs. Kerbs chipped.

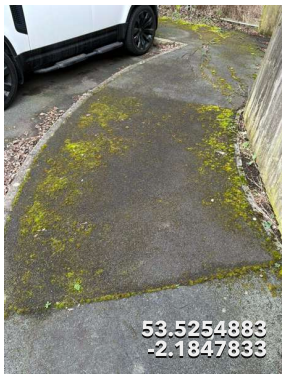
Photo 236

Caspian Rd
Large vegetation growth along footway. Scratches along footway at back of kerbs.
