Date: 22nd November 2024
Reference: 15-974 V22

GAS MEMBRANE VALIDATION – BENNETT STREET

Project Name:	Bennett Street
Project Number:	15-974
Client:	Kellen Homes
Date:	22-11-2024
Project Manager:	M. Dee
Engineer:	J. James
Ground Gas Risk Assessment:	Vapor Membranes Required
Gas Membrane Installers Name & Qualifications:	JCW Gas Membranes Ltd, NVQ Level 2 – Installation of Gas Membranes in Construction
Plot:	170-172

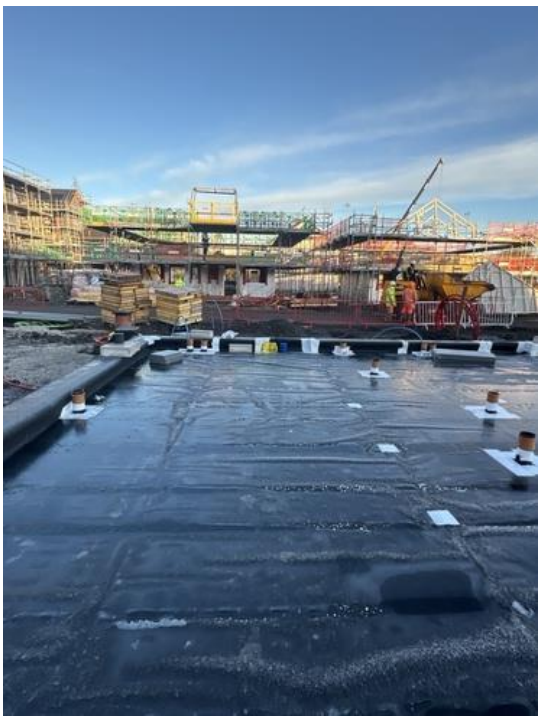
Are folds running in line with joints? (no joints cutting across folds)	Pass
Extent of Coverage: Is the membrane covering the entire plot? Does membrane span over outside walls?	Yes

Condition of sub-grade and underside of gas membrane: Check that the subgrade does not contain rough/uneven surfaces, is appropriately clean and that there are no hard/sharp objects. That protective sand blinding or geotextile (if specified) is present and meets the design criteria. (Lift back the membrane and photo the subfloor)	Pass
Slab / membrane condition (is membrane clear of snow, standing water, debris or insulation): Can membrane be fully seen and photographed – ask contractor to remove an debris so membrane can be fully seen an inspected – this is a requirement of NHBC and local authorities.	Pass
External Wall Air bricks: Numbers, size. positions as design drawing? (Minimum of 3 walls)	Pass

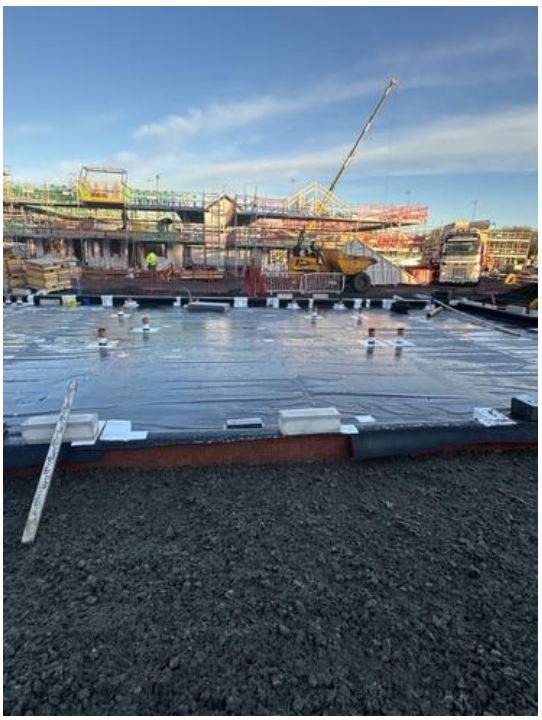
Condition of sub-grade and underside of gas membrane: Check that the subgrade does not contain rough/uneven surfaces, is appropriately clean and that there are no hard/sharp objects. That protective sand blinding or geotextile (if specified) is present and meets the design criteria. (Lift back the membrane and photo the subfloor)	Pass

Slab / membrane condition (is membrane clear of snow, standing water, debris or insulation): Can membrane be fully seen and photographed – ask contractor to remove an debris so membrane can be fully seen an inspected – this is a requirement of NHBC and local authorities.	Pass
External Wall Air bricks: Numbers, size. positions as design drawing? (Minimum of 3 walls)	Pass

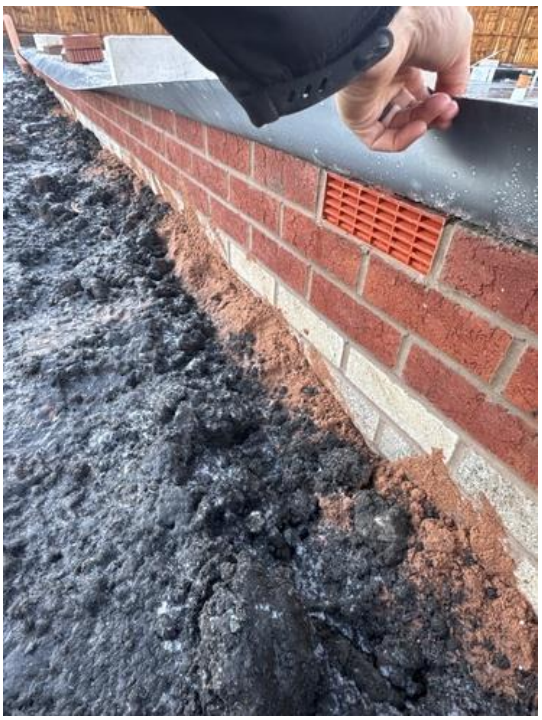
Condition of sub-grade and underside of gas membrane: Check that the subgrade does not contain rough/uneven surfaces, is appropriately clean and that there are no hard/sharp objects. That protective sand blinding or geotextile (if specified) is present and meets the design criteria. (Lift back the membrane and photo the subfloor)

Slab / membrane condition (is membrane clear of snow, standing water, debris or insulation): Can membrane be fully seen and photographed – ask contractor to remove an debris so membrane can be fully seen an inspected – this is a requirement of NHBC and local authorities.
