CRACK MONITORING
for Subsidence Management Services

3 Winster Avenue, MANCHESTER, M20 2YG

Client:	Subsidence Management Services
Client Contact:	John Morrison
Claim Number:	500392020
Client Reference:	IFS-LBG-SUB-22-0102241
Policy Holder:	Mr Kevin Stout
Report Date:	10 February 2023
Our Ref:	M19269

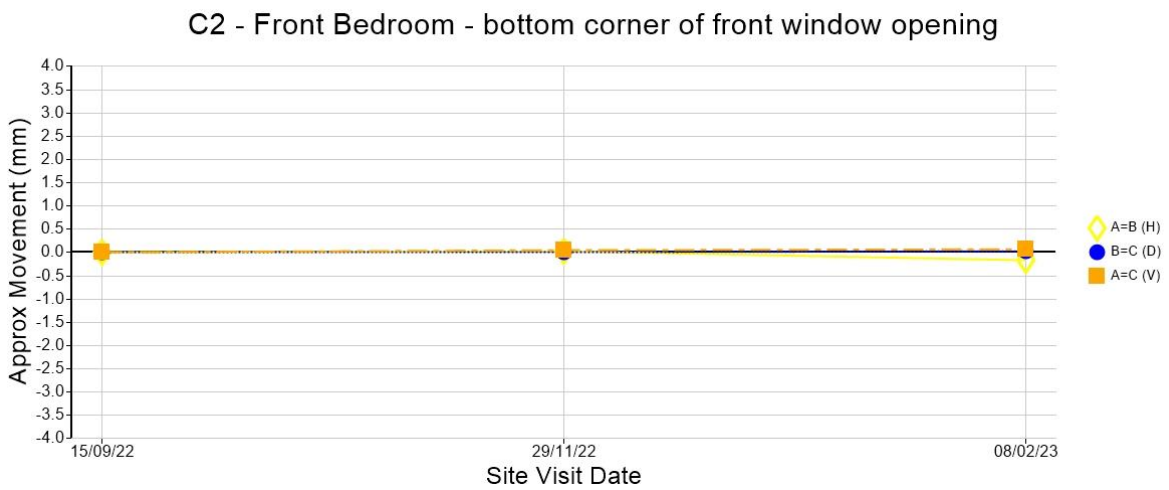
Crack Monitoring Difference Graphs

The following graphs display the progressive movement that each Crack Monitoring Station recorded at each separate site visit date to give an overall look at how much the property is moving.
