LEVEL MONITORING

for Subsidence Management Services

3 Winster Avenue, MANCHESTER, M20 2YG

Client:	Subsidence Management Services
Client Contact:	John Morrison
Claim Number:	500392020
Client Reference:	IFS-LBG-SUB-22-0102241
Policy Holder:	Mr Kevin Stout
Report Date:	10 February 2023
Our Ref:	M19269

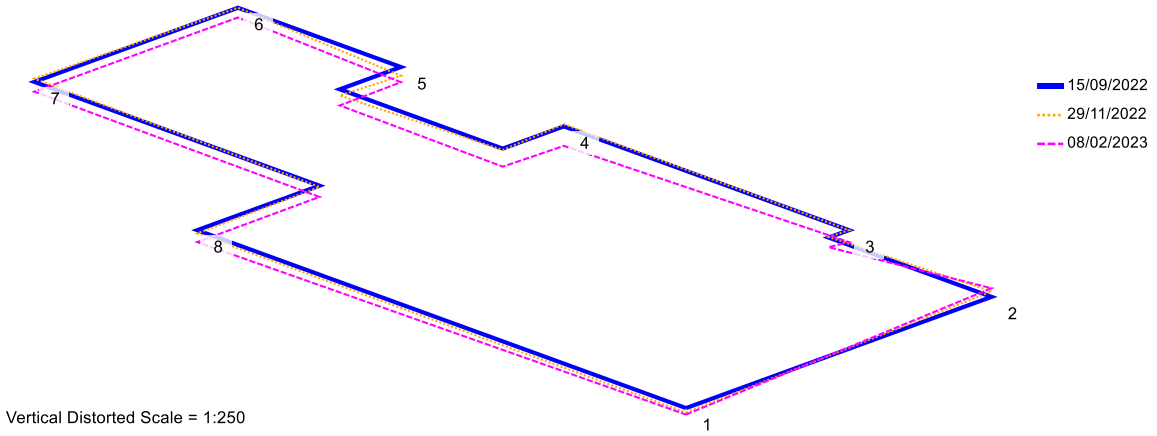
Level Monitoring Displacement Map

The following image shows an isometric representation of the movement of the property, based on the Level Monitoring Stations that were installed.
