Jersey Wharf, Ancoats

Remediation Verification Report

Curtins Ref: 077879-CUR-XX-XX-T-GE-00005

Client Name: John Sisk & Son Ltd

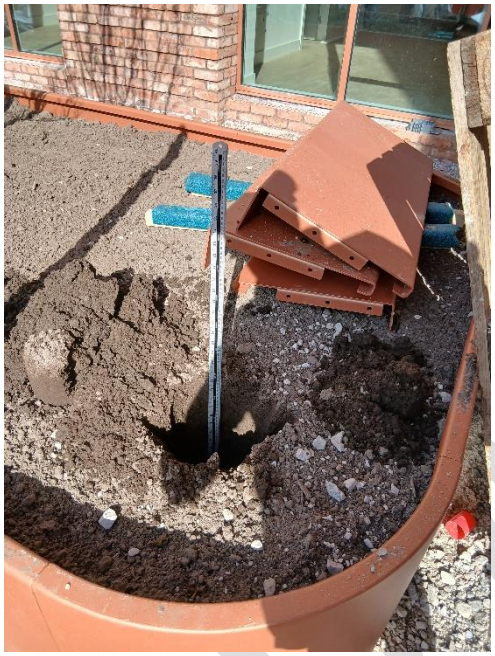
Hole: TP102

Photographic Record: Capping Layer Depth Validation

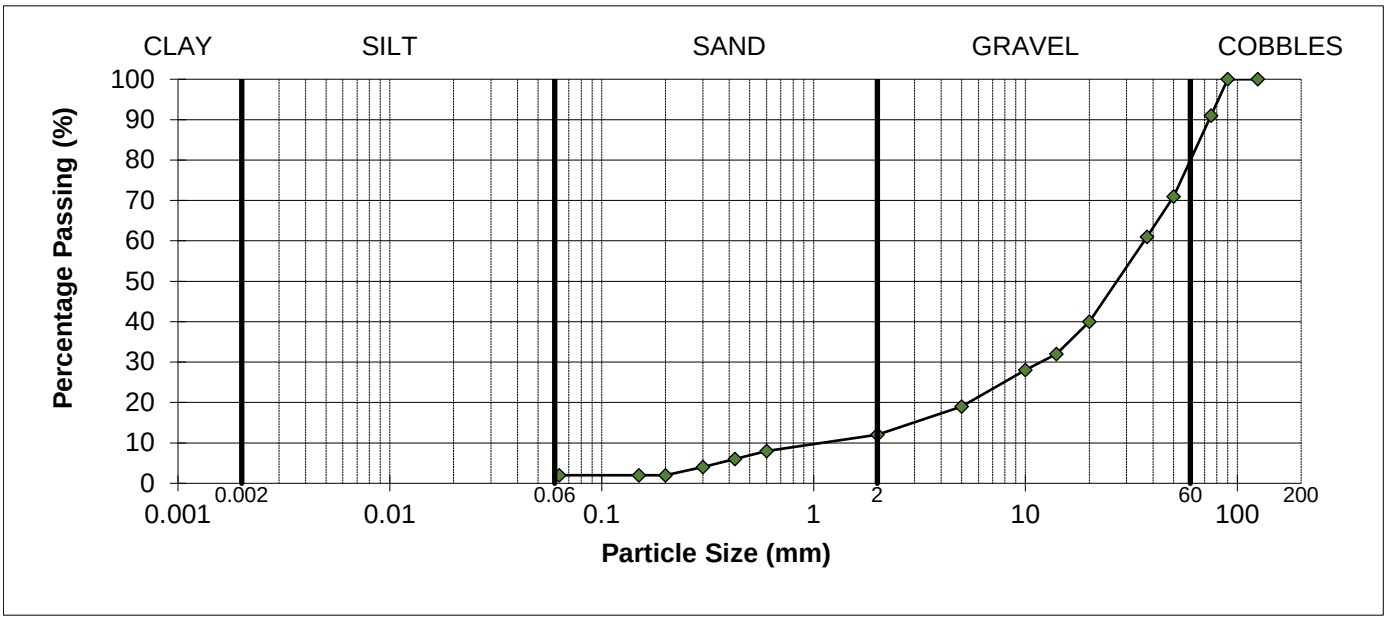
REMARKS
Sample complies with the advised grading specification for a 6F2 material (SHW 2016)
As received water content = 9.4%

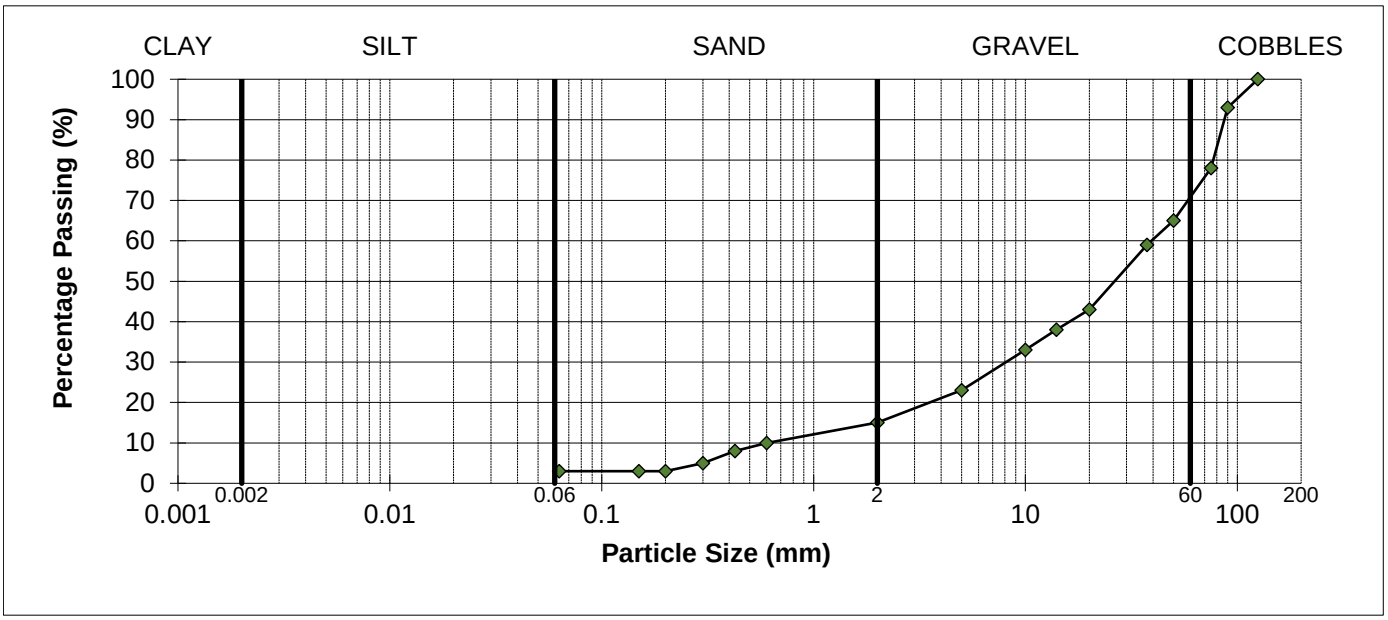
REMARKS
Sample complies with the advised grading specification for a 6F2 material (SHW 2016)
As received water content = 10.9%

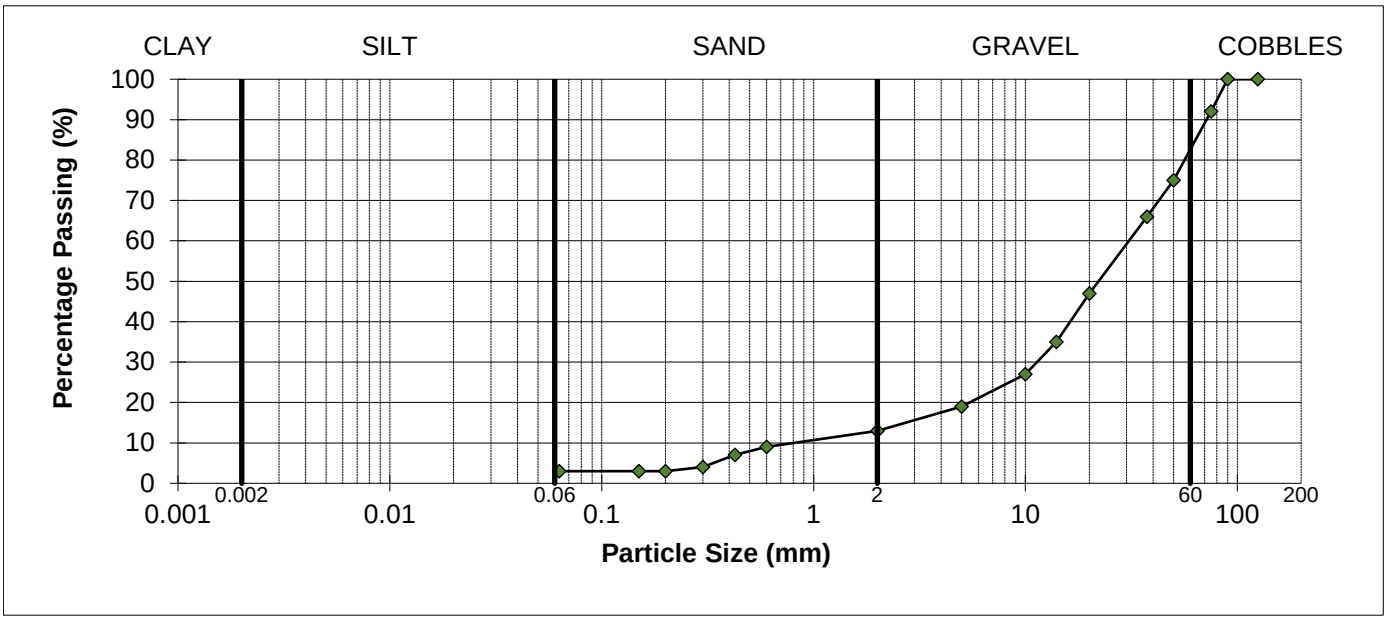
REMARKS
Sample complies with the advised grading specification for a 6F2 material (SHW 2016)
As received water content = 10.0%

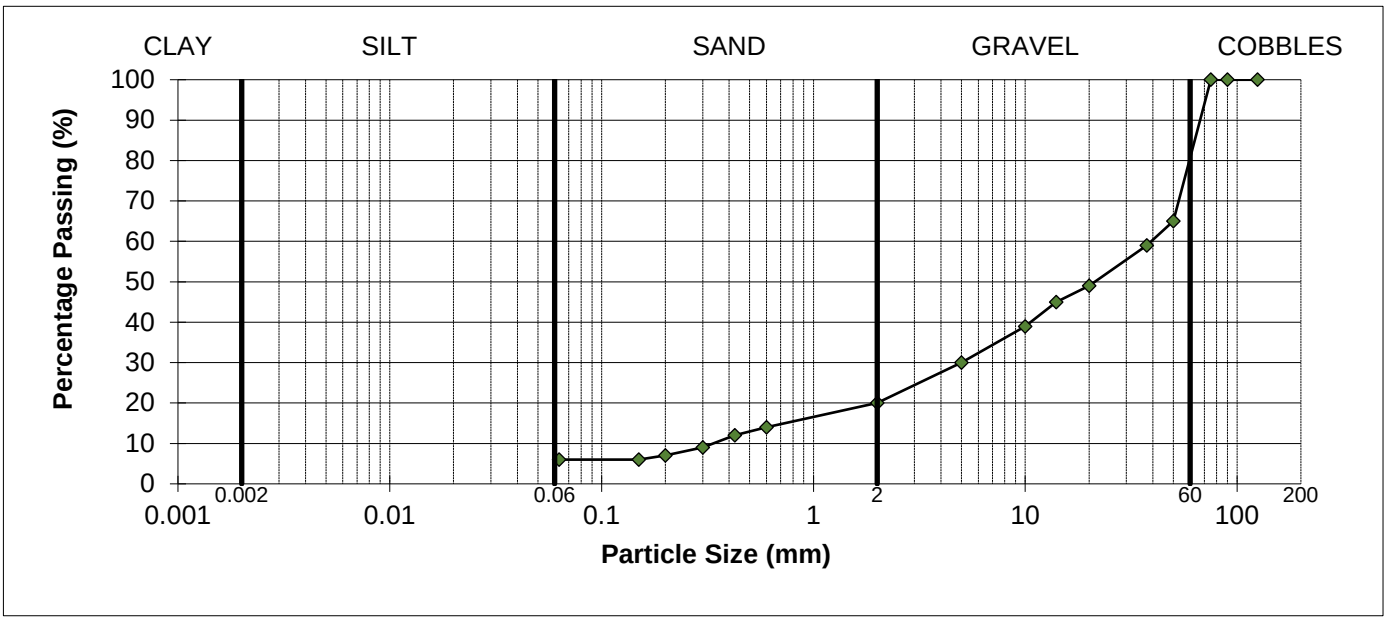
REMARKS
Sample complies with the advised grading specification for a 6F2 material (SHW 2016)
As received water content = 13.4%

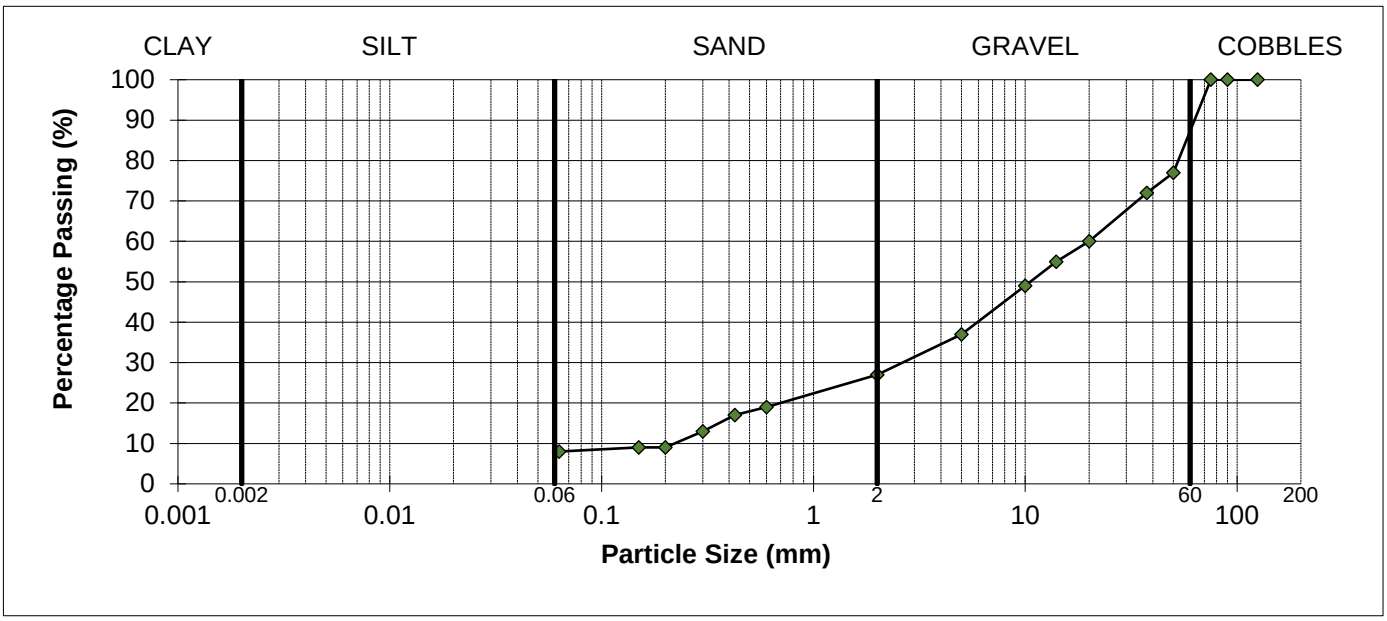
REMARKS
Sample complies with the advised grading specification for a 6F2 material (SHW 2016)
As received water content = 15.2%

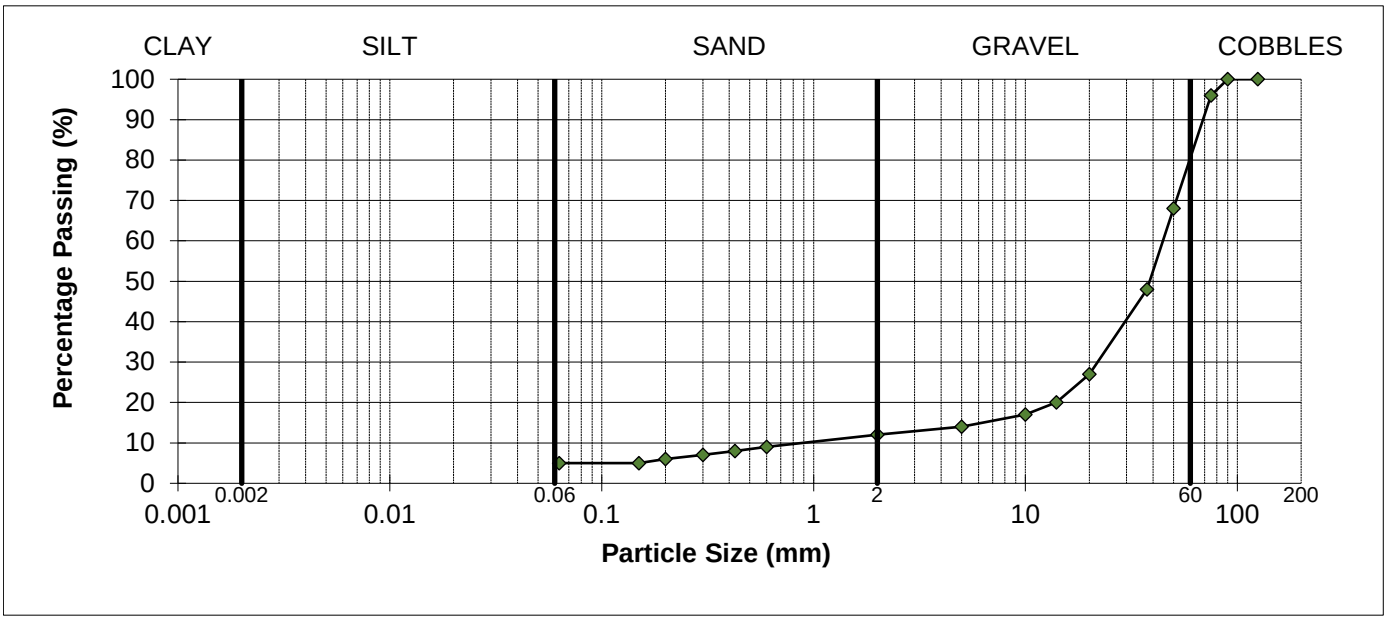
REMARKS
Sample complies with the advised grading specification for a 6F2 material (SHW 2016)

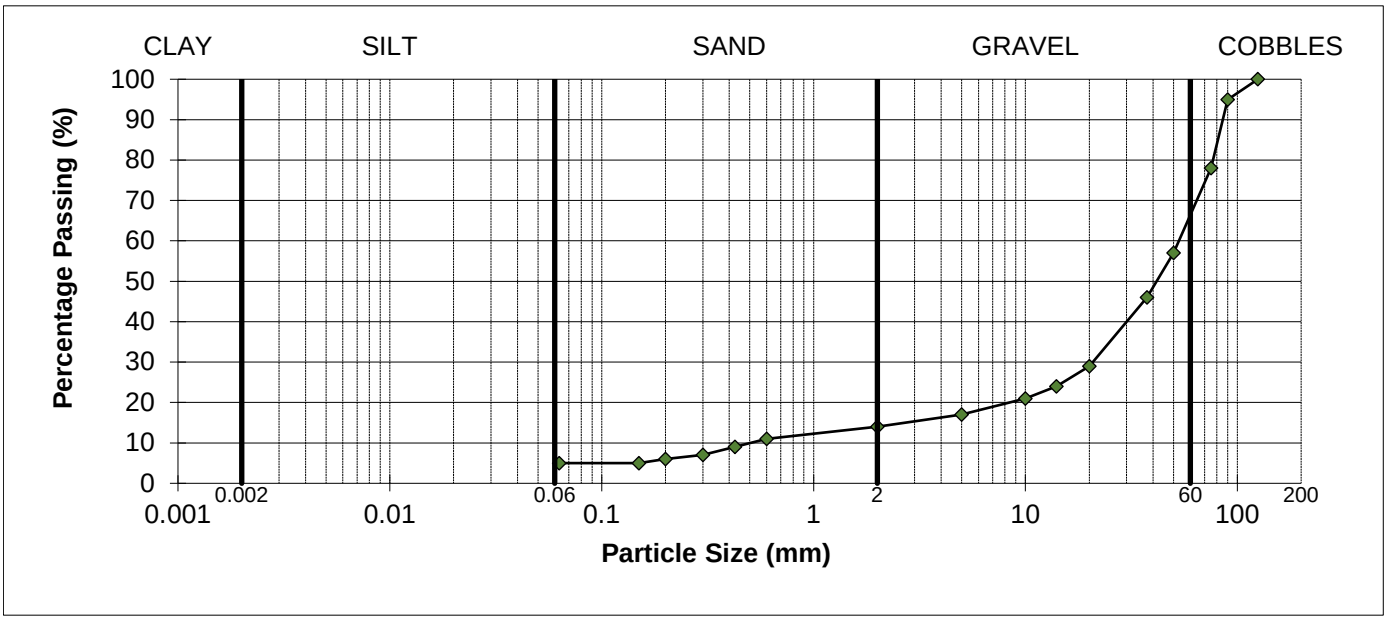
REMARKS
Sample complies with the advised grading specification for a 6F2 material (SHW 2016)

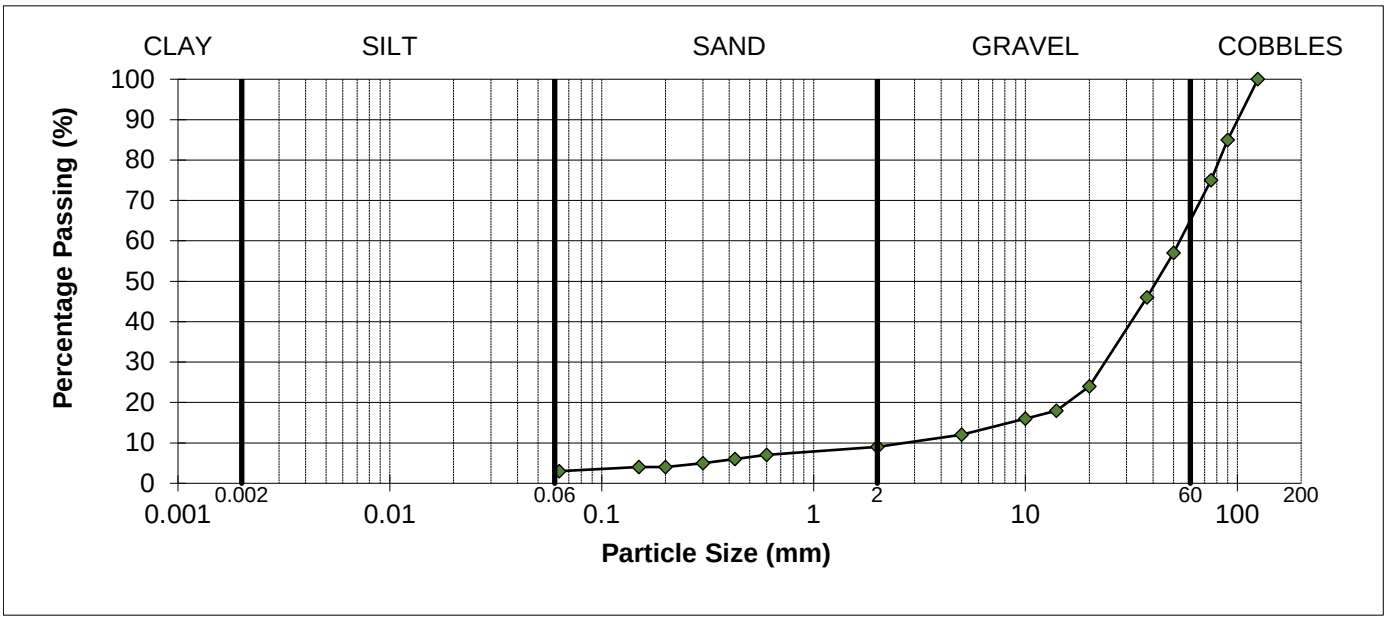
REMARKS
Sample complies with the advised grading specification for a 6F2 material (SHW 2016)
