MIRABEL HOUSE
GREAT DUCIE STREET
MANCHESTER

PHASE 2 GEO-ENVIRONMENTAL INVESTIGATION, RISK ASSESSMENT AND REMEDIATION STRATEGY

Job Number: LKC 21 1684
Date: January 2023
Client: One Heritage Great Ducie Street Ltd

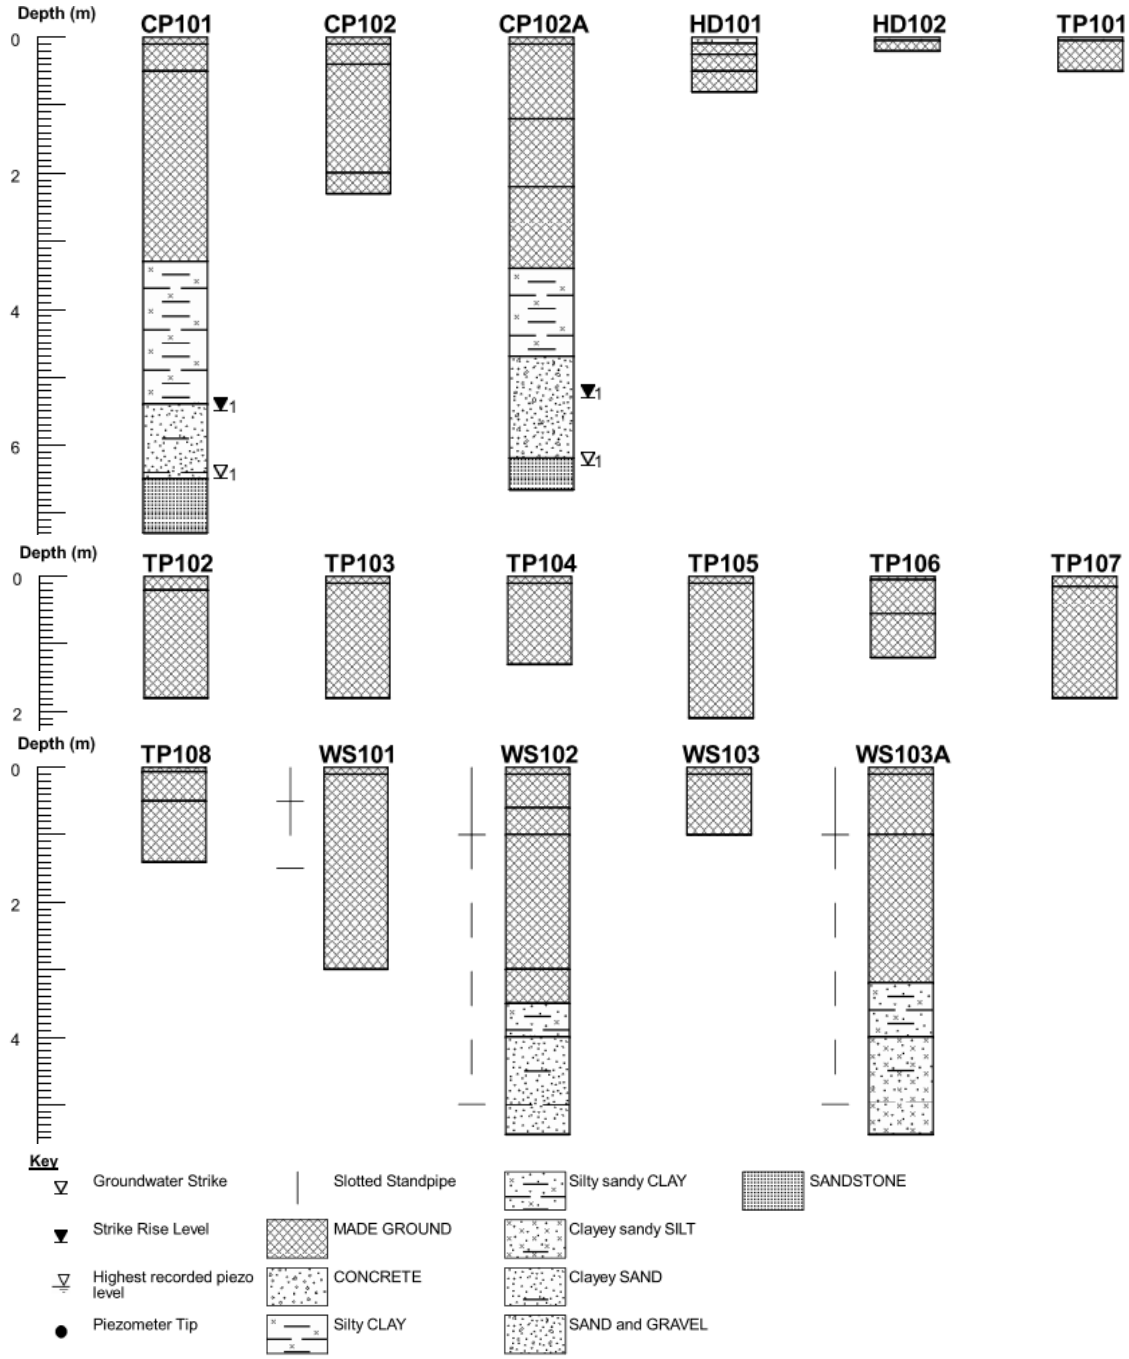
Plate 4-1: Summary of ground conditions.

The ground conditions beneath the site comprised made ground underlain by natural cohesive strata to depths of between 4.0m and 5.4mbgl which is further underlain by granular strata to depths of between 6.2m and 6.5mbgl. Bedrock of red sandstone was encountered at the base of the cable percussive boreholes. A summary section of the logs is provided in Plate 4-1, with additional comments below.

Superficial deposits comprised soft to firm variably silty sandy CLAY underlain by loose to very dense granular deposits of slightly sandy clay and clay bound SANDs and GRAVELs to depths of between 6.2-6.5mbgl. Soft clayey sandy SILT was recorded wihtin WS103A from a depth of 4.00mbgl to the base of the exploratory hole.

Red SANDSTONE was encountered at the base of the cable percussive boreholes and proven to a depths of 14.9-16.1mbgl within the rotary cored boreholes. Parameters including total and solid core recovery (TCR and SCR), rock quality designation (RQD) and fracture indices (FI) are included on the profile logs in Appendix B.

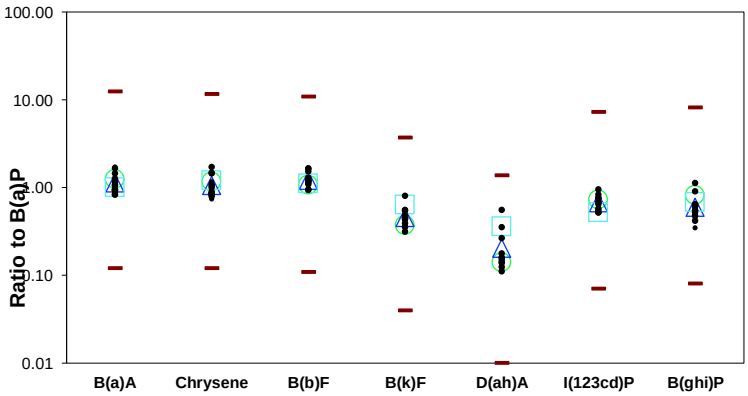
Graph 6-1: The ratio of PAH to B(a)P in soil for all available data at the site based on 15 samples (where values were >LOD to allow the calculation of a ratio).

Graph 6-1 summarises the study site data with respect to how the ratios of carcinogenic PAHs relate to B(a)P, within the confidence limits provided in the HPA document.

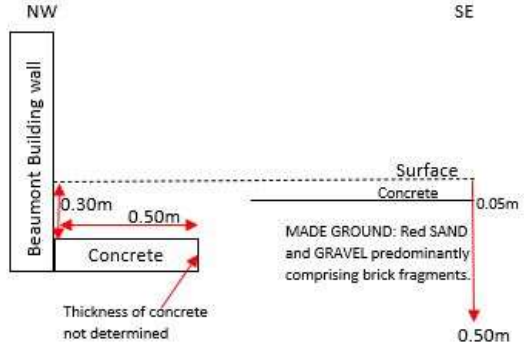
TP101 cross section S1. Not to scale.
Hand auger refusal at 0.50mbgl on brick.

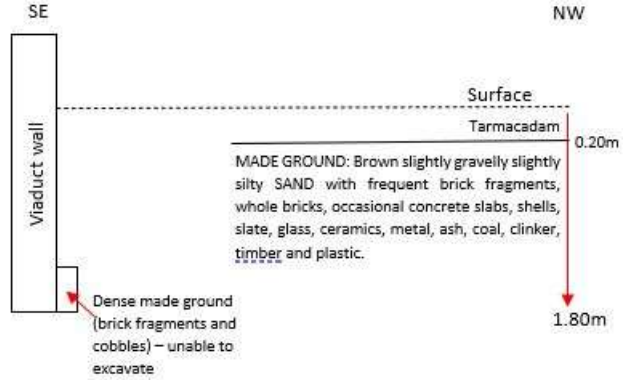
TP102 cross section S1. Not to scale. Pit not excavated beyond 1.80mbgl due to machine limitations. Base of / foundations of viaduct wall not encountered.

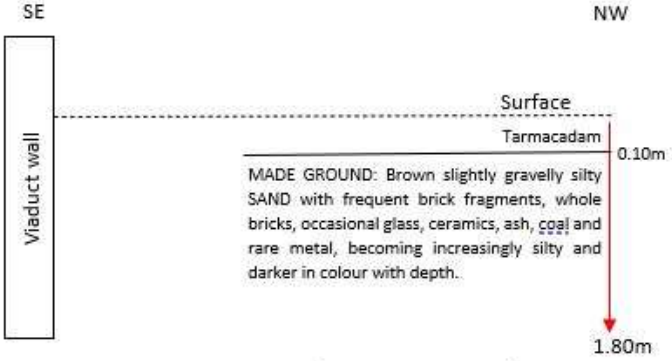
TP103 cross section S1. Not to scale. Pit not excavated beyond 1.80mbgl due to machine limitations. Base of / foundations of viaduct wall not encountered.

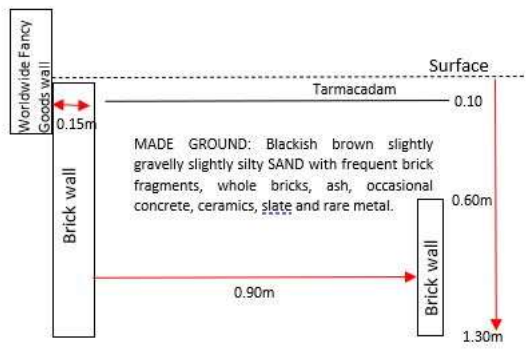
TP104 cross section S1. Not to scale. Pit not excavated beyond 1.30mbgl due to instability of NNE brick wall. Bases of walls not encountered.

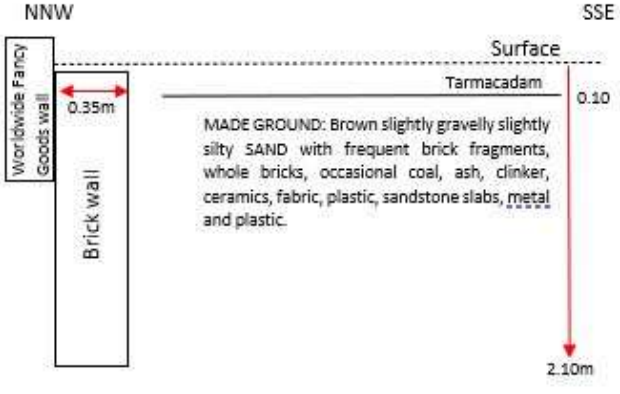
TP105 cross section S1. Not to scale. Base of wall not encountered.

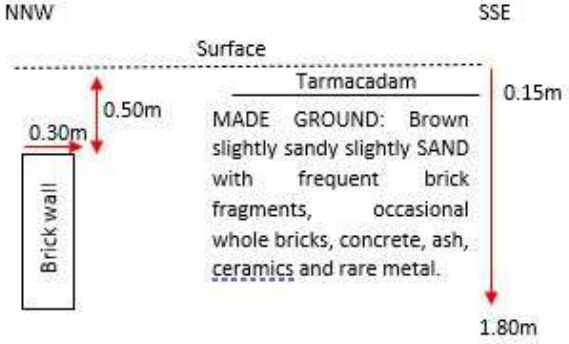
TP107 cross section S1. Not to scale. Base of brick wall not encountered. Pit not excavated beyond 1.80mbgl due to limitations of the machine.

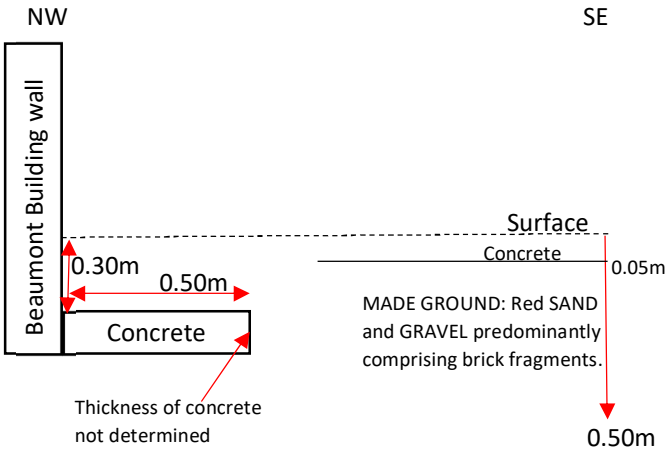
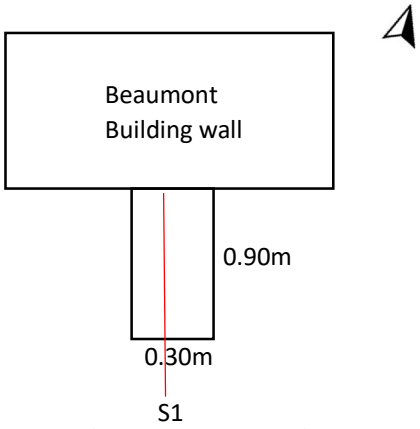
TP101 cross section S1. Not to scale.
Hand auger refusal at 0.50mbgl on brick.

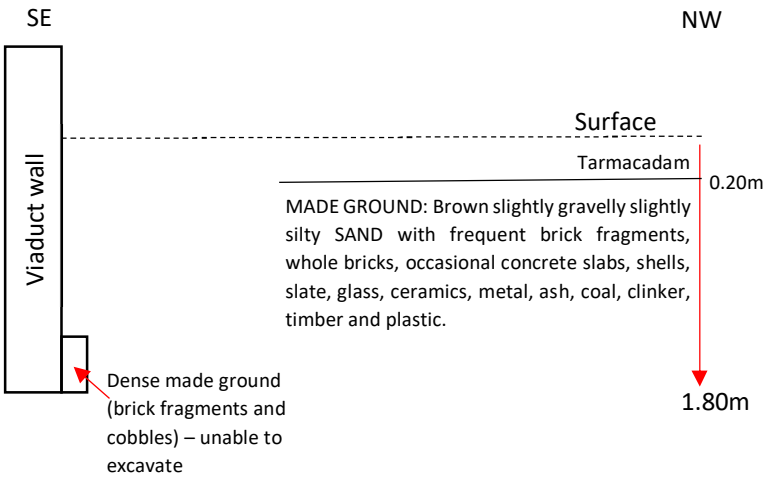
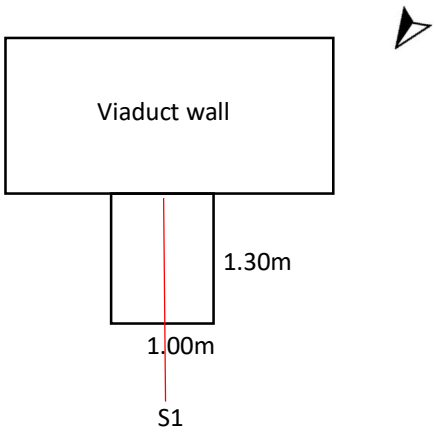
TP102 and TP103 were excavated adjacent to the viaduct in the southern area of site. The pits were excavated to 1.80mbgl and the base of / foundations of the viaduct wall were not encountered. The pits were not excavated beyond 1.80mbgl due machine limitations.

TP102 cross section S1. Not to scale. Pit not excavated beyond 1.80mbgl due to machine limitations. Base of / foundations of viaduct wall not encountered.

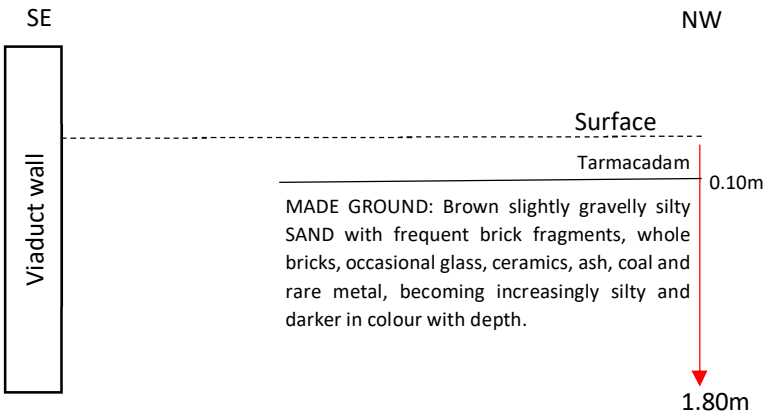
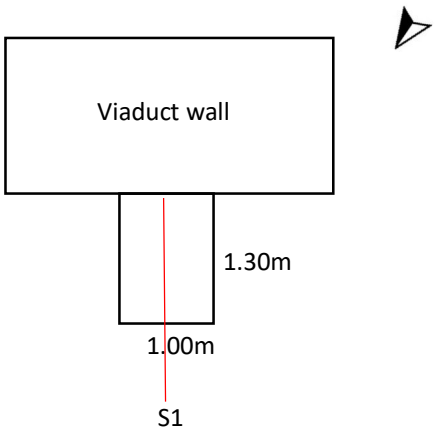
TP103 cross section S1. Not to scale. Pit not excavated beyond 1.80mbgl due to machine limitations. Base of / foundations of viaduct wall not encountered.

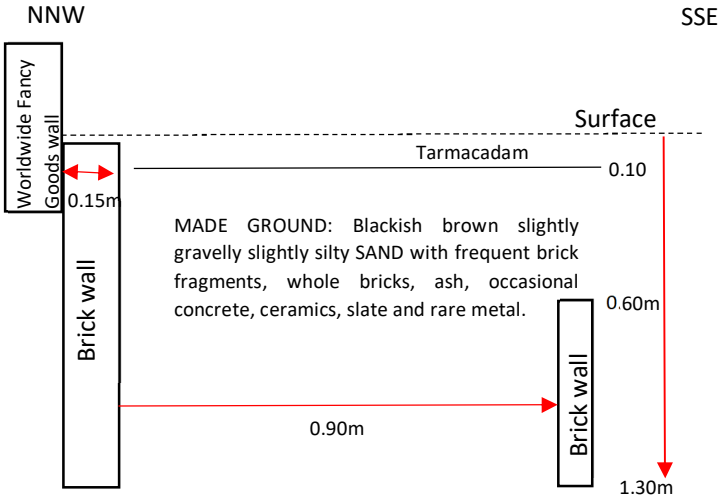
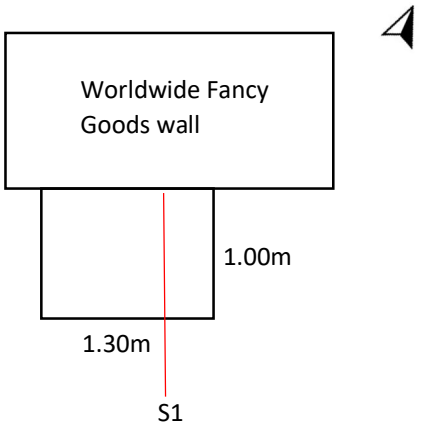
TP104 cross section S1. Not to scale. Pit not excavated beyond 1.30mbgl due to instability of NNE brick wall. Bases of walls not encountered

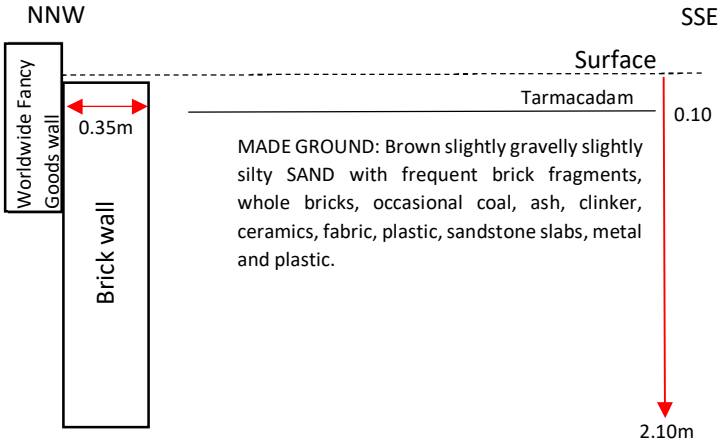
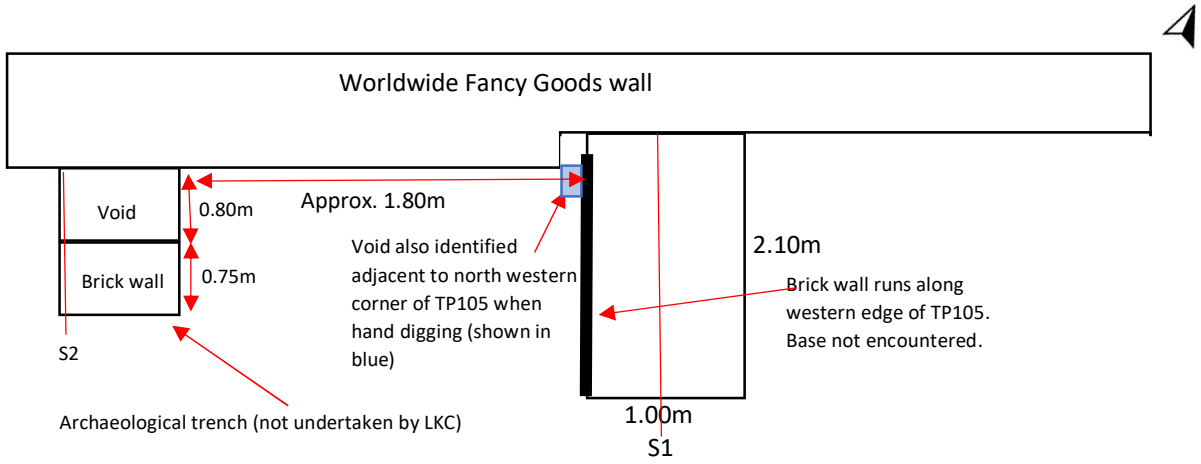
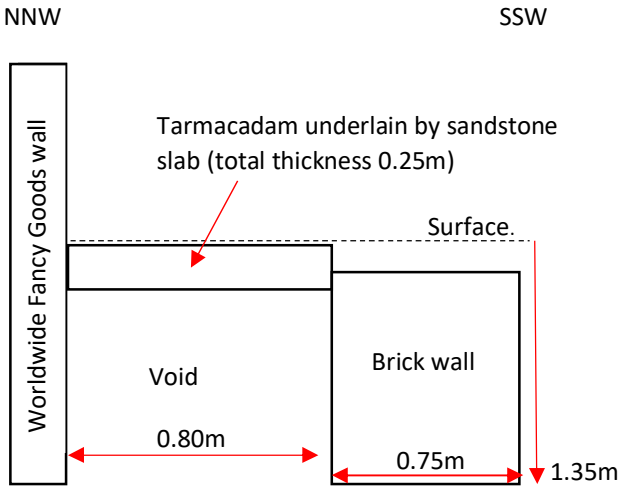
TP105 cross section S1. Not to scale. Base of wall not encountered.

TP105 plan view. Not to scale. Archaeological trench to the west (not undertaken by LKC). Cross section shown below (S2).

S2. Not to scale. Archaeological trench (not undertaken by LKC) cross section. Base of walls not encountered.

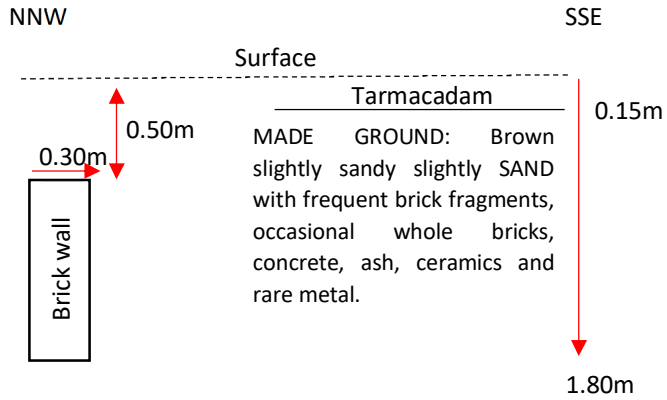
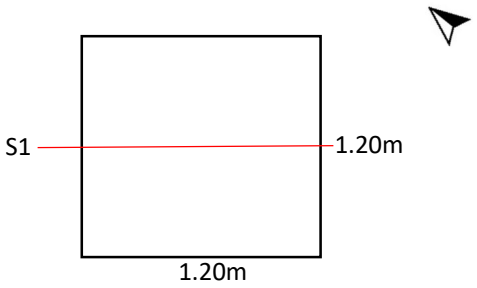
TP107 was excavated in the central area of site to expose suspected remnant foundations at approximately 0.70mbgl. A brick wall was encountered in the north western side of the pit at 0.50mbgl. The base of the wall was not encountered.

TP107 cross section S1. Not to scale. Base of brick wall not encountered. Pit not excavated beyond 1.80mbgl due to limitations of the machine.
