Phase II Geoenvironmental Site Assessment

Site: Hinchley Road, Charlestown
Reference: 17-994-R1-1
Date: January 25

Report reference	17-994-R1

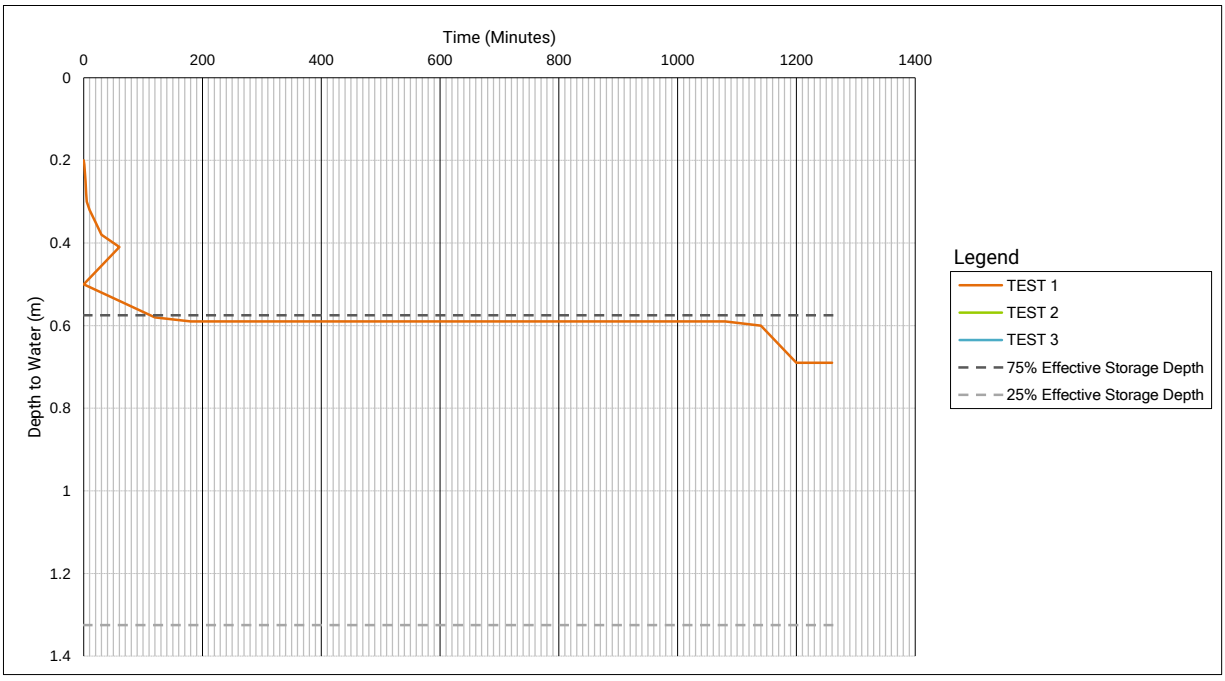
Site:	Hinchley Rd		**Trial Pit Number:**	SA102	
Job Number:	17-994		**Length:**	2.90	m
Date of Test:	30-31/10/2024		**Width:**	0.70	m
			Depth:	1.50	m
Drafted	Rev	Auth	**Groundwater Level:**	Not Encountered	m
MSD	1	DC

DESIGN SOIL INFILTRATION RATE, f	**N/A - Failed to reach 25% effective depth within 24 hours and therefore tests were terminated.**

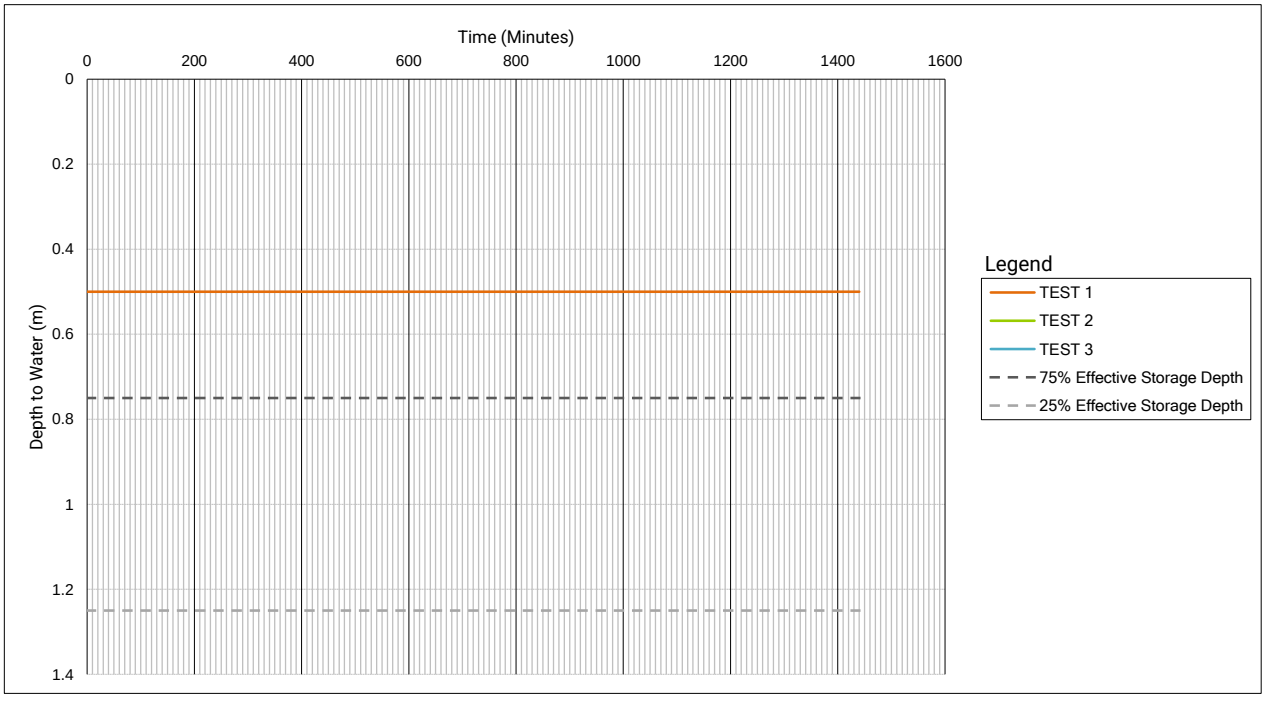
Site:	Hinchley Rd	**Trial Pit Number:**	SA103
Job Number:	17-994	**Length:**	2.60 m
Date of Test:	30-31/10/2024	**Width:**	0.70 m
		Depth:	2.20 m
		Groundwater Level:	Not encountered m

DESIGN SOIL INFILTRATION RATE, f	**N/A - Failed to reach 25% effective depth within 24 hours and therefore tests were terminated.**
